# Pier Substructure

## City of Naples / Naples Pier

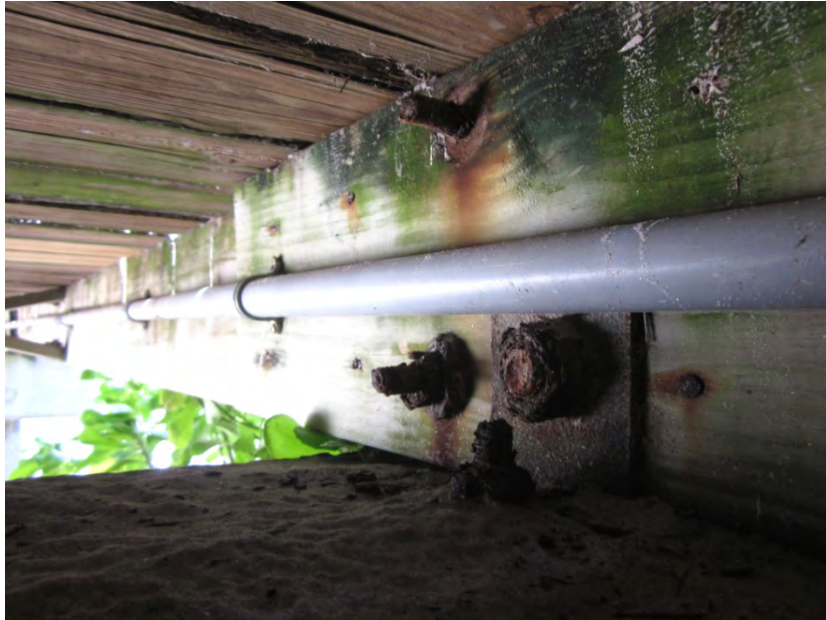
| Photo | Descriptions/Comments |
|---|---|
| | <p><b><u>Issue:</u></b> The rail post thru-bolt connectors and anchor bolt/ clip angle assembly on this side are undergoing severe corrosion as well. Note the top thru-bolt washer and hex-nut have been corroded away.</p> <p><b><u>Resolution:</u></b> Perform regular inspection and replace severely corroded washers and hex-nuts. In some case the galvanized clip angle may need replacement as well.</p> |

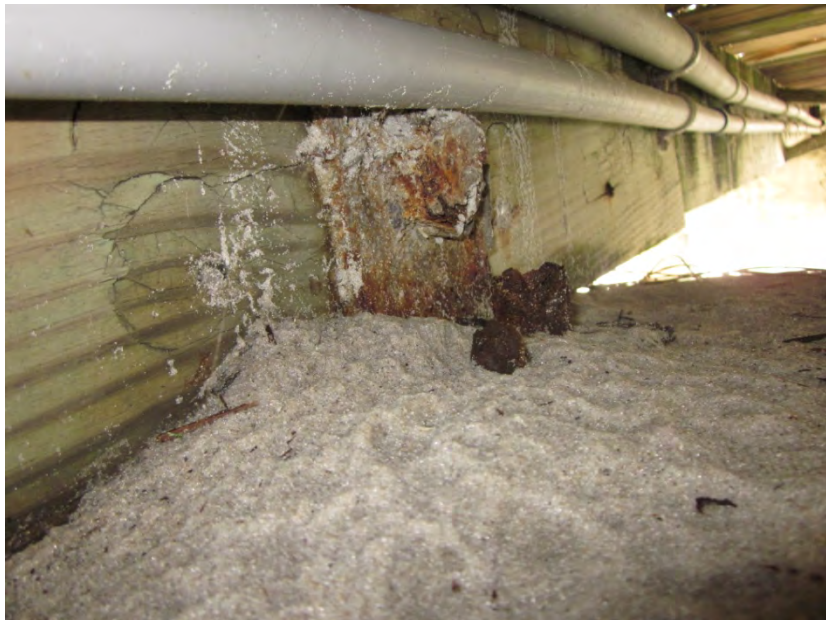
| Photo | Descriptions/Comments |
|---|---|
| | <p><b><u>Issue:</u></b> View of an inside stringer anchor bolt/clip angle assembly which is normally buried under the wet beach sand and debris causing accelerated corrosion of the metal hardware.</p> <p><b><u>Resolution:</u></b> Regular inspection and replacement of deteriorated hardware is required.</p> |

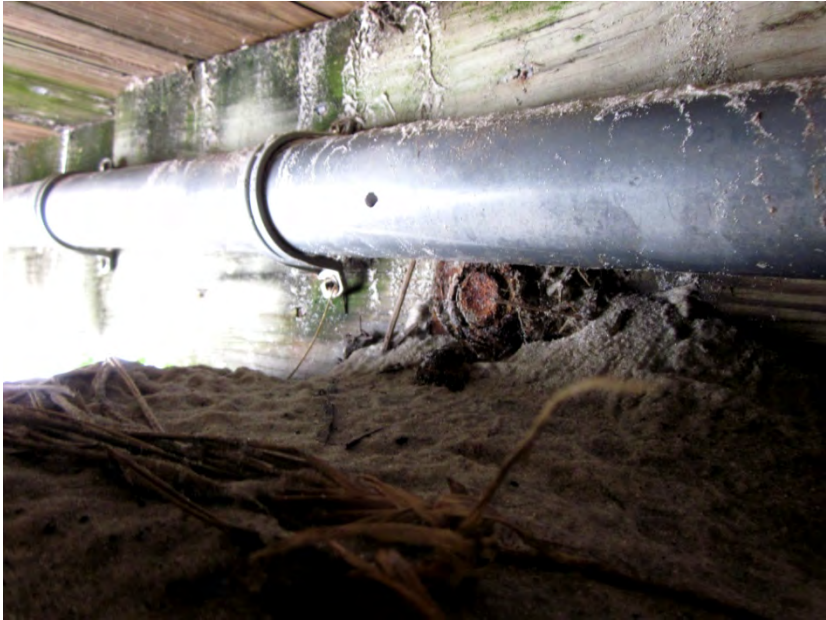
| Photo | Descriptions/Comments |
|---|---|
| | <p><b><u>Issue:</u></b> See preceding issue.</p> <p><b><u>Resolution:</u></b> See preceding resolution.</p> |

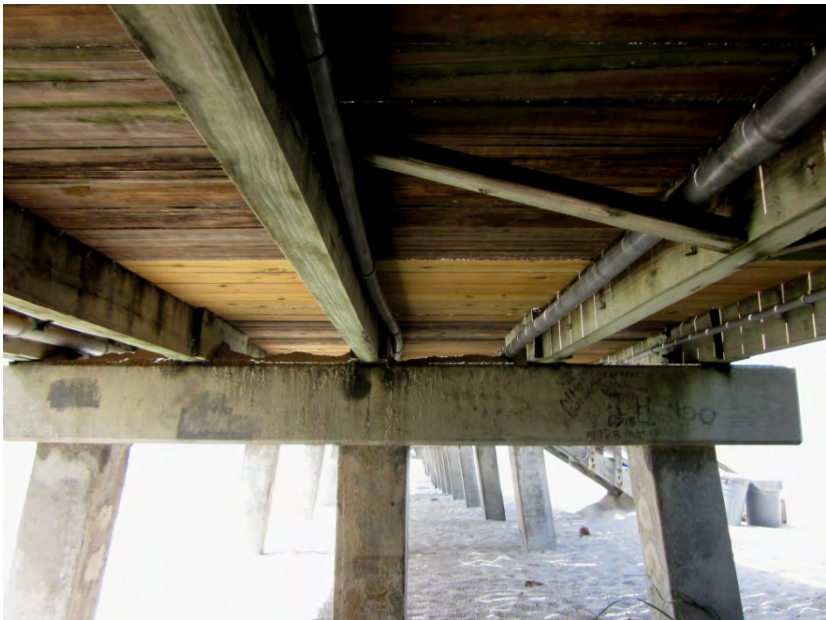
| Photo | Descriptions/Comments |
|---|---|
| | <p><b><u>Description:</u></b> General view of the decking underside and the substructure, looking seaward at Pier #4. Note the water piping and electrical conduits. Also note random horizontal cross-bracing.</p> |

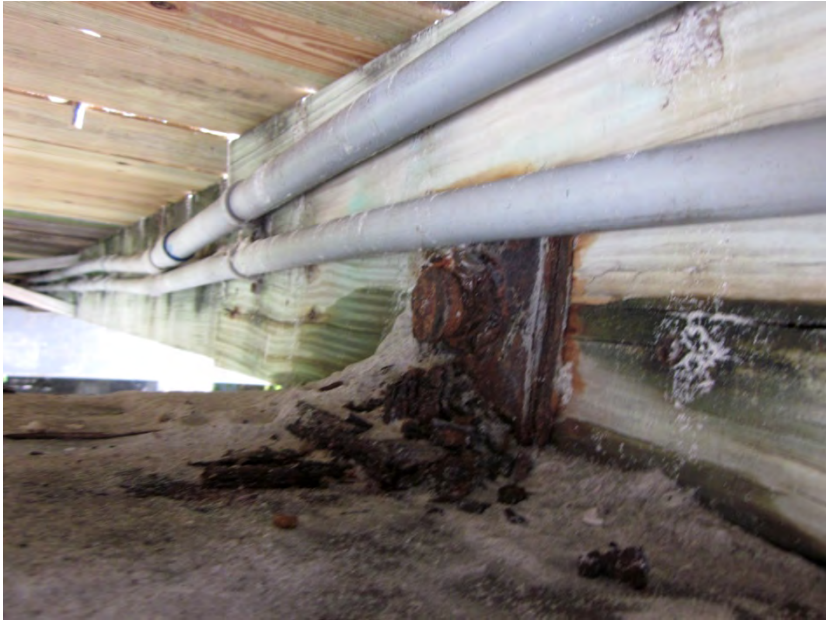
| Photo | Descriptions/Comments |
|---|---|
| | <p><b><u>Issue:</u></b> See preceding issue.</p> <p><b><u>Resolution:</u></b> Inspect and replace corroded metal hardware. Replace all broken plastic pipe straps and hangers to properly support the pipe/conduit.</p> |

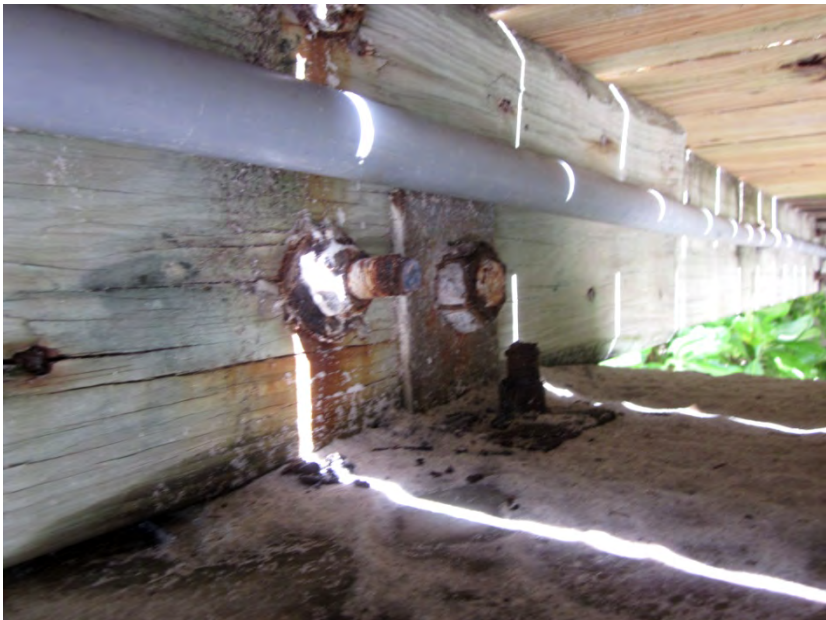
| Photo | Descriptions/Comments |
|---|---|
| | <p><b><u>Issue:</u></b> See preceding issue.</p> <p><b><u>Resolution:</u></b> Inspect and replace corroded metal hardware. Replace all broken plastic pipe straps and hangers to properly support the pipe/conduit.</p> |

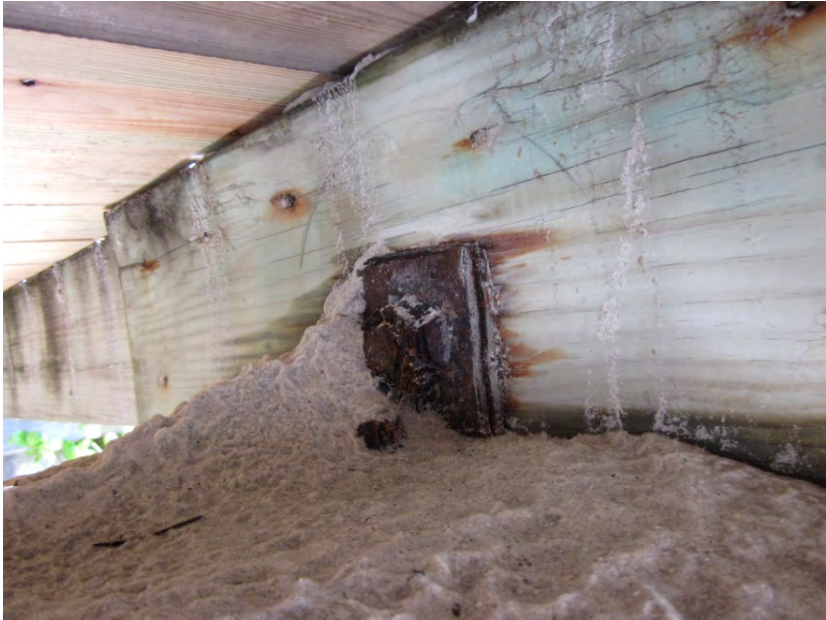
| Photo | Descriptions/Comments |
|---|---|
| | <p><b><u>Issue:</u></b> See preceding issue.</p> <p><b><u>Resolution:</u></b> See preceding resolution.</p> |

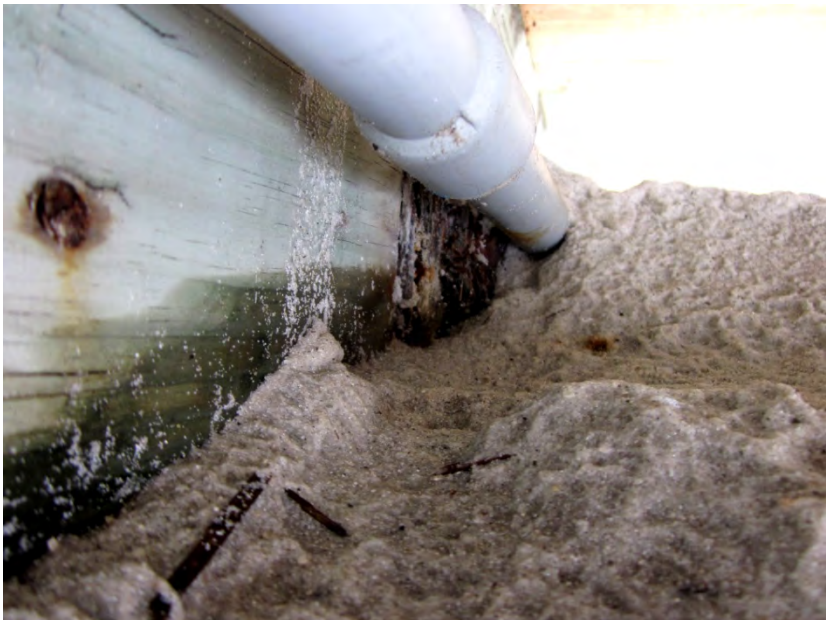
| Photo | Descriptions/Comments |
|---|---|
| | <p><b><u>Issue:</u></b> See preceding issue.</p> <p><b><u>Resolution:</u></b> Inspect and replace corroded metal hardware. Replace all broken plastic pipe straps and hangers to properly support the pipe/conduit.</p> |

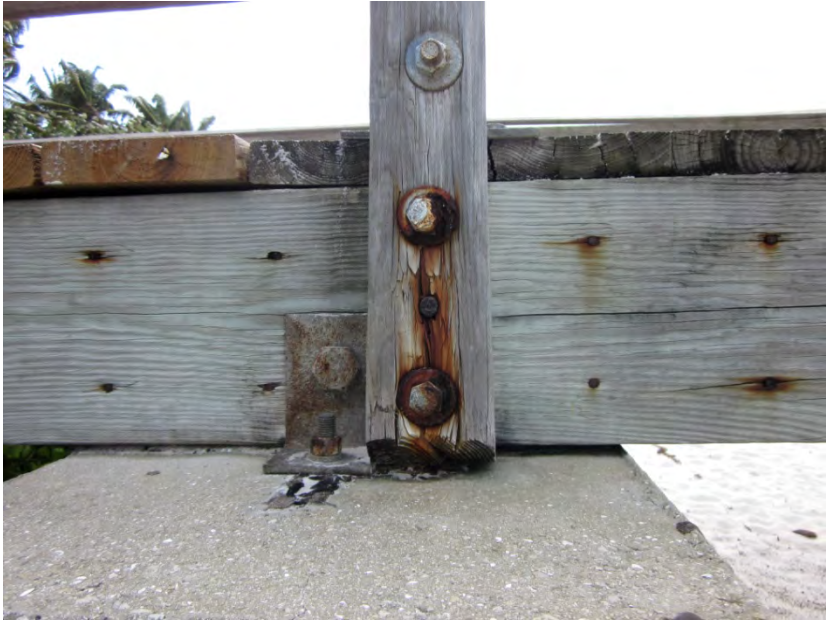
| Photo | Descriptions/Comments |
|---|---|
| | <p><b>Description:</b> The rail post base thru-bolts display sign of corrosion which starts from the opposite side. The anchor bolt/clip angle assembly appears satisfactory.</p> |

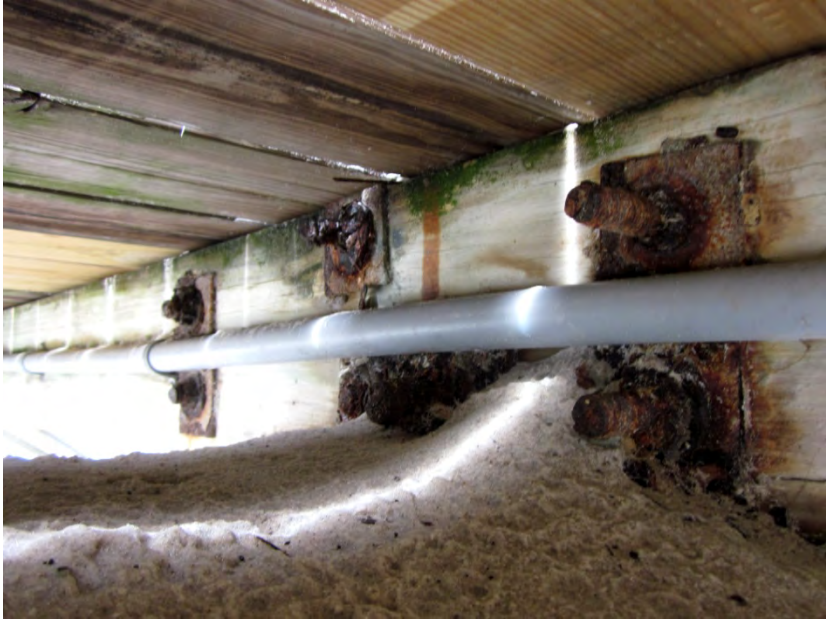
| Photo | Descriptions/Comments |
|---|---|
| | <p><b><u>Issue:</u></b> View of the same assembly on the interior face, which reveals severe corrosion of almost all the thru-bolts.</p> <p><b><u>Resolution:</u></b> Inspect and replace corroded metal hardware. Replace all broken plastic pipe straps and hangers to properly support the pipe/conduit.</p> |

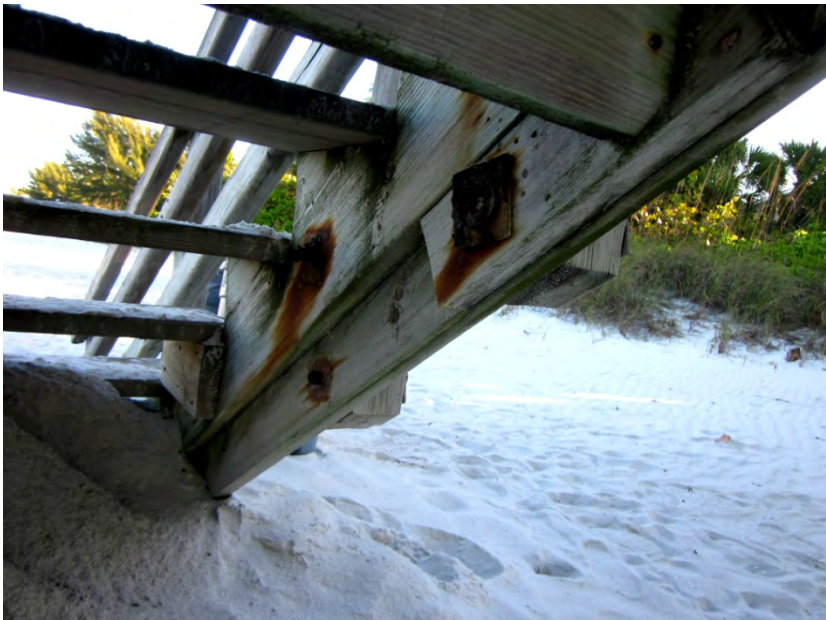
| Photo | Descriptions/Comments |
|---|---|
| | <p><b><i>Issue:</i></b> Almost all of the stair assembly thru-bolt connections display severe corrosion of the metal hardware.</p> <p><b><i>Resolution:</i></b> Inspect and replace corroded metal hardware.</p> |

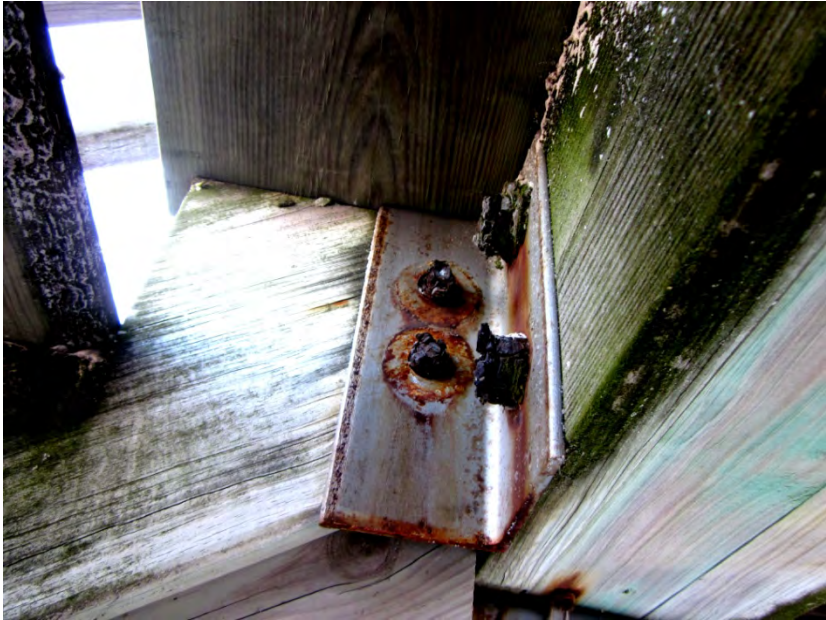
| Photo | Descriptions/Comments |
|---|---|
| | <p><b><i>Issue:</i></b> Stair stringer/deck stringer vertical connection assembly display severe corrosion of the metal hardware.</p> <p><b><i>Resolution:</i></b> Inspect and replace corroded metal hardware. To ensure structural soundness and durability, and to provide users a sense of safety and aesthetic, the entire stair may have to be rebuilt with better corrosion and weather resistant materials in near term.</p> |

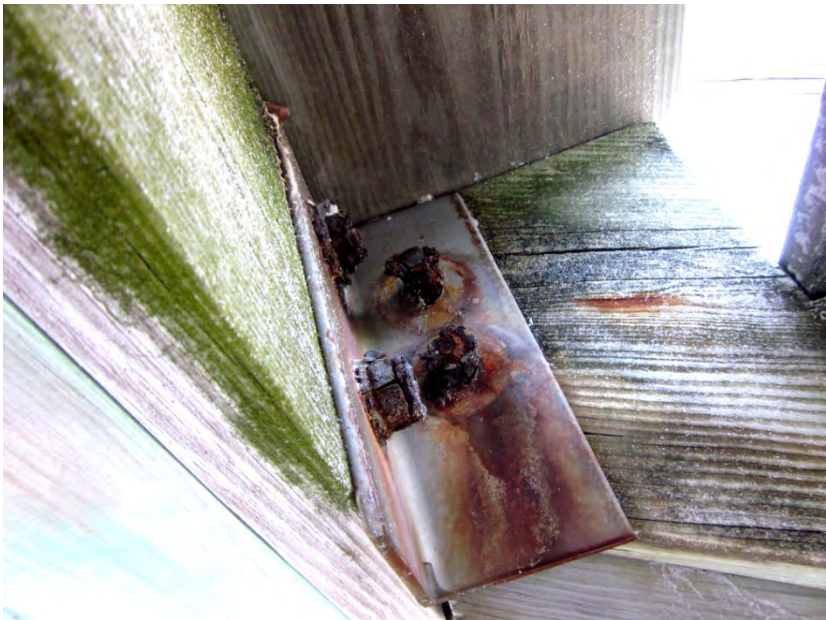
| Photo | Descriptions/Comments |
|---|---|
| | <p><b><i>Issue:</i></b> See preceding issue.</p> <p><b><i>Resolution:</i></b> See preceding resolution.</p> |

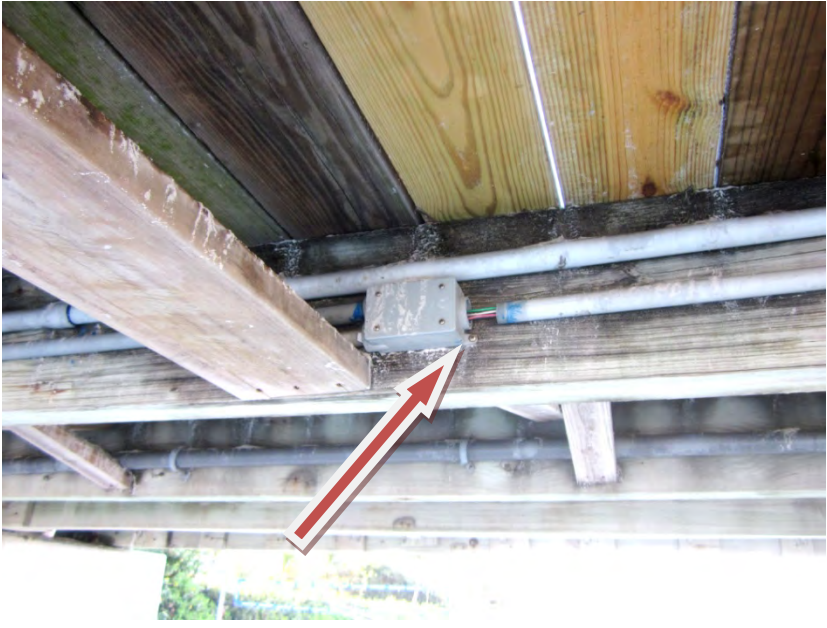
| Photo | Descriptions/Comments |
|---|---|
| | <p><b><u>Issue:</u></b> The movement of the deck under wind gust can pull pipe/conduit out of its joint and/or rip a pipe segment out of its strapping.</p> <p><b><u>Resolution:</u></b> Repair or replace all broken and loose pipe/conduit fitting and wiring when the deck boards are due for removal and replacement. Provide proper and durable pipe/conduit straps and hangers to ensure firm attachment and support against periodic dynamic loads.</p> |

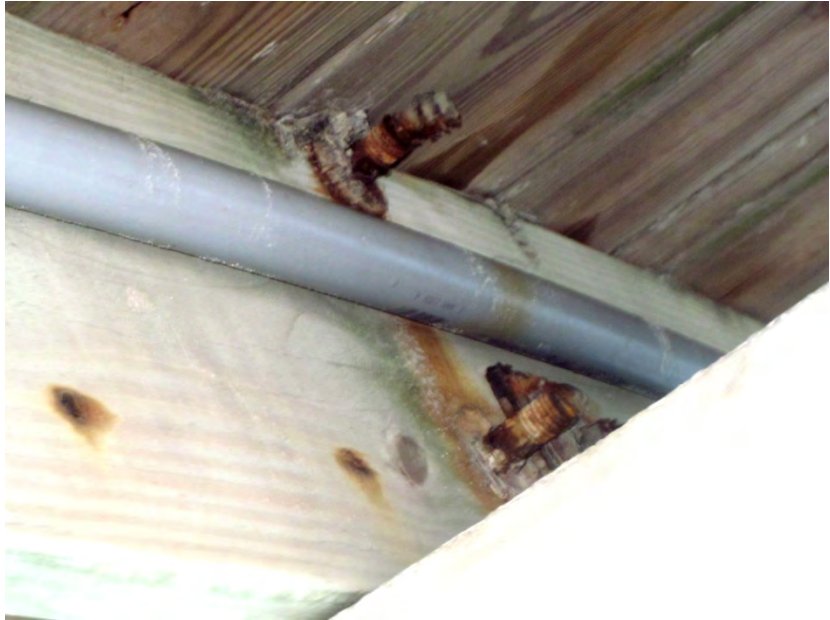
| Photo | Descriptions/Comments |
|---|---|
| | <p><b><i>Issue:</i></b> Pier #9. See preceding issue. Note the two hex-nuts and a washer have corroded away and cleared from the end of the rail post thru-bolts causing potential faulty structural connections.</p> <p><b><i>Resolution:</i></b> Require immediate close inspection and repair/replacement.</p> |

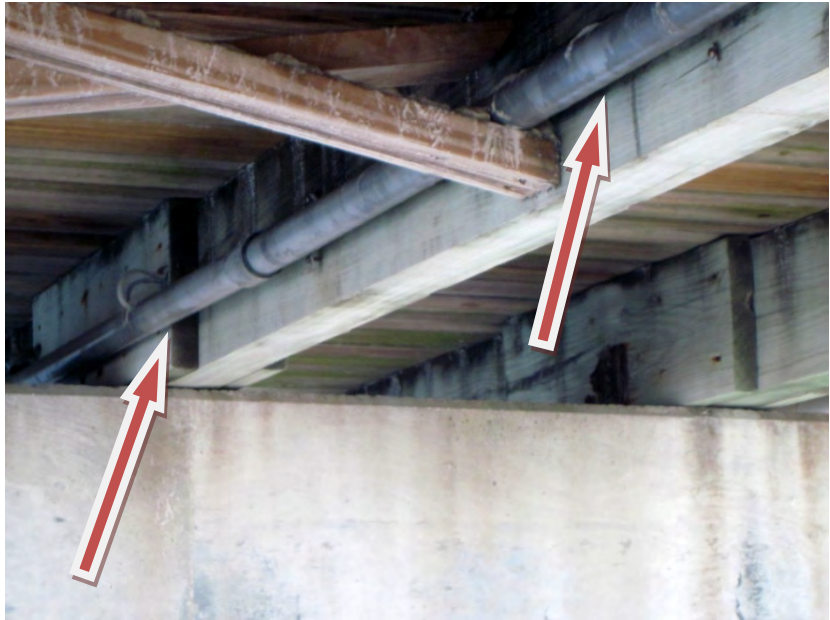
| Photo | Descriptions/Comments |
|---|---|
| | <p><b><i>Issue:</i></b> The stress caused by the movement of the main power supply conduit is beyond the working strength of these thin plastic pipe straps.</p> <p><b><i>Resolution:</i></b> Provide new plastic pipe straps with better working strength and durability (i.e. more material thickness/cross-section, mass, etc).</p> |

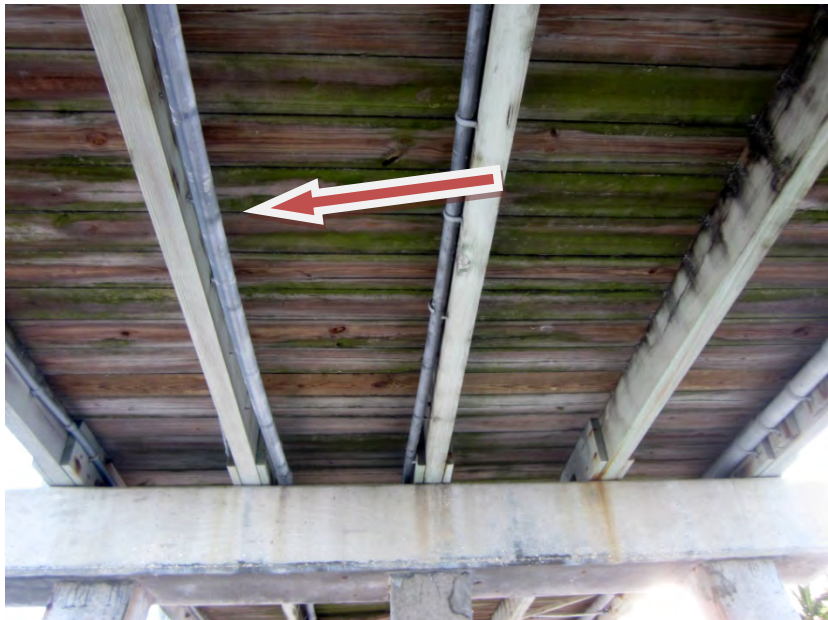
| Photo | Descriptions/Comments |
|---|---|
| | <p><b>Issue:</b> The stress caused by the movement of the main power supply conduit is beyond the working strength of these thin plastic pipe straps. Note the conduit has dropped away from its strapping alongside the stringer.</p> <p><b>Resolution:</b> Provide new plastic pipe straps with better working strength and durability (i.e. more material thickness/cross-section, mass, etc).</p> |

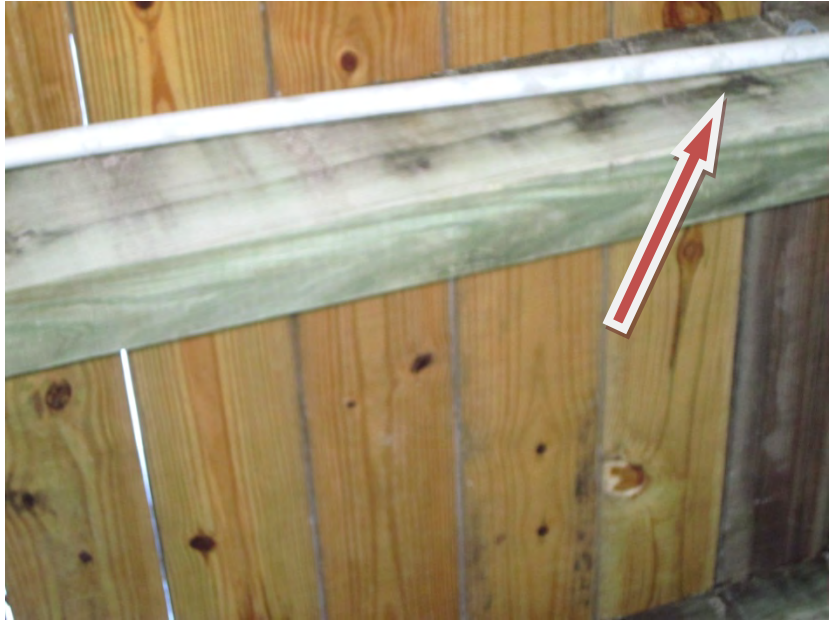
| Photo | Descriptions/Comments |
|---|---|
| | <p><b><u>Issue:</u></b> Pier #11 – Pier #12. The stress caused by the movement of the main power supply conduit is beyond the working strength of these thin plastic pipe straps.</p> <p><b><u>Resolution:</u></b> Provide new plastic pipe straps with better working strength and durability (i.e. more material thickness/cross-section, mass, etc).</p> |

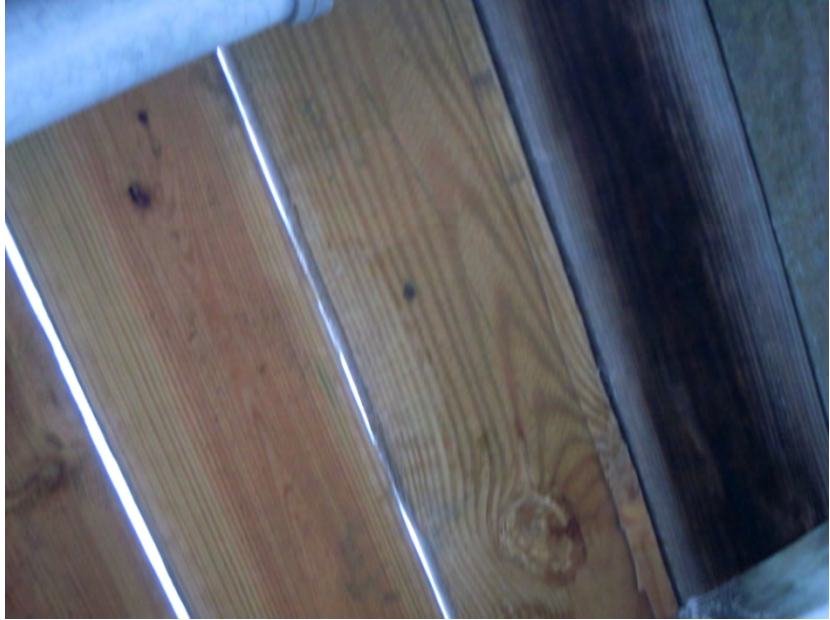
| Photo | Descriptions/Comments |
|---|---|
| | <p><b><u>Description:</u></b> Typical view of the substructure framing and the condition of the decking in the vicinity of Pier #12. Note the multiple replacement boards besides the old boards.</p> |

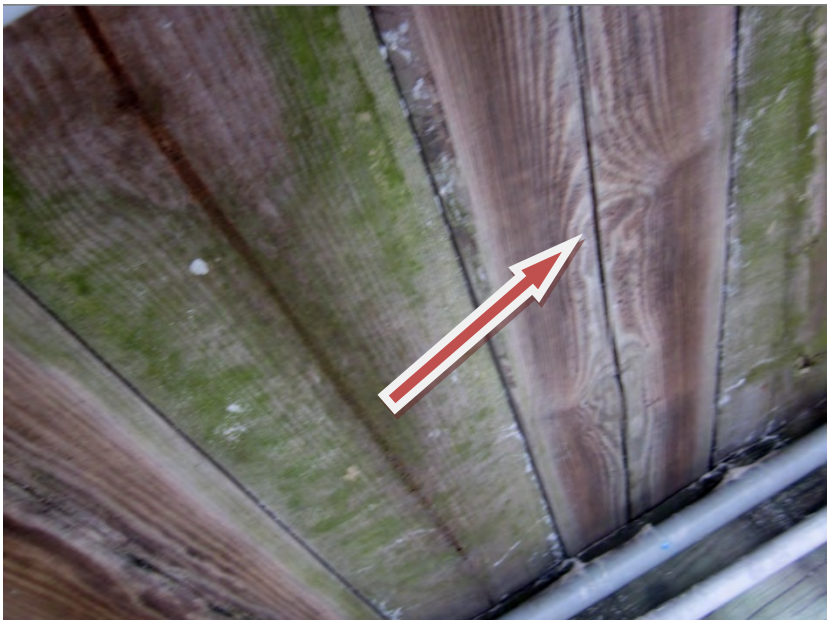
| Photo | Descriptions/Comments |
|---|---|
| | <p><i><u>Description:</u></i> Typical view of the substructure framing and the condition of the decking underside from Pier #7. Note a board with split fiber.</p> |

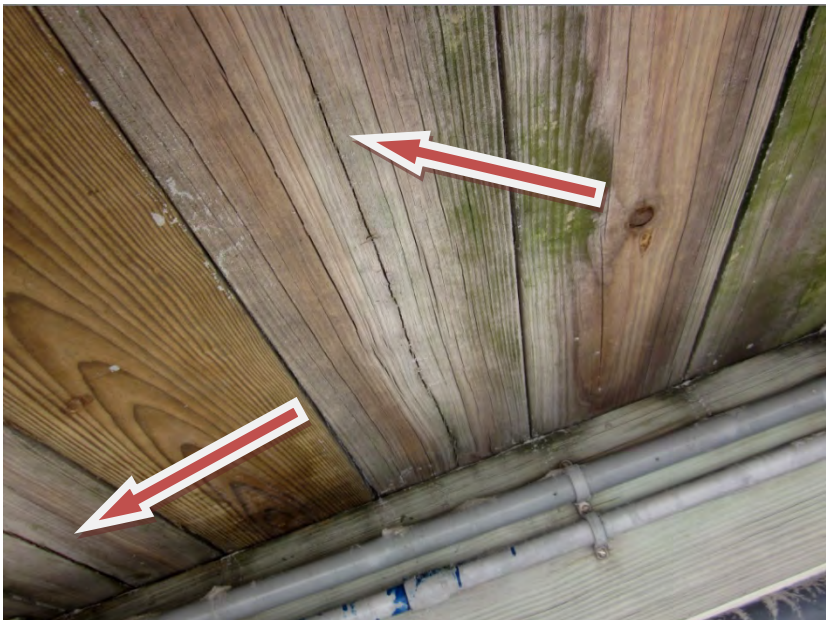
| Photo | Descriptions/Comments |
|---|---|
| | <p><i><u>Description:</u></i> Typical view of the substructure framing and the condition of the decking underside from Pier #10. Note boards with split fiber.</p> |

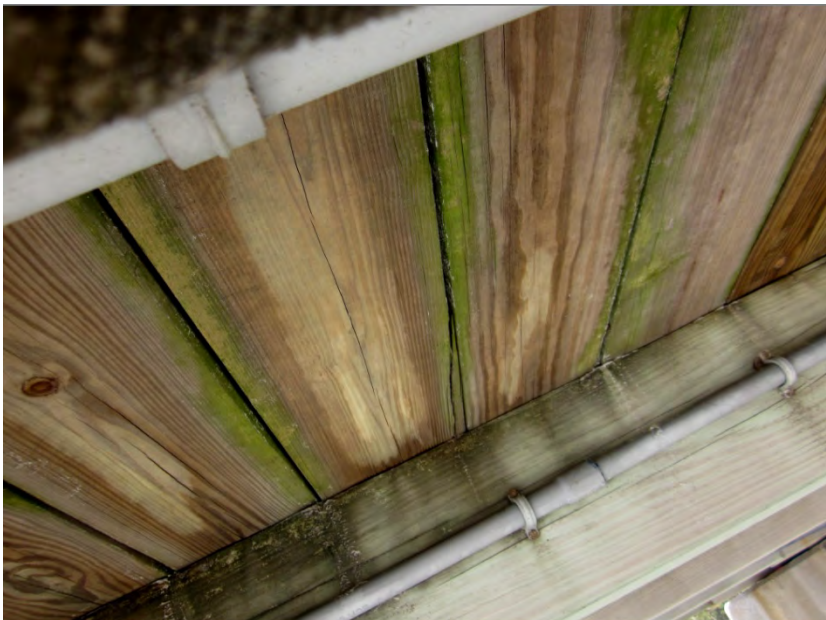
| Photo | Descriptions/Comments |
|---|---|
| | <p><i><u>Description:</u></i> Typical view of the substructure framing and the condition of the decking underside from Pier #7. Note algae growth between boards.</p> |

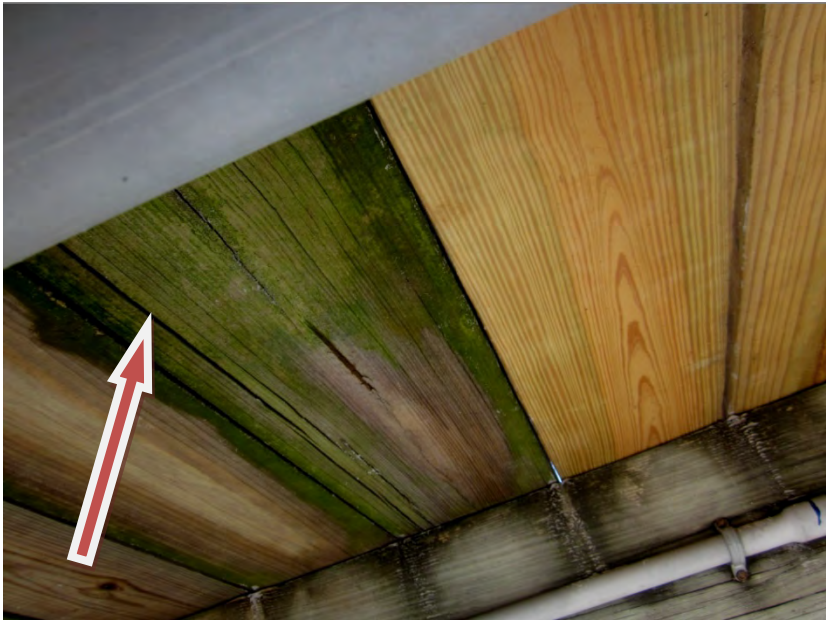
| Photo | Descriptions/Comments |
|---|---|
| | <p><i><u>Description:</u></i> Typical view of the substructure framing and the condition of the decking underside from Pier #7. Note a board with split fiber and covered with algae which accelerates wood decay. Note replacement board.</p> |

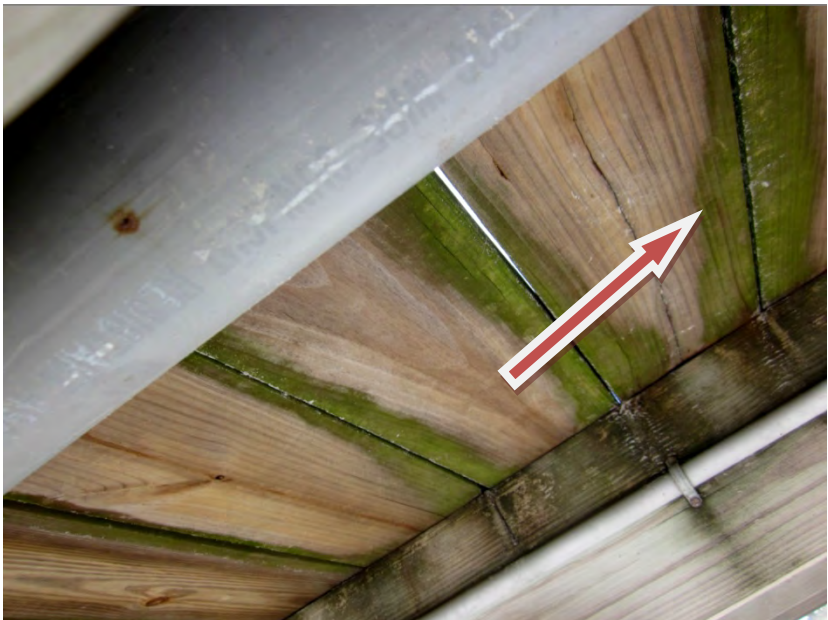
| Photo | Descriptions/Comments |
|---|---|
| | <p><i><u>Description:</u></i> Typical view of the substructure framing and the condition of the decking underside from Pier #16. Note proliferation of algae between the gaps.</p> |

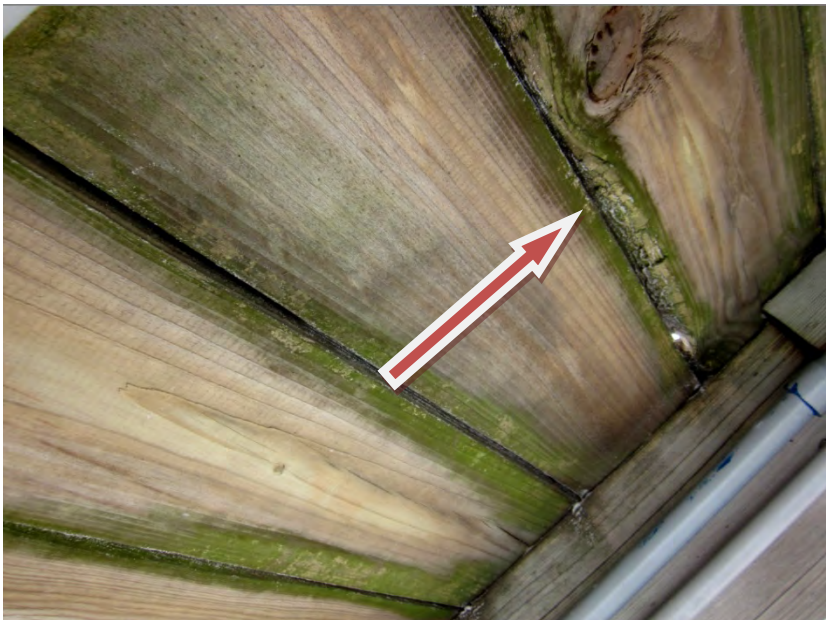
| Photo | Descriptions/Comments |
|---|---|
| | <p><i>Description:</i> Typical view of the substructure framing and the condition of the decking underside from Pier #17. Note proliferation of algae between the gaps. The board on the right is beginning to decay from the edge.</p> |

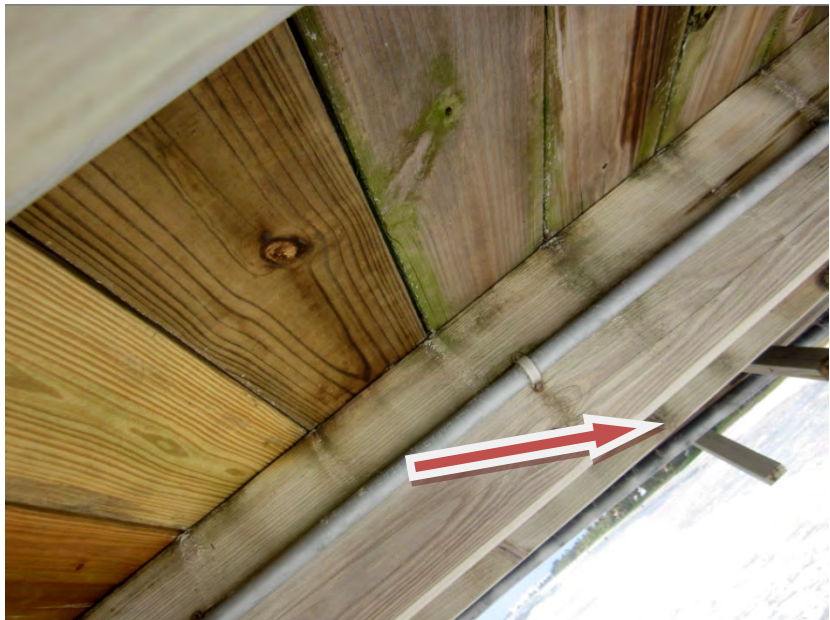
| Photo | Descriptions/Comments |
|---|---|
| | <p><i>Description:</i> Typical view of the substructure framing and the condition of the decking underside from Pier #18. Note proliferation of algae between the gaps. Note multiple replacement boards. Also note some loose cross-bracing hanging beyond.</p> |

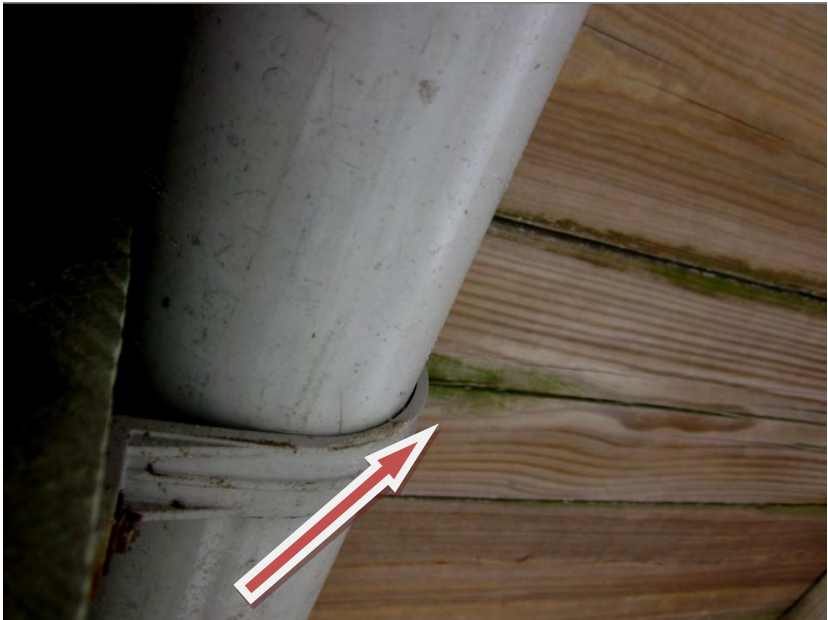
| Photo | Descriptions/Comments |
|---|---|
| | <p><i>Description:</i> Typical view of the substructure framing and the condition of the decking underside from Pier #16. Note the fiber split in the middle board despite its fresh appearance. The start of algae growth within the split indicates that moisture is migrating through the split from top to bottom. This is where wood decay is naturally taking root.</p> |

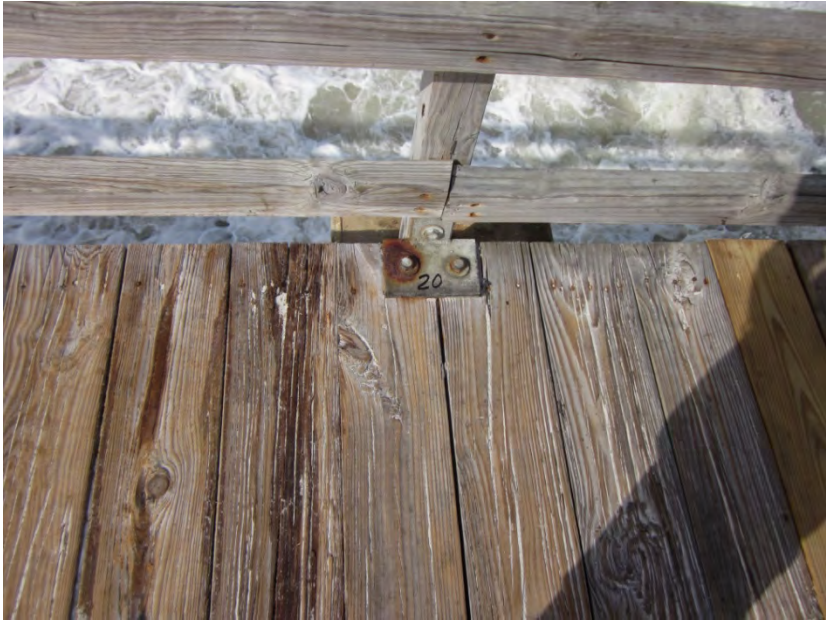
| Photo | Descriptions/Comments |
|---|---|
| | <p><b>Description:</b> View over Pier #20. As the pier begins to go over water seaward, the impact of the sea environment is increasingly harsh on wood and metal hardware. Note the sign of decay on the board immediately to the left of the post. Note a decaying board on the left.</p> |

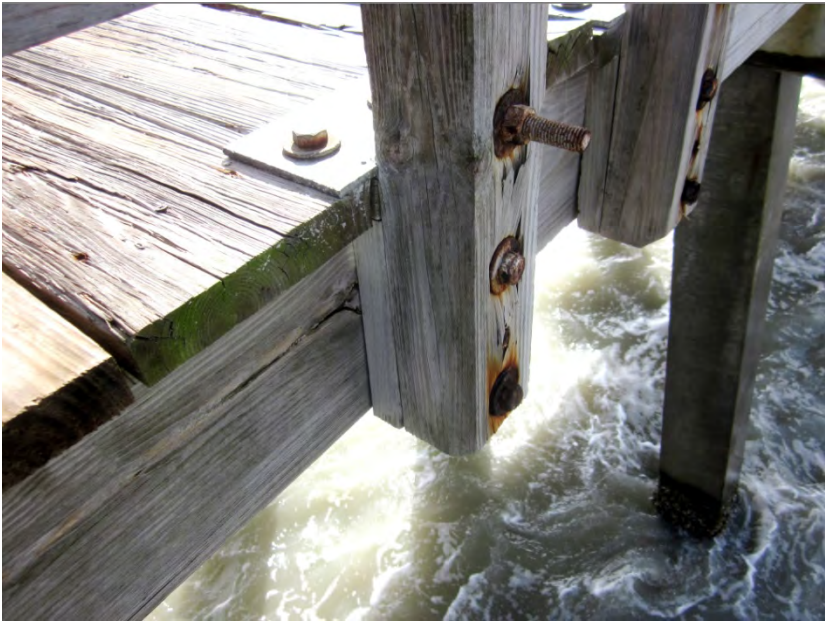
| Photo | Descriptions/Comments |
|---|---|
| | <p><b><u>Issue:</u></b> See preceding issue. This pair is only for mounting pedestrian lighting.</p> <p><b><u>Resolution:</u></b> See preceding resolution.</p> |

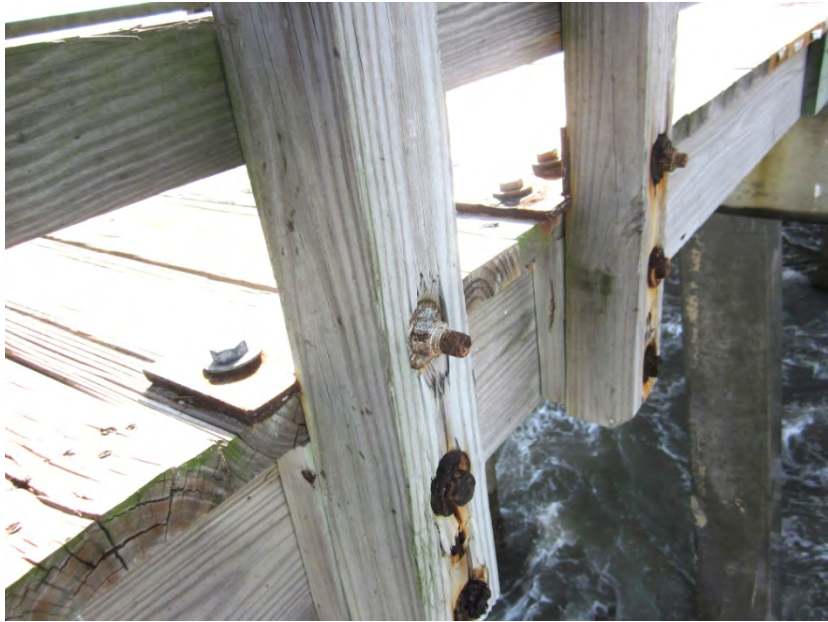
| Photo | Descriptions/Comments |
|---|---|
| | <p><b><u>Issue:</u></b> See preceding issue. This pair is only for mounting pedestrian lighting.</p> <p><b><u>Resolution:</u></b> See preceding resolution.</p> |

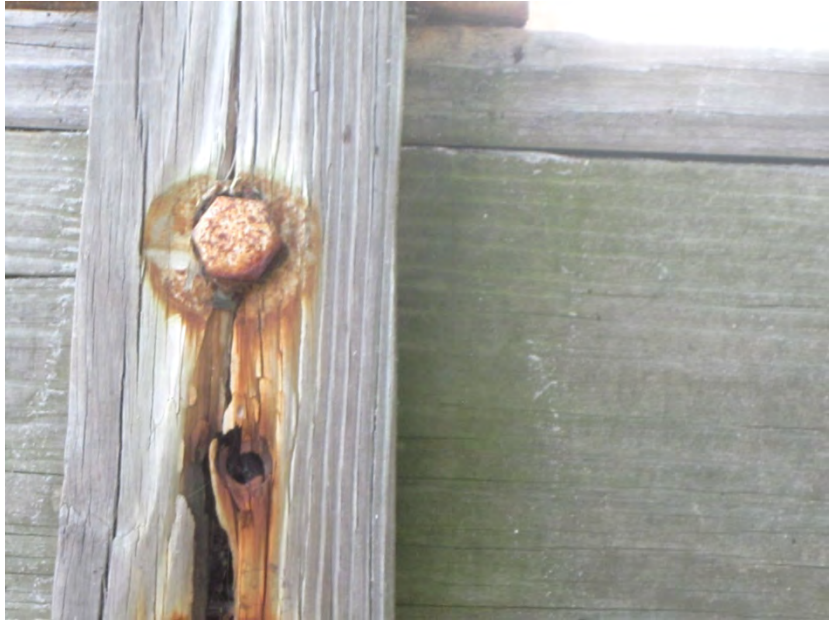
| Photo | Descriptions/Comments |
|---|---|
| | <p><b><u>Issue:</u></b> Similar pattern of rail post and thru-bolt connection issue.</p> <p><b><u>Resolution:</u></b> See preceding resolution.</p> |

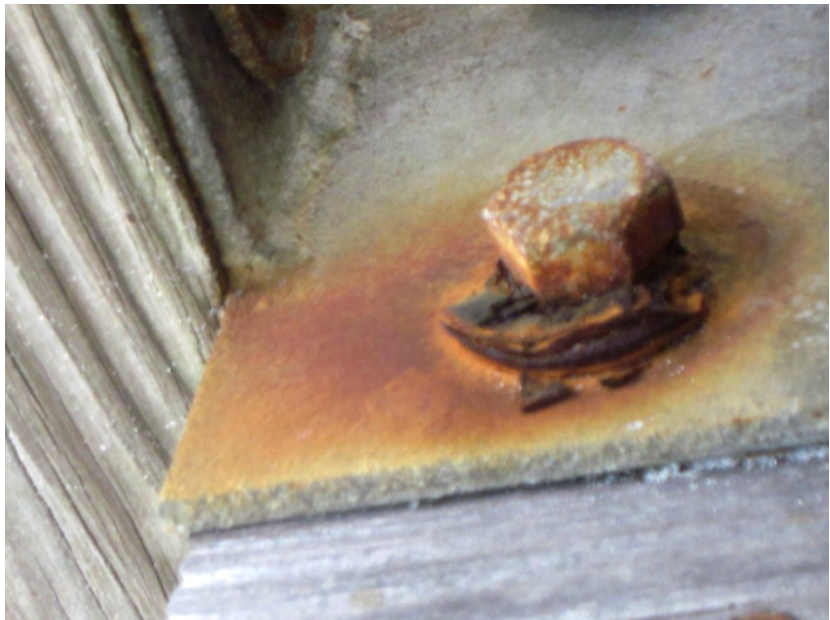
| Photo | Descriptions/Comments |
|---|---|
| | <p><b><u>Issue:</u></b> View of the post-to-deck clip angle lag screw connection undergoing early corrosion beginning with washers.</p> <p><b><u>Resolution:</u></b> See preceding resolution.</p> |

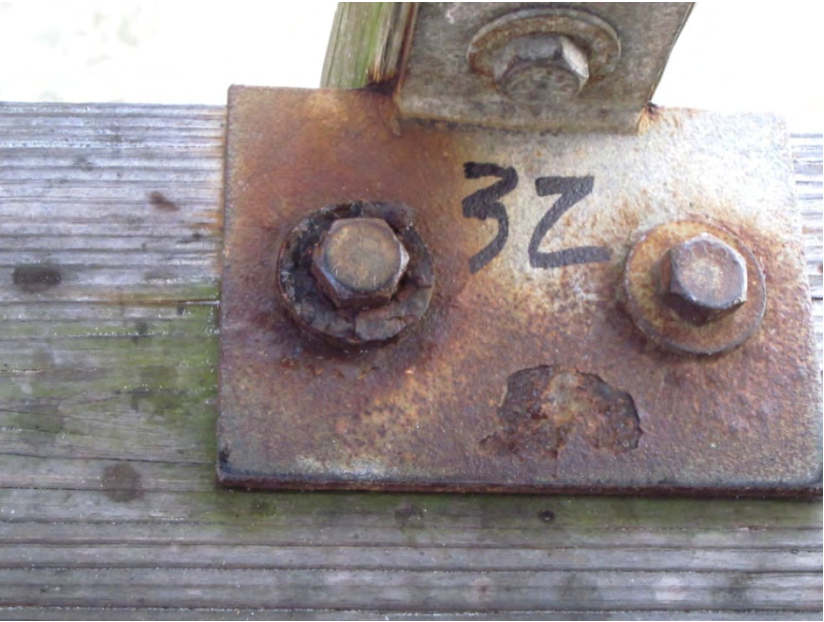
| Photo | Descriptions/Comments |
|---|---|
| | <p><b><u>Description:</u></b> View over Pier #32. Note horizontal connection hardware corrosion beginning with washers.</p> |

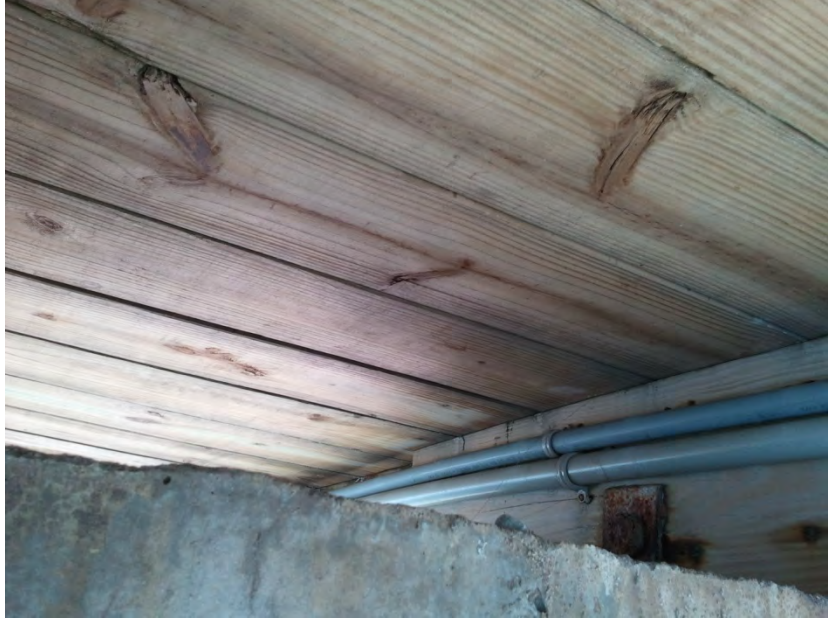
| Photo | Descriptions/Comments |
|---|---|
| | <p><b>Description:</b> View of the underside at Pier #44. Note the stringer anchor bolt/clip angle displays only mild corrosion.</p> |

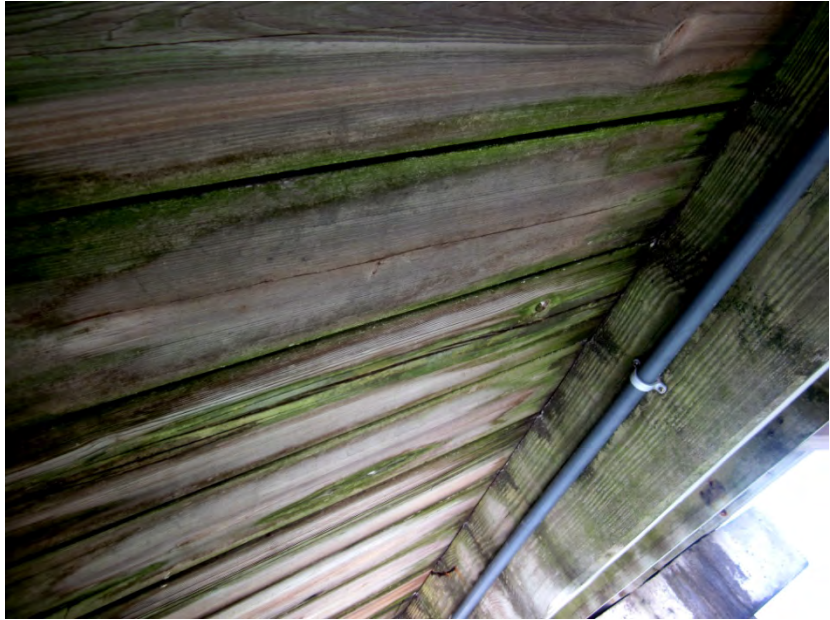
| Photo | Descriptions/Comments |
|---|---|
| | <p><b>Issue:</b> In stormy day and high waves the deck is being washed in sea spray for the duration. Note the boards are soggy from such weather event. Note board with split fiber in the center.</p> <p><b>Resolution:</b> Perform periodic inspection of the utility piping below deck. Repair/replace/remove broken piping. Provide new plastic pipe straps with better working strength and durability (i.e. more material thickness/cross-section, mass, etc).</p> |

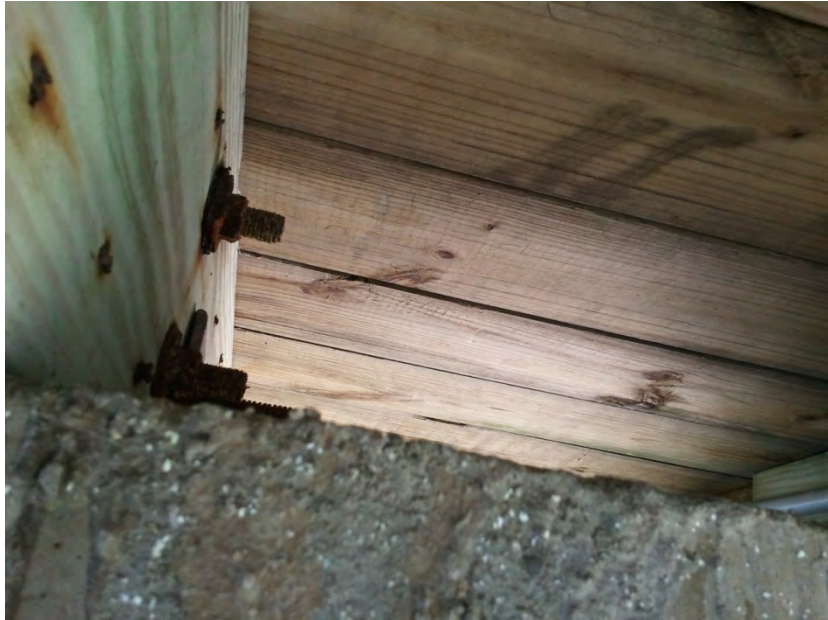
| Photo | Descriptions/Comments |
|---|---|
| | <p><i><u>Description:</u></i> View of the underside at Pier #53. Note the rail post thru-bolt connectors display only mild corrosion.</p> |

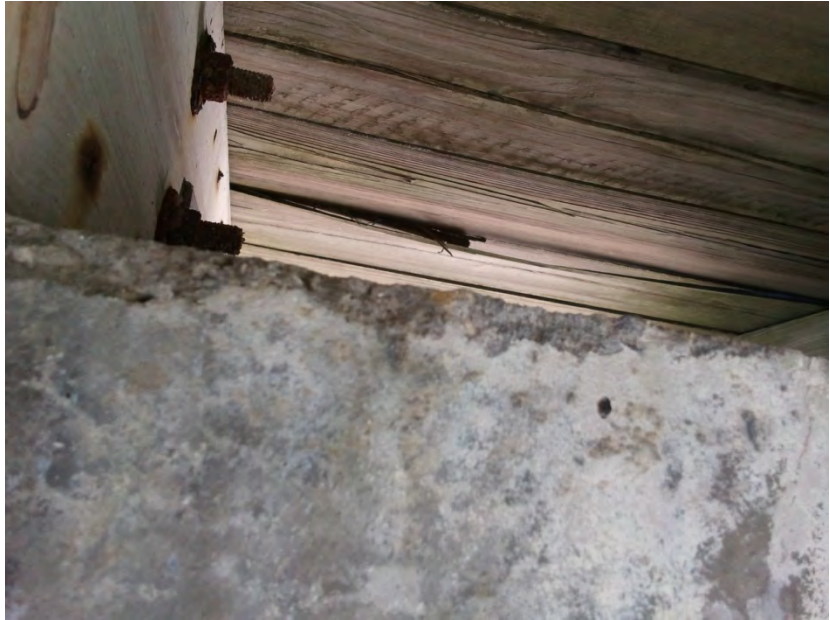
| Photo | Descriptions/Comments |
|---|---|
| | <p><i><u>Description:</u></i> View of the underside at Pier #60. Note the rail post thru-bolt connectors display only mild corrosion.</p> |
