Owner
City of Naples

Police Station / Fire Department

Executive Summary Report

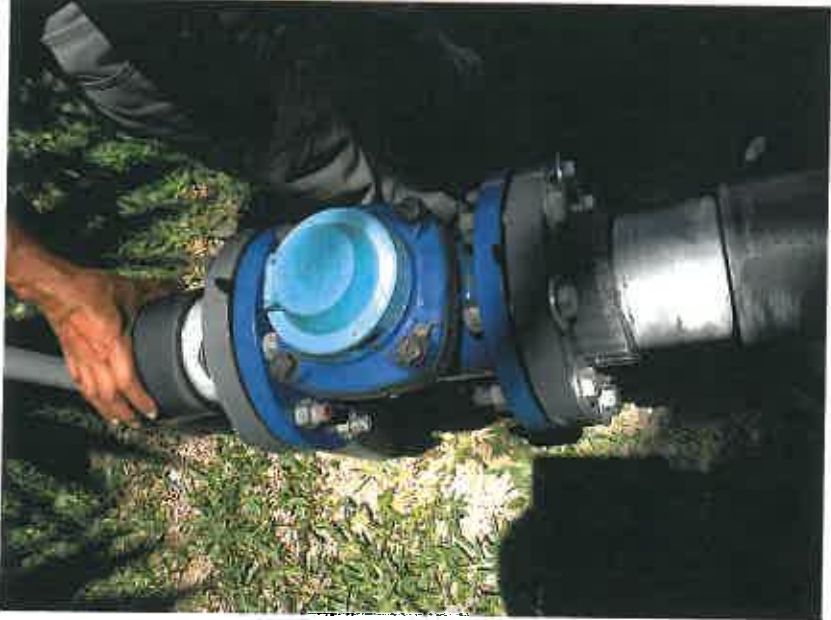
<p><u>Description:</u> View one of the geothermal (supply or recharge well?) Northwest of the West building.</p>

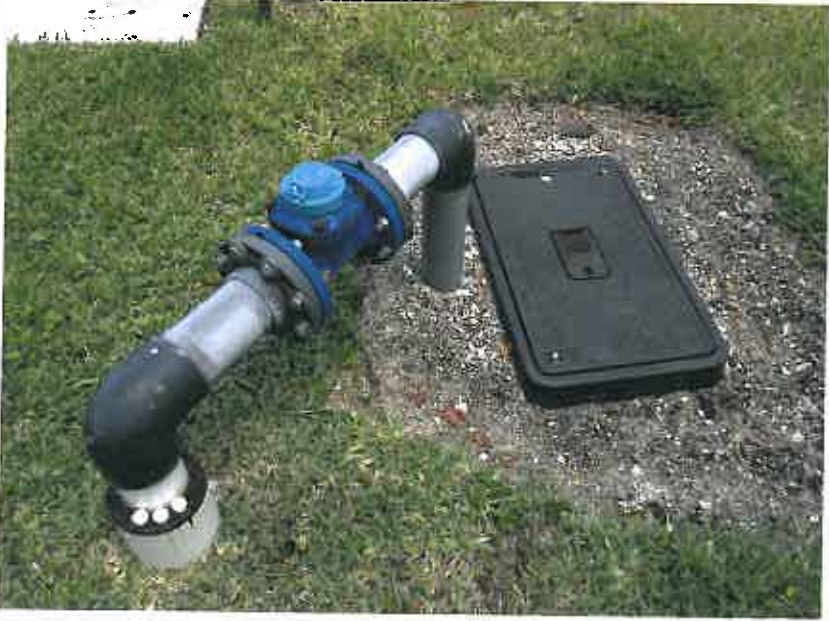
<p><u>Description:</u> View one of the geothermal (supply or recharge well?) Northeast of the East building.</p>

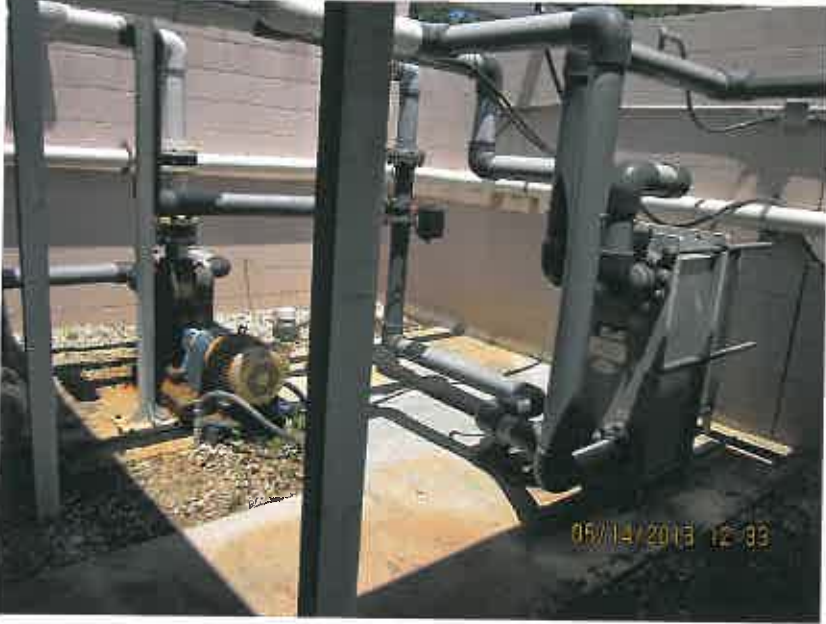
<p>Description: View of the geothermal well pumps (left) and the plate heat-exchanger (right), within the geothermal compound.</p>

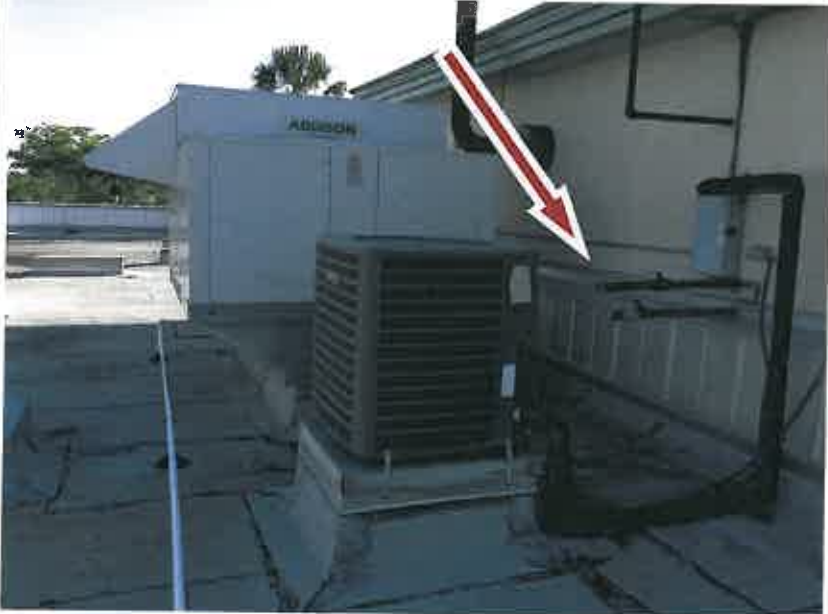
<p><u>Description:</u> View of a conventional DX condenser unit at the rear of the East building part of a fresh air handling unit (FAHU) air-conditioning system in the building's attic mezzanine.</p> <p>The cut-off and abandoned copper pipes coming out of the wall might have been previously supplying geothermal water to a now-removed RTU serving one of the spaces in the West building below.</p>

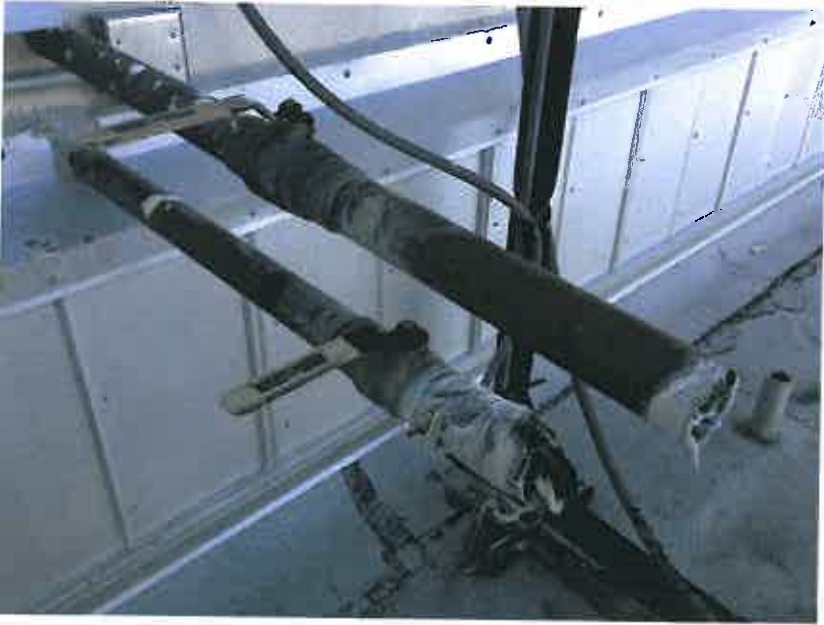
<p><u>Description:</u> View of the abandoned copper pipes.</p>

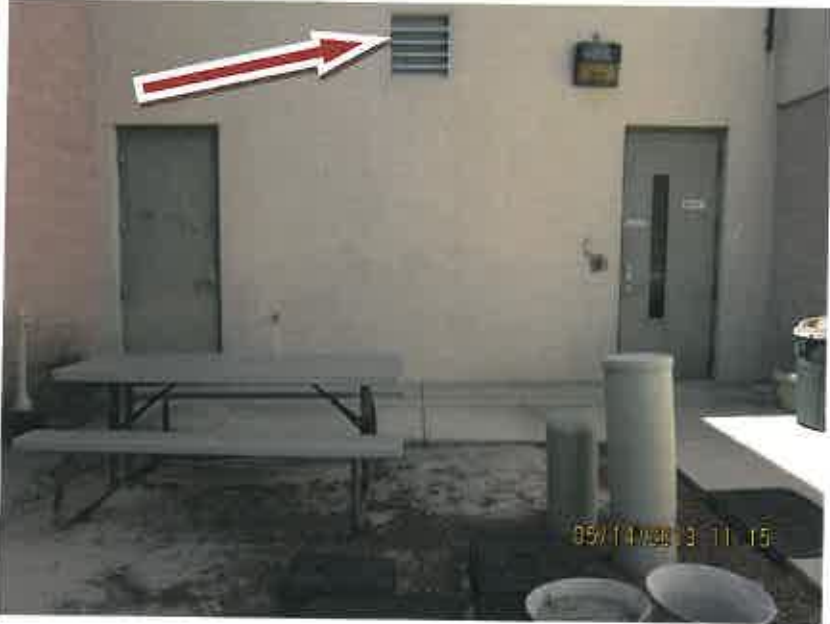
<p>Description: View of the outside-air intake grille on the North side of the rear stairwell. The door to the left is the storage room where the emergency generator fuel tank is located. The door on the right is the emergency exit for the West building. The geothermal entrance riser is located behind this door on the right hand side.</p>

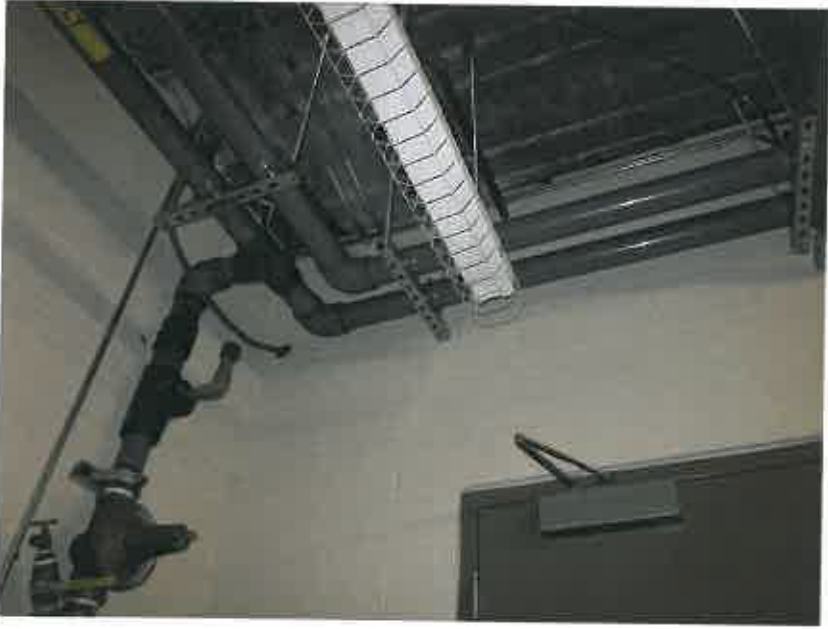
<p>Description: View of the geothermal entrance riser at the corner of the North emergency exit door. Note the supply/return piping going to East building to the right, and going to West building to the left.</p>

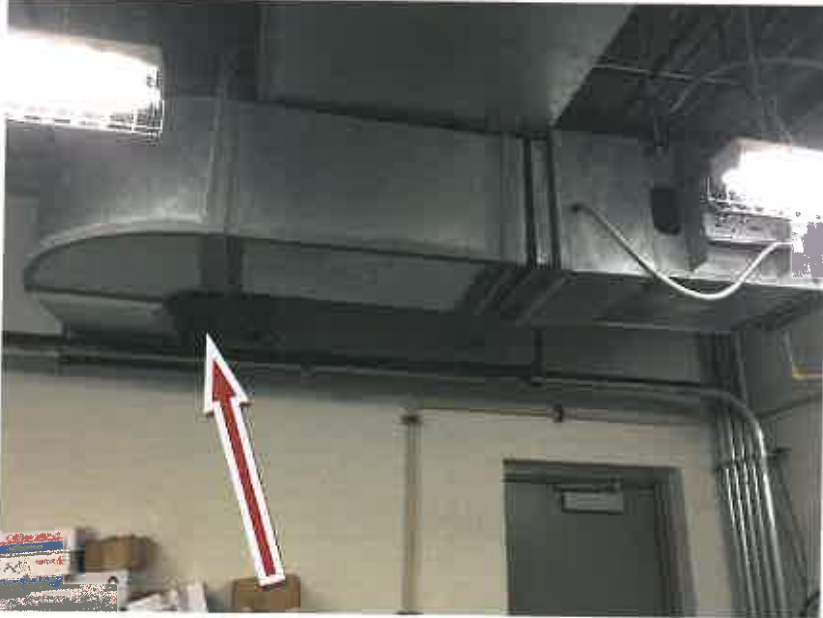
<p>Description: View of the East building HVAC fresh-air intake and return-air ductwork going through a fan coil dehumidifier on the right before entering the FAHU air-conditioning in the attic mezzanine.</p>

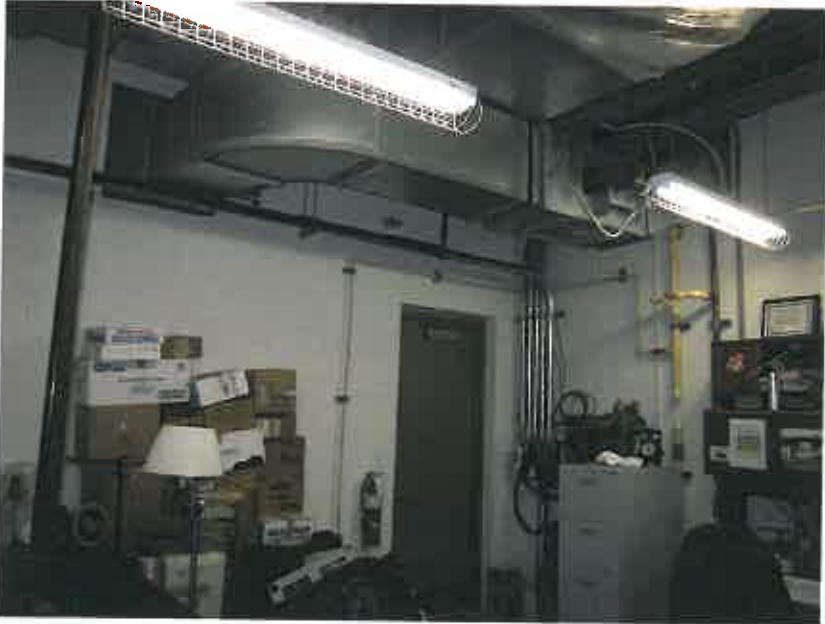
<p>Description: View inside the East building storage room. Note the fuel storage tank with the vent stack on the left.</p>

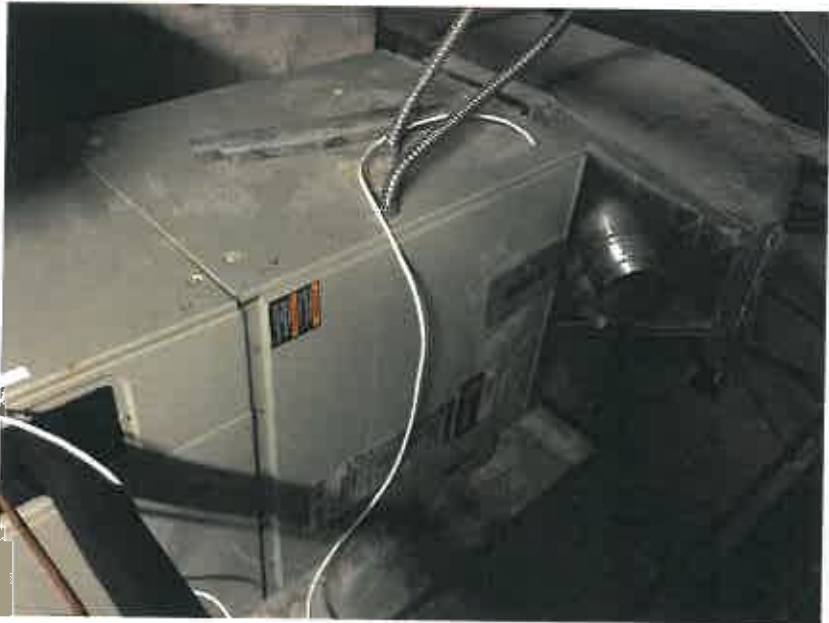
<p><u>Description:</u> View of the DX FAHU air-conditioning in the East building's attic mezzanine. Note the supply distribution ductwork on the end of the unit.</p>

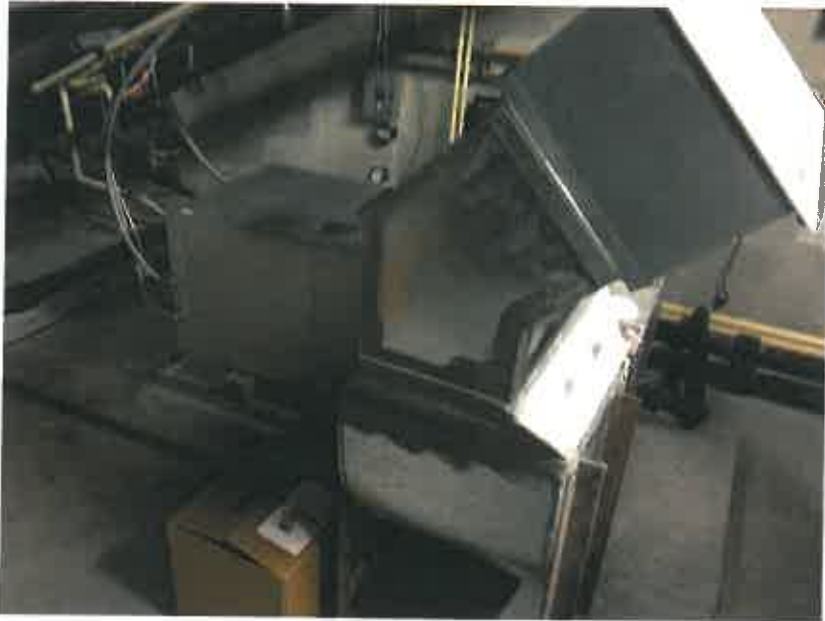
<p><u>Description:</u> View of a geothermal heat pump/AHU in the same attic mezzanine. Note the unit's air intake terminal and grille in the foreground. The supply distribution outlet is through the floor.</p>

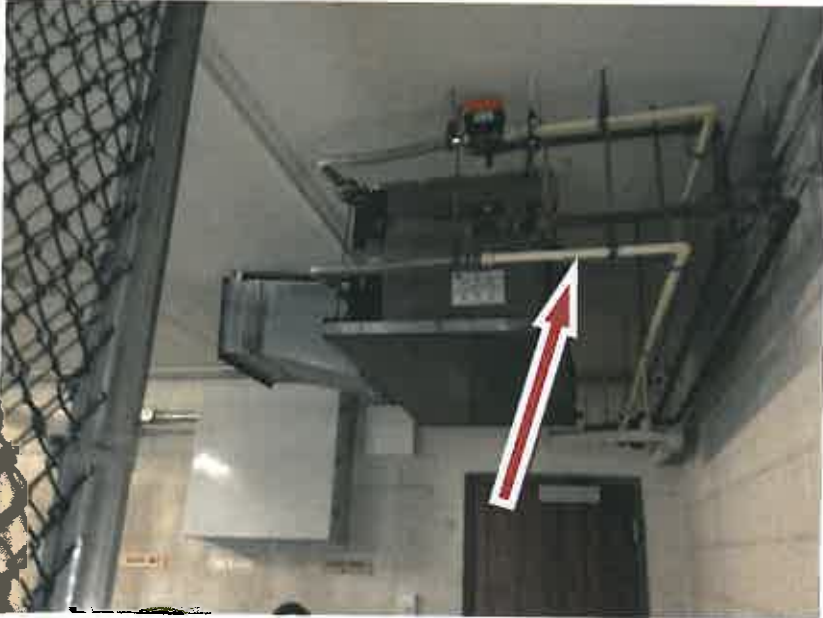
<p><u>Description:</u> View of a heat pump/AHU serving the garage. Note the substituted PVC and the abandoned copper supply/return piping.</p>

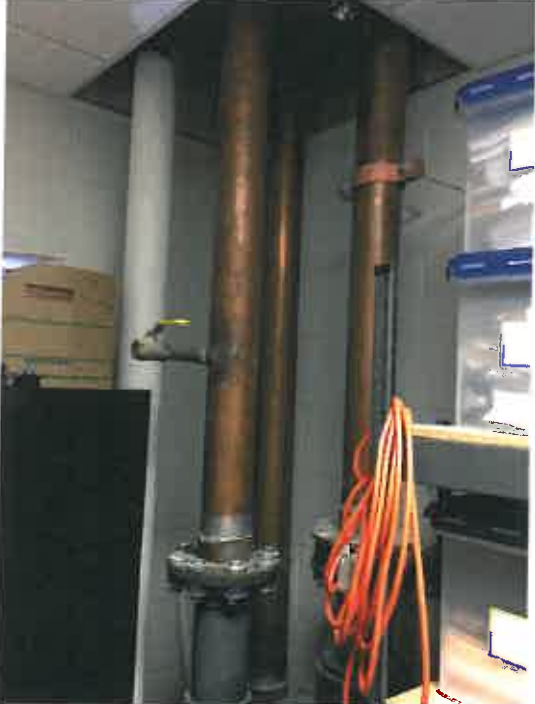
<p><u>Description:</u> View of the abandoned geothermal and active domestic water copper piping on the first floor.</p>

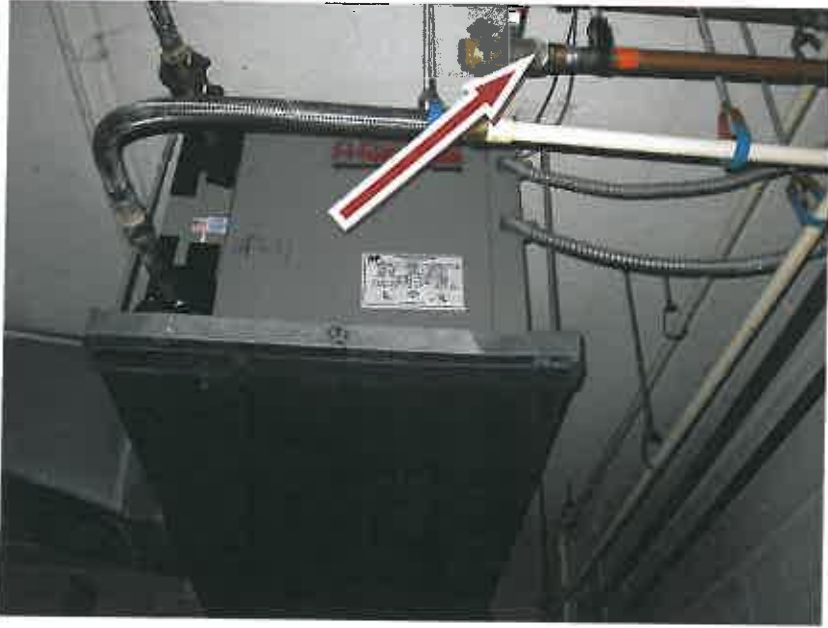
A close-up photograph of HVAC equipment in a mechanical room. A red arrow with a white outline points to a horizontal copper pipe. Other pipes, including a white PVC pipe and a black flexible duct, are visible in the background.	<p><u>Description:</u> Typical view of the geothermal heat pump/AHU mounting inside mechanical rooms. Note the abandoned copper supply/return piping.</p>

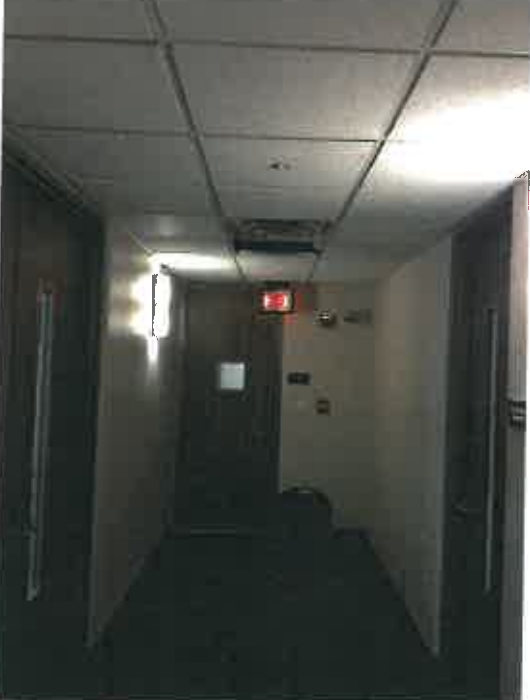
A photograph of a long, narrow hallway with a drop ceiling and fluorescent lighting. A red exit sign is visible at the end of the hallway. The hallway appears to be a central corridor.	<p><u>Description:</u> The remaining of the building's heat pump/AHU's are hung within the attic space above the North/South first and second floor central corridors, such as this one.</p>

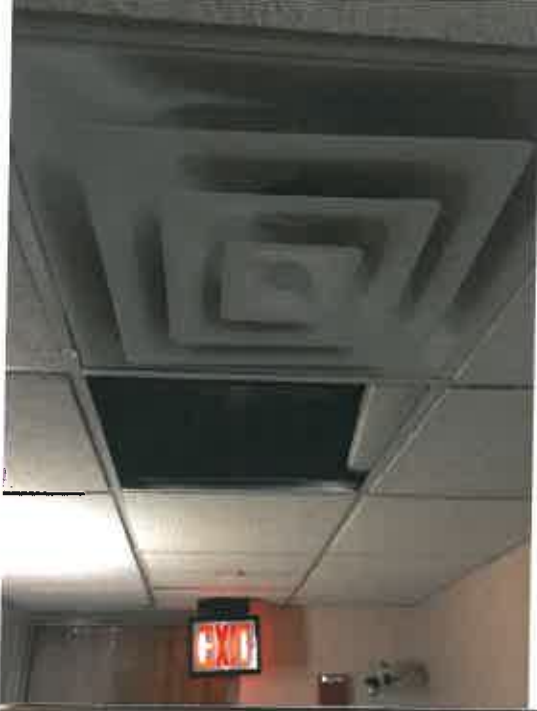
<p><u>Description:</u> The bottom of the condensate pan is just a few inches above the ceiling tile. Note the diffuser seen here is not for supply air distribution as it is not connected to duct.</p>

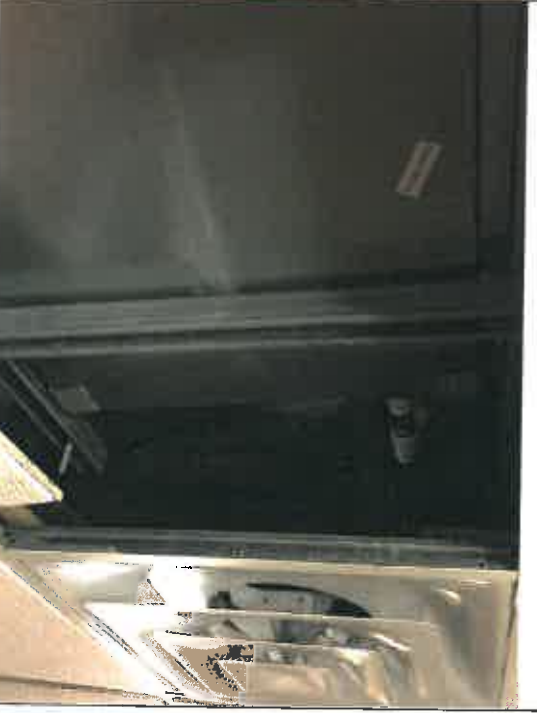
<p><u>Description:</u> The return air is directed from the hallway up through the un-ducted diffuser up to the ceiling return air plenum above and subsequently drawn into the AHU air intake.</p>

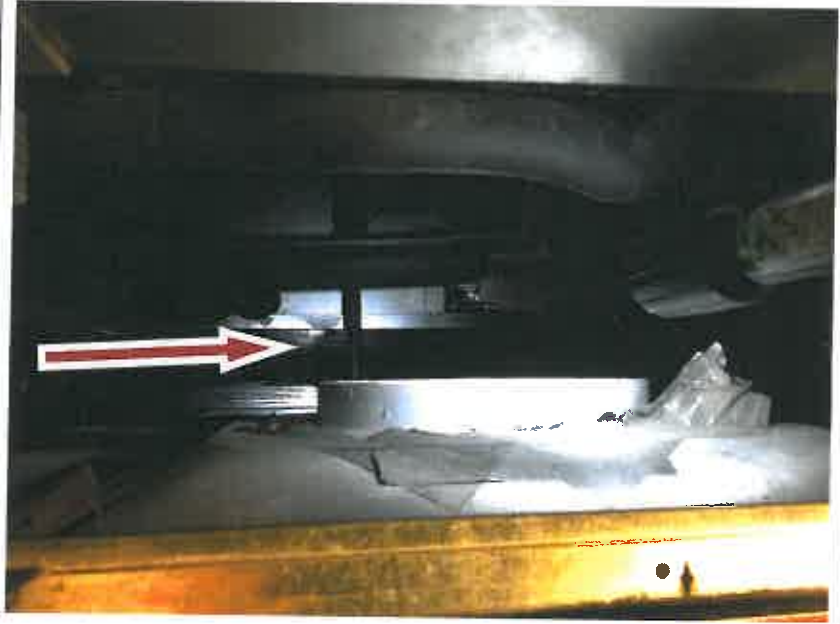
A photograph of an attic plenum space. A red arrow points to a circular, un-ducted diffuser. The space is dimly lit, with some insulation and structural elements visible.	<p>Description: View of the attic plenum space. Note the un-ducted diffuser used as return air passage.</p>

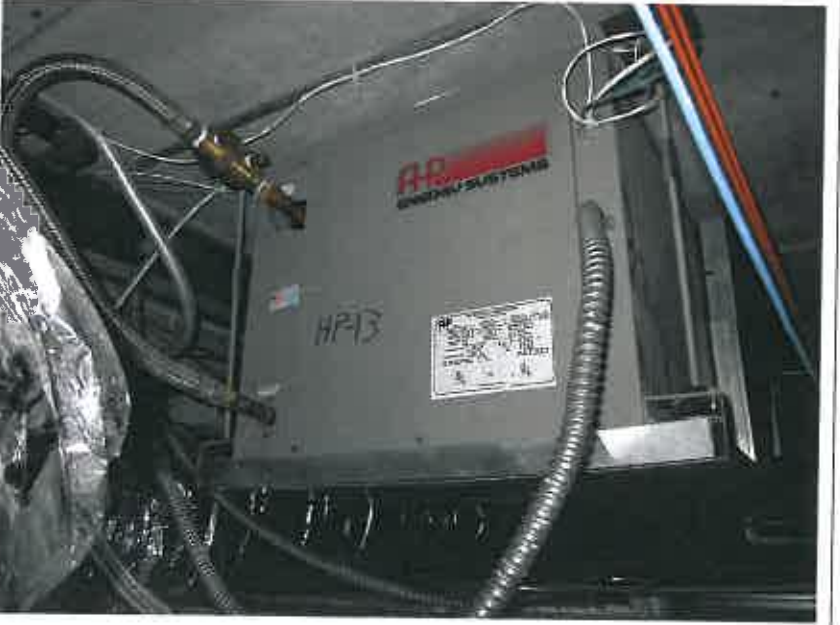
A photograph of a heat pump geothermal unit. The unit is labeled "HP-13" and "A.P. SYSTEMS". It shows flexible supply and return piping, with a flexible supply branch ductwork on the left.	<p>Description: Typical view of the heat pump geothermal supply and return piping within the attic space/return air plenum. Note flexible supply branch ductwork. On the left.</p>

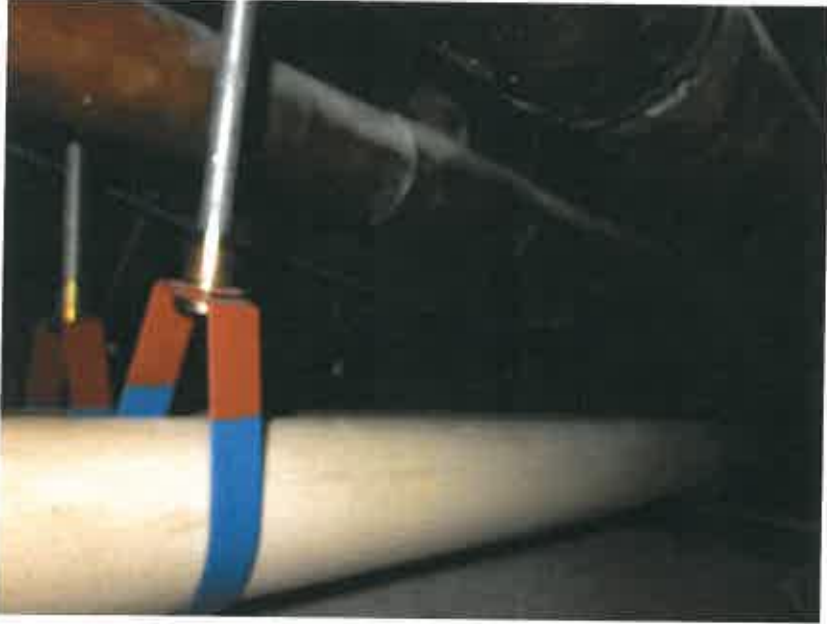
<p><u>Description:</u> View of the abandoned copper piping alongside the substituted PVC geothermal piping.</p>

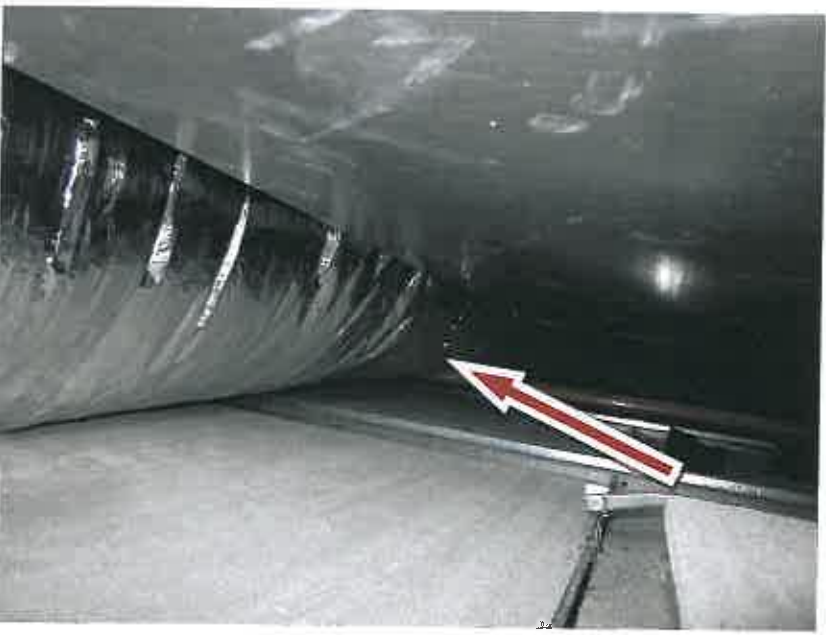
<p><u>Description:</u> View of the bottom of a condensate pan below a heat pump/AHU. Note the extensive use of flexible ductwork in the tight plenum space.</p>

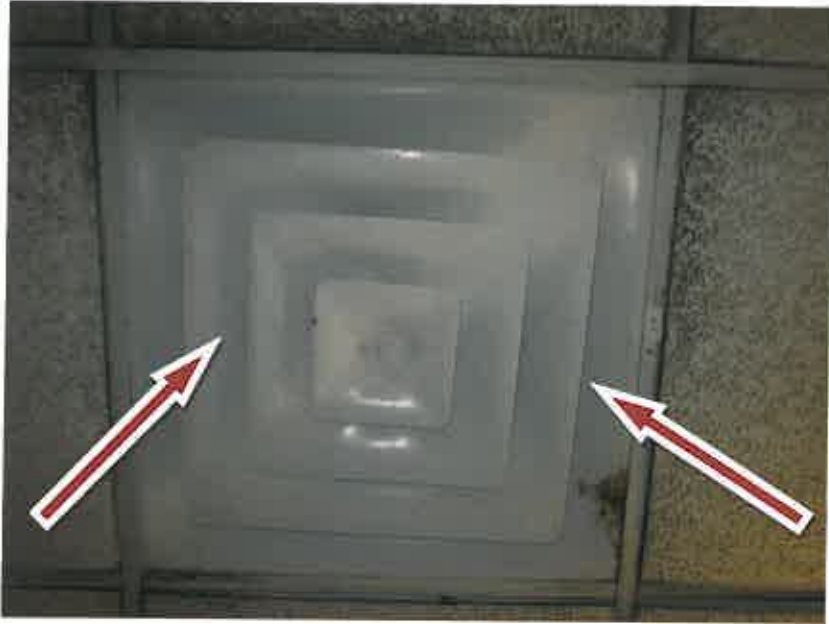
<p><u>Description:</u> This diffuser is also being used as a passage for return air from the central corridor judging from the dust stain on the surrounding ceiling tiles' edges.</p>

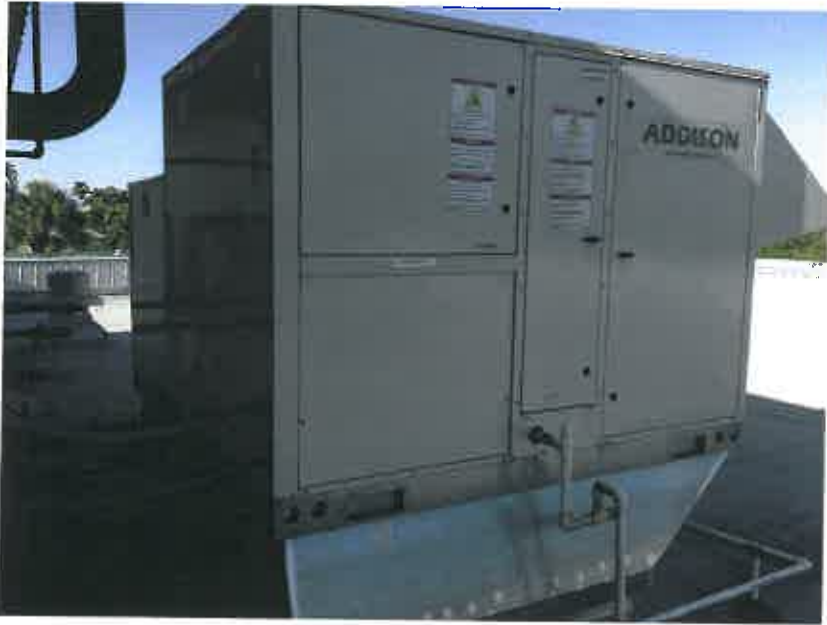
<p>Description: View of the rooftop horizontal fresh-air handling unit (FAHU) air conditioning West of the Police Dept. building West wall providing outside air for the Fire Dept. building.</p>

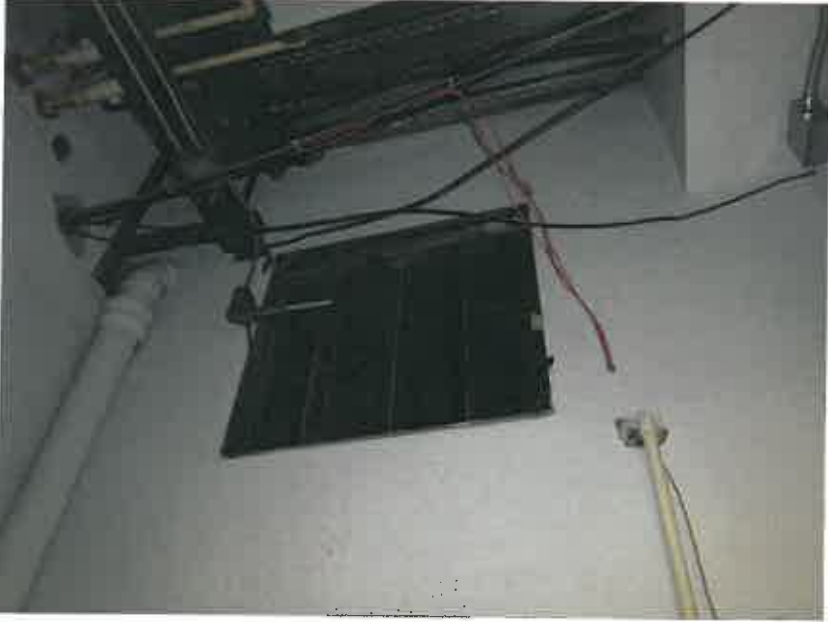
<p><u>Description:</u> Conditioned fresh air is being forced through the ceiling plenum, and through openings in the interior walls and walls above the mechanical rooms where the AHUs are generally located.</p>

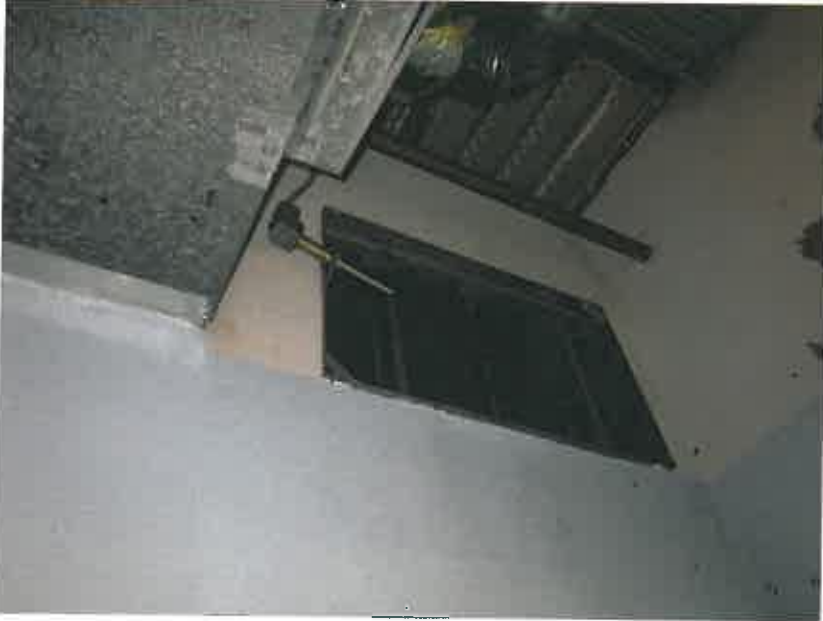
<p><u>Description:</u> Typical opening in the mechanical room wall for fresh-air distribution.</p>

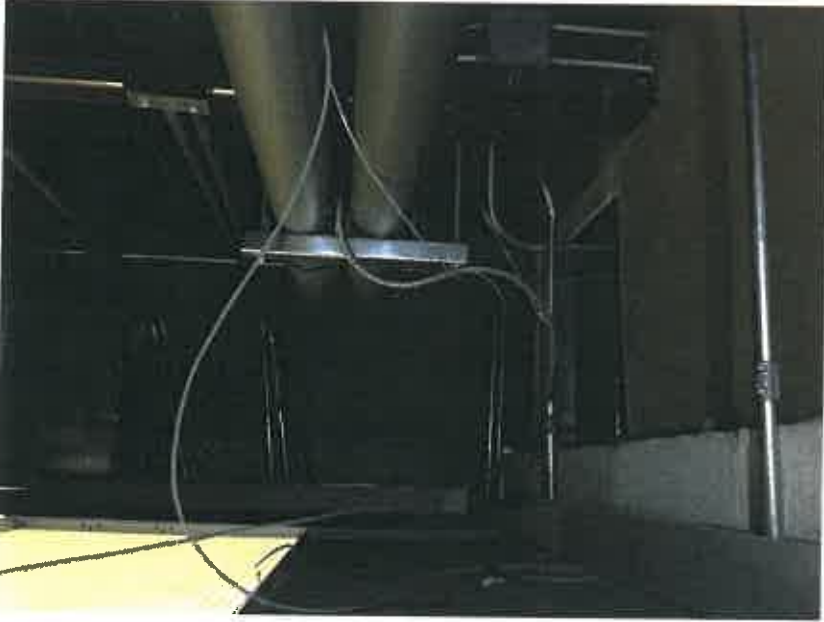
<p><u>Description:</u> Typical opening through interior wall for fresh-air distribution.</p>

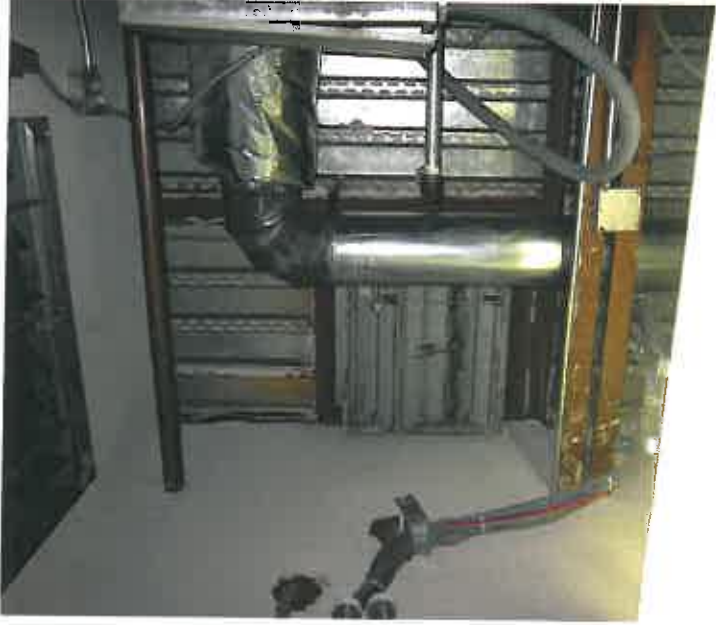
<p><u>Description:</u> Return air sometimes is seen ducted in a round ductwork and dropped into the air intake grille of the AHU in the mechanical room below.</p>

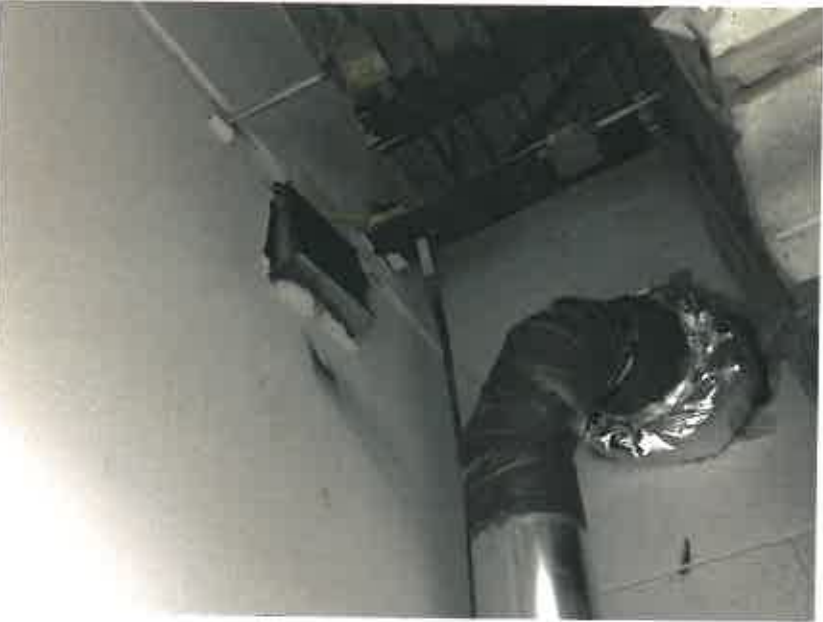
<p><u>Description:</u> View of a typical return-air duct over a mechanical room where HP-2 is located. Note the pre-cooled outside air opening on the left.</p>

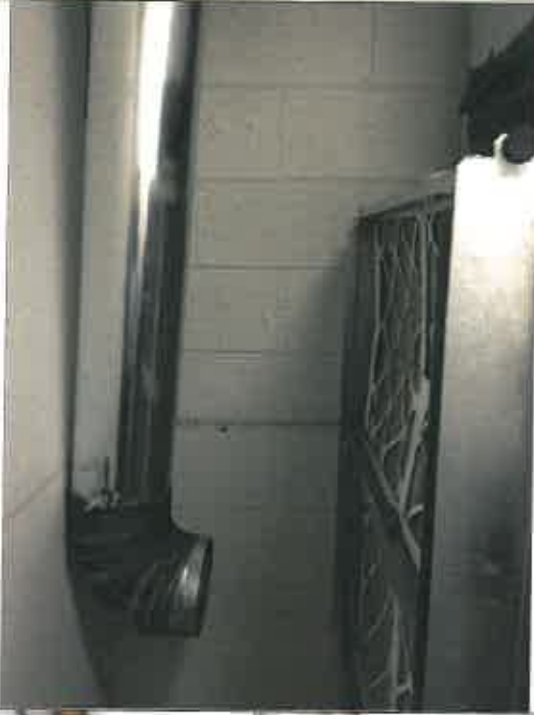
<p><u>Description:</u> View of a return-air duct being brought down from the ceiling onto the return-air intake grille of HP-2 mechanical room.</p>

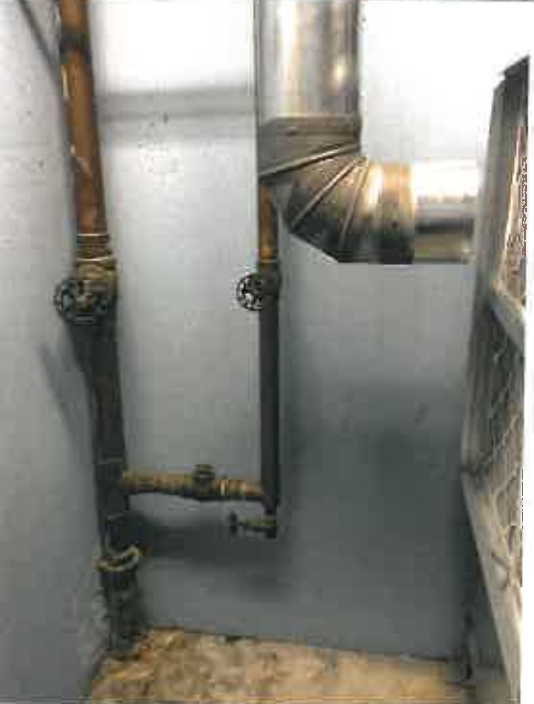
<p><u>Description:</u> View of a similar configuration in for HP-6 mechanical room.</p>

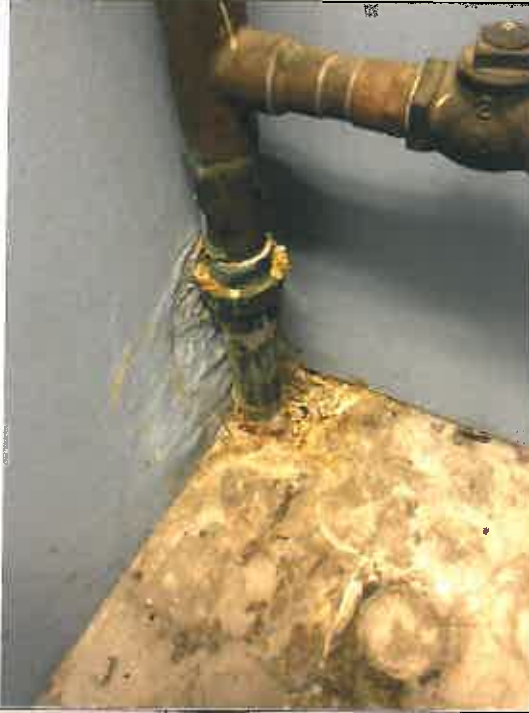
<p><u>Description:</u> View of an efflorescence buildup around the domestic water copper pipe union joint as a result of the chemical reaction of the pipe with various salts in water.</p>

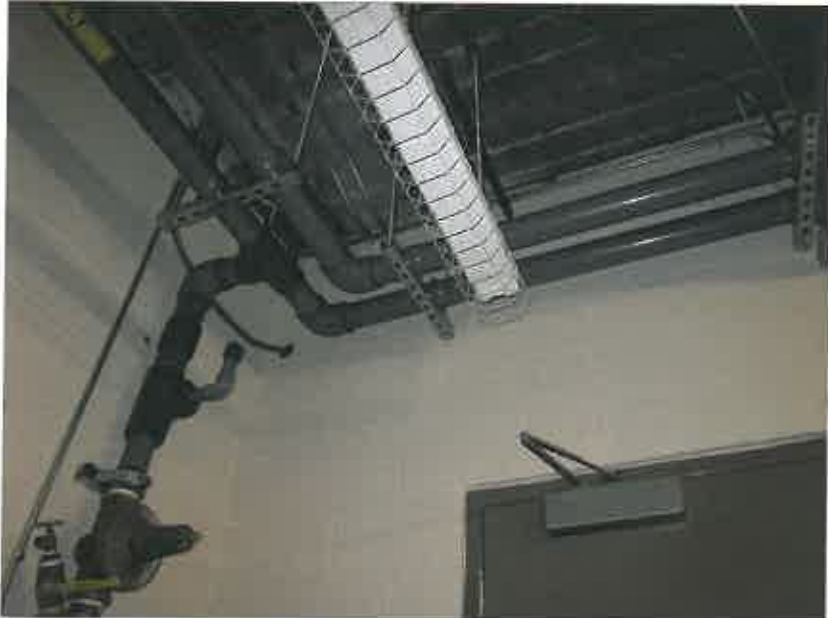
<p><u>Description:</u></p> <p>The riser feed the West building to the left, and the east building to the right.</p> <p>Note the return line is running parallel to the supply.</p> <p>Note the North emergency exit door at the North building joint corridor.</p>

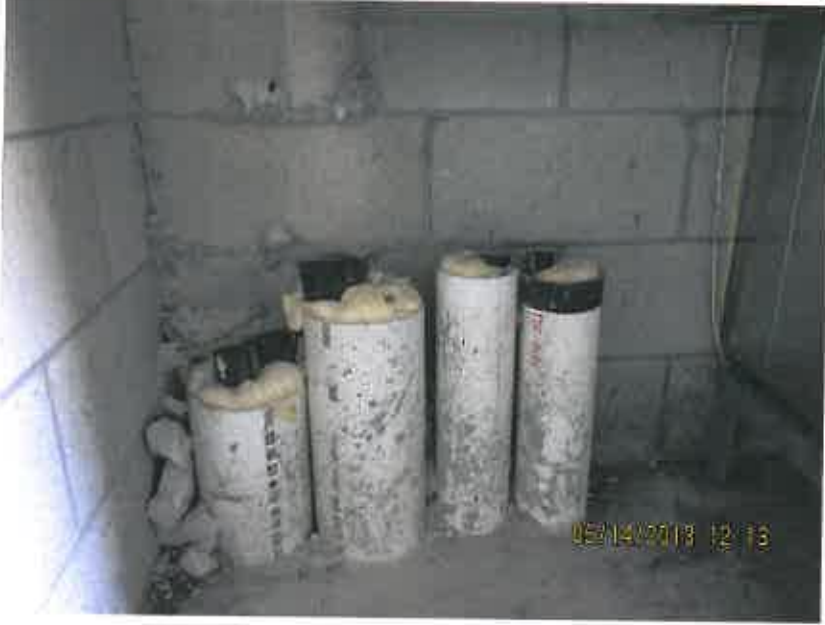
A photograph showing several vertical refrigerant lines in a mechanical room. The lines are wrapped in white insulation and are situated in a corner of a room with concrete walls. A timestamp '05/14/2013 12:13' is visible in the bottom right corner of the photo.	<p><u>Description:</u> View of the refrigerant lines once serving the previous DX systems in the South mechanical room.</p>
