WEEKLY SUMMARY REPORT – CONTRACT WEEK 32

21-036 EAST NAPLES BAY

DREDGING AND ROCK REMOVAL PROJECT

Date: 5/23/2022 to 5/27/2022						
Inspectors: Sam Boyd/Alan Bechok	Stantec PIN: 2028113191		Accidents 🛛 Yes	⊠No		
Days of Week: Monday to Friday	Contract Days: 218 to 222	Total Days: 365	Accident Report #:	N/A		
Canal(s) Worked In: X-X	Stations Worked Between: 0+25 to 5+75

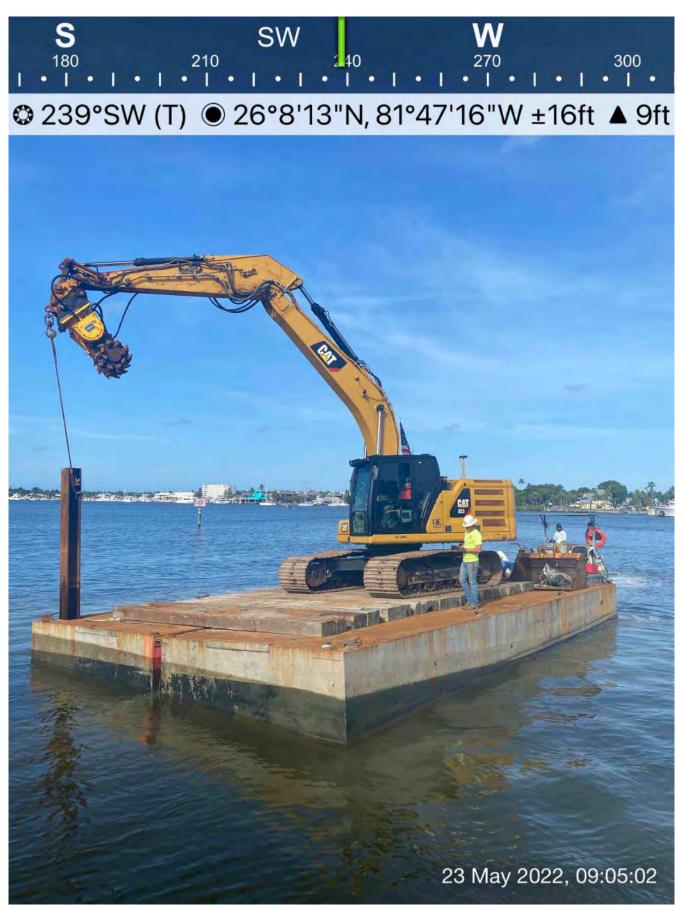
323 excavator lifting spud to allow push boat to transport barge from Canal CC-CC to Canal X-X

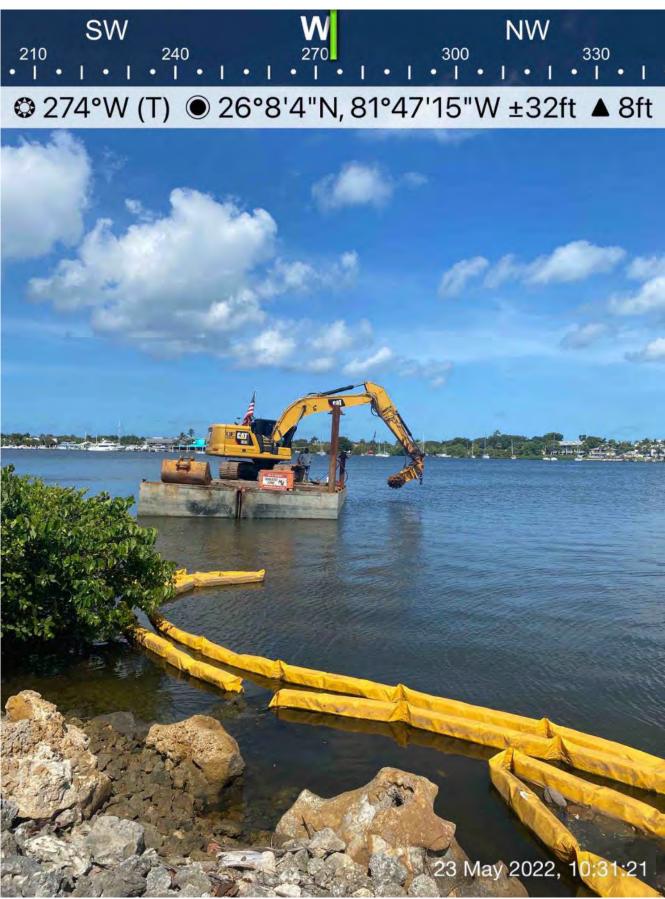
Pumping water out from the bottom of the barge

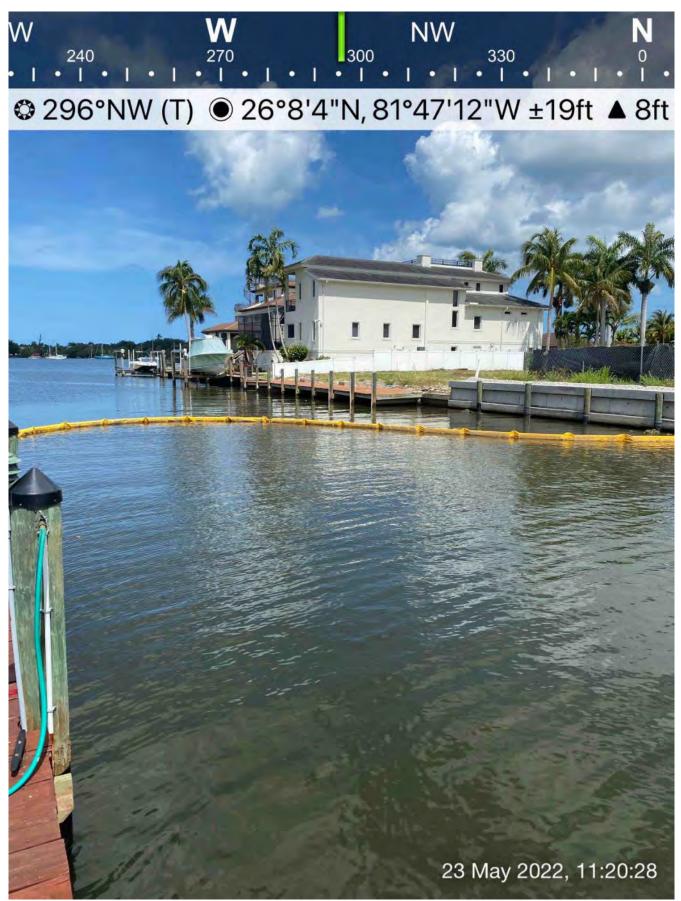
Turbidity curtain installed across Canal X-X at station 3+75

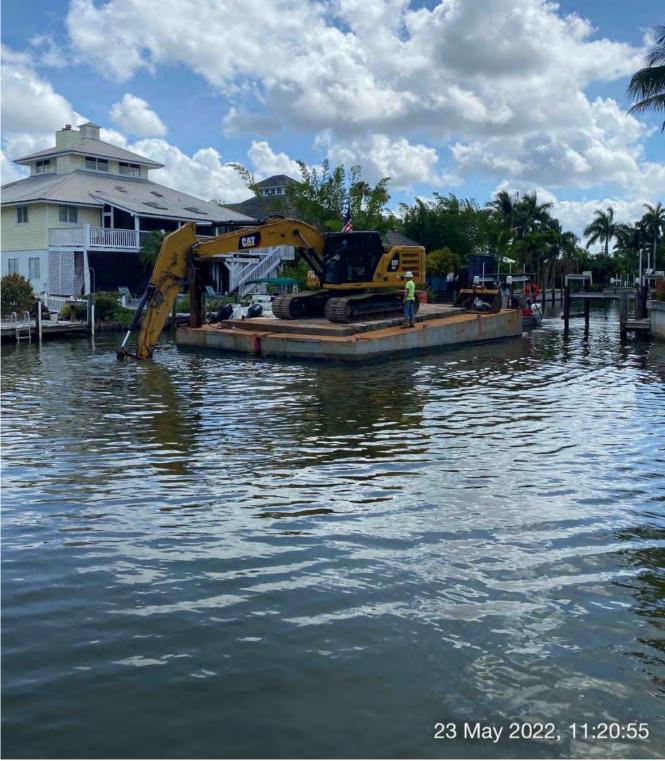
323 excavator checking elevations and grinding rock at station 5+75

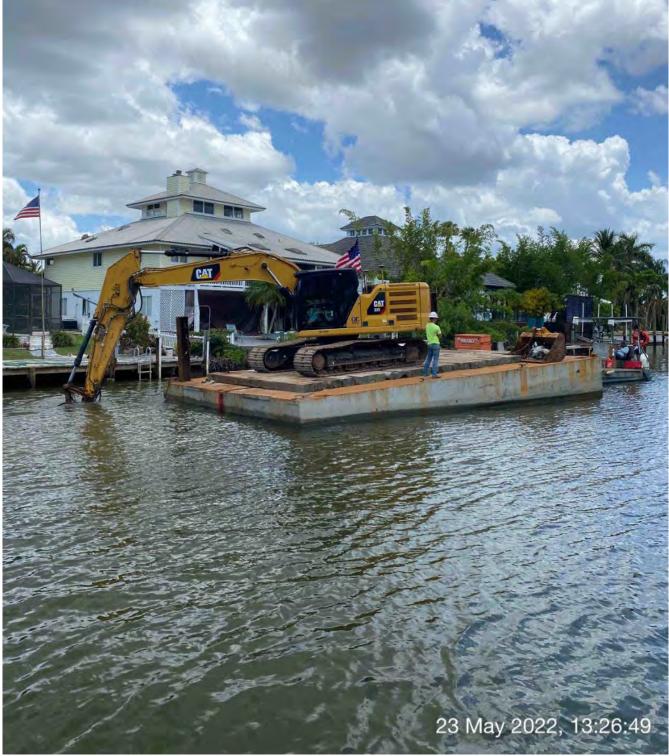
323 excavator checking elevations and grinding rock at station 5+50

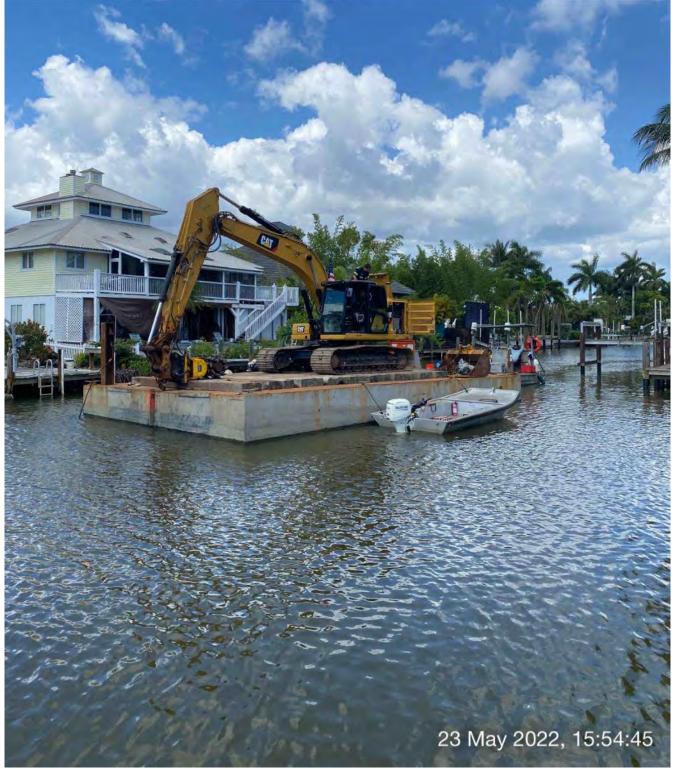
Mechanic on barge fixing coolant hose on 323 excavator

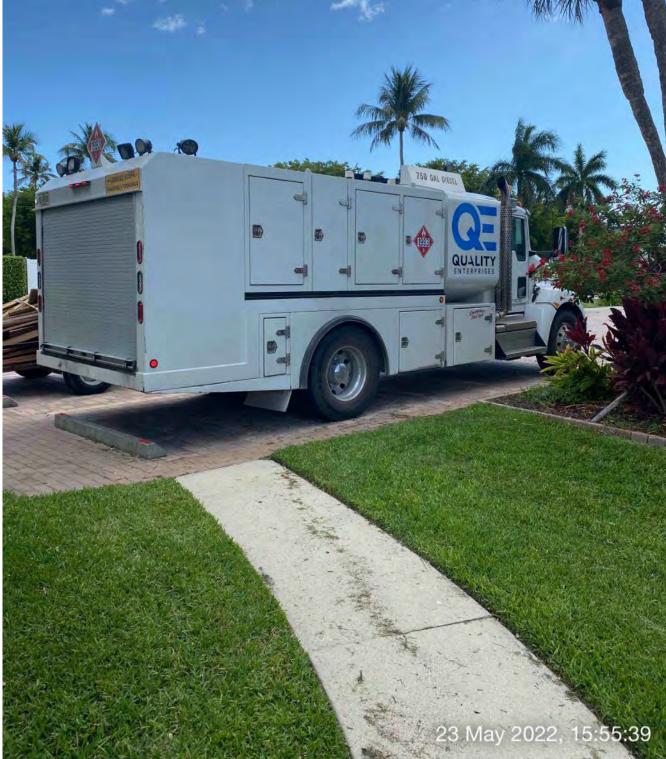
Mechanic truck at the end of Little Neck Court near Canal X-X

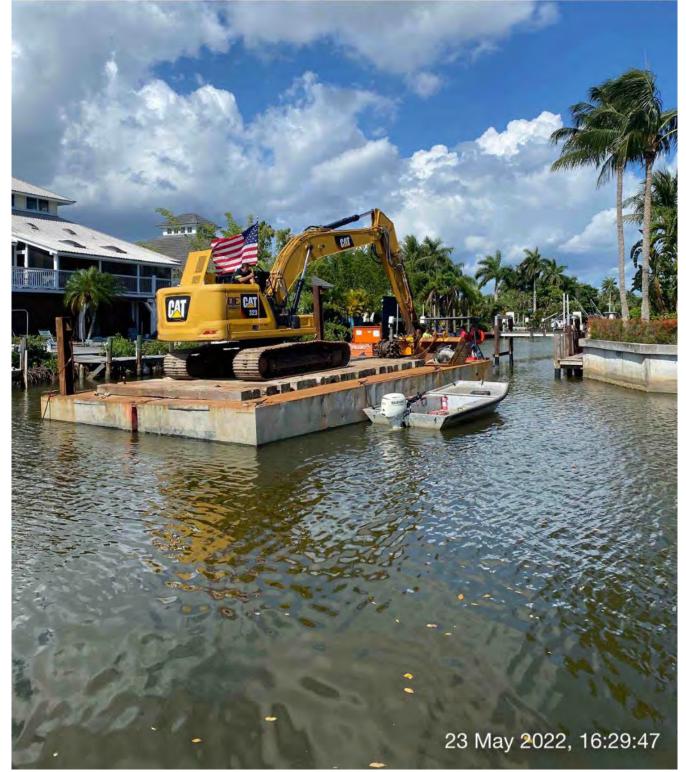
Mechanic on barge fixing coolant hose on 323 excavator

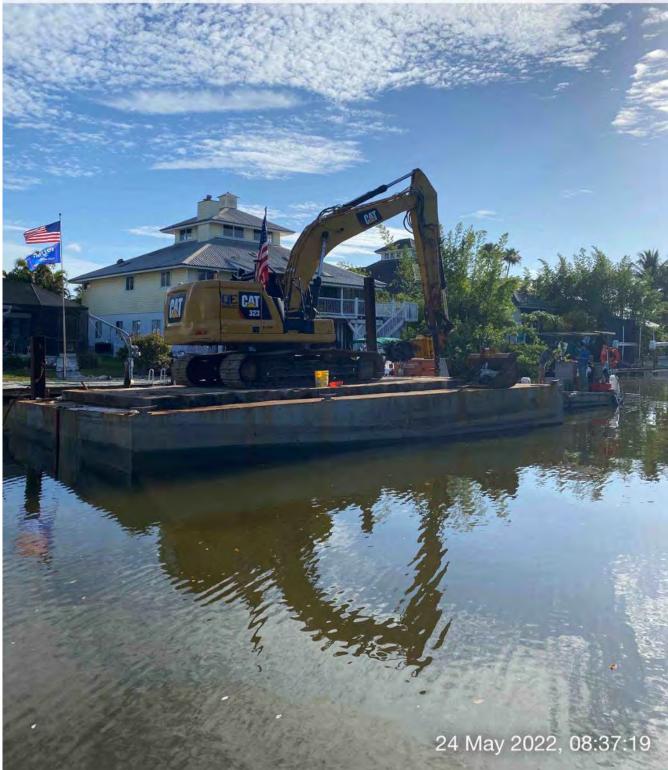
323 excavator on barge at station 5+50

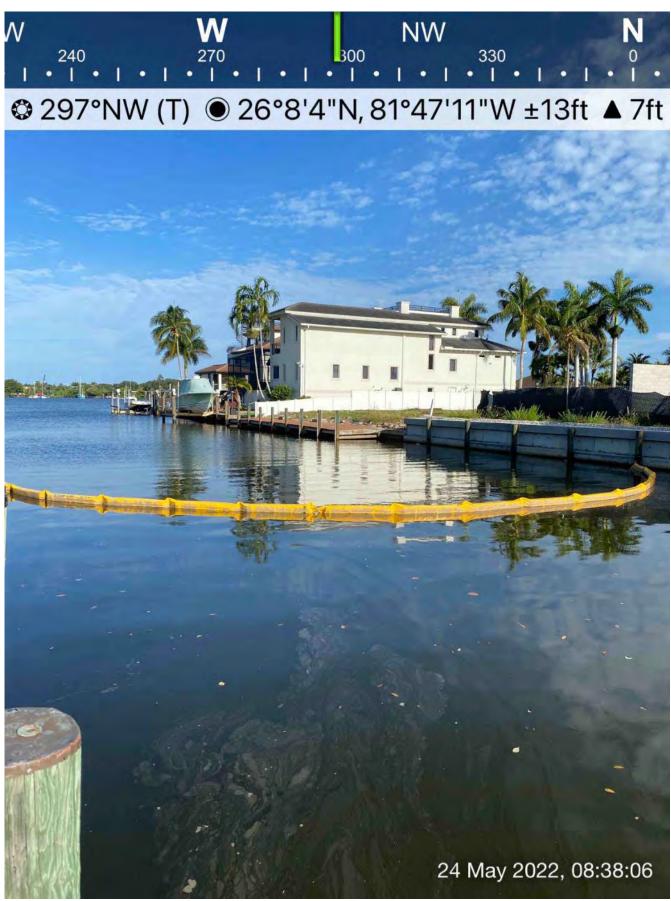
Turbidity curtain installed across Canal X-X at station 3+75

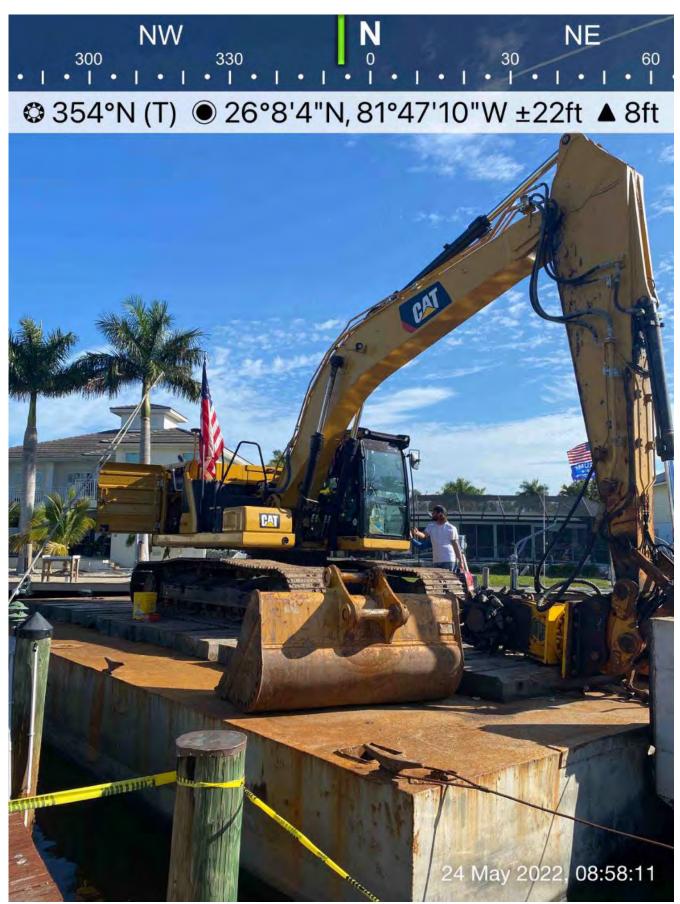
Barge and 323 excavator pushed up against the dock at between Canals X-X and Y-Y

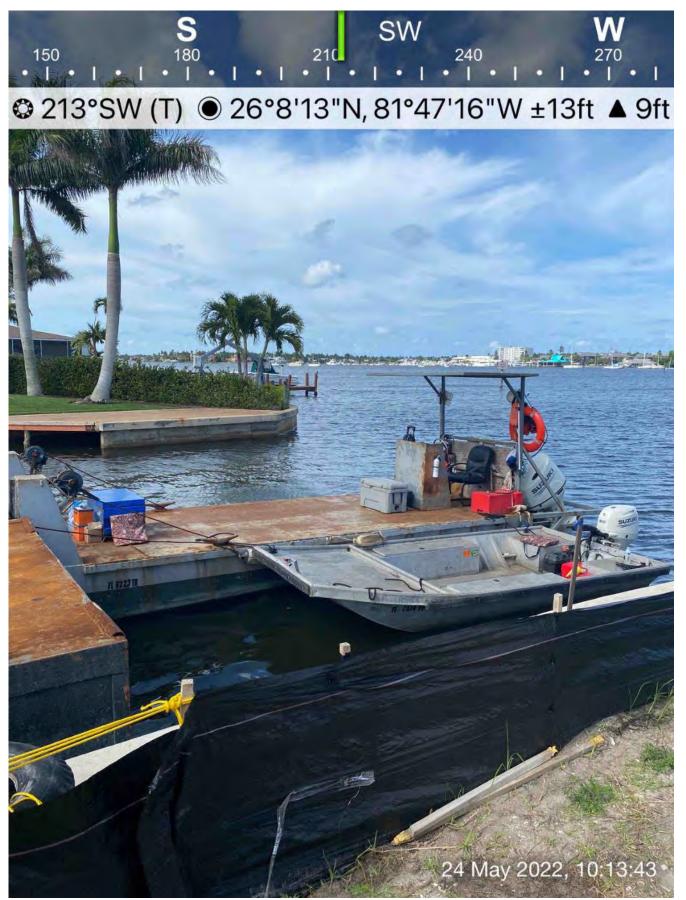
Push boat and support boat staged in Canal CC-CC at station 1+00.

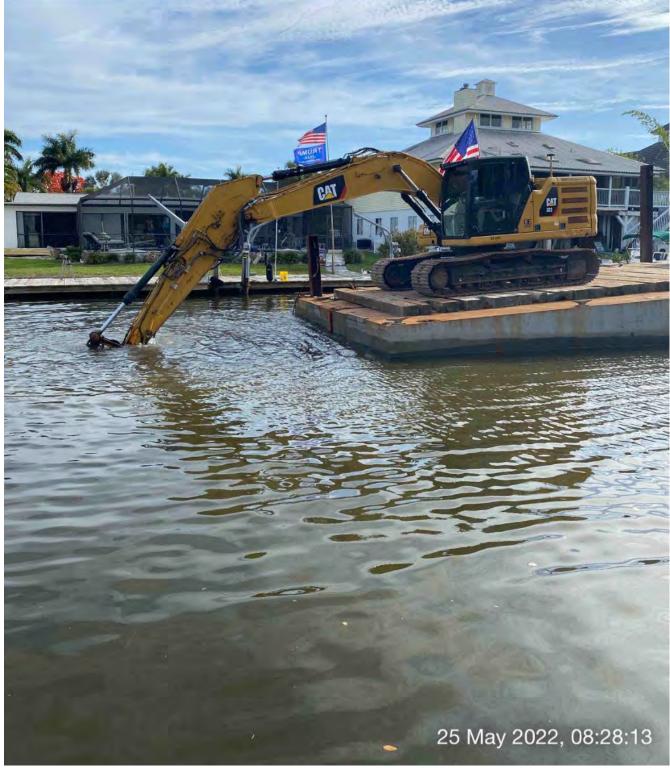
323 excavator grinding rock at station 5+25

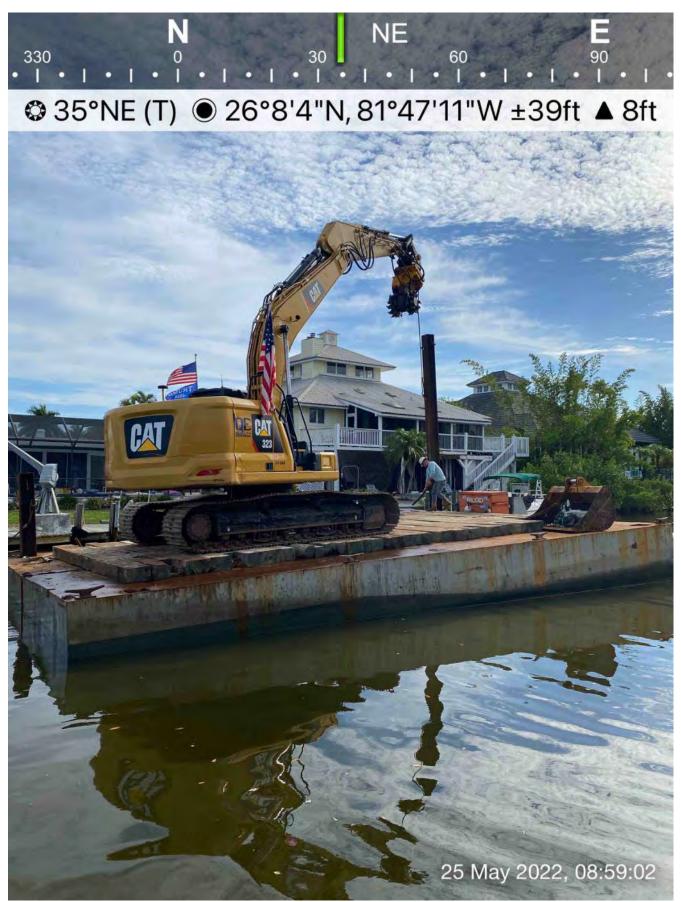
323 excavator lifting spud to allow push boat to mobilize barge at station 5+25

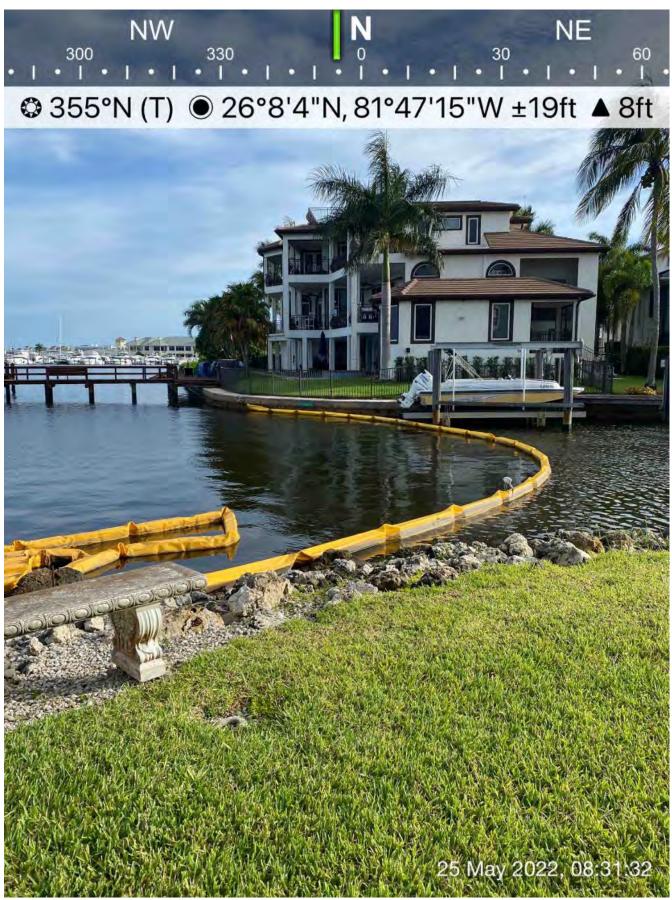
Turbidity curtain installed across the mouth of Canal X-X

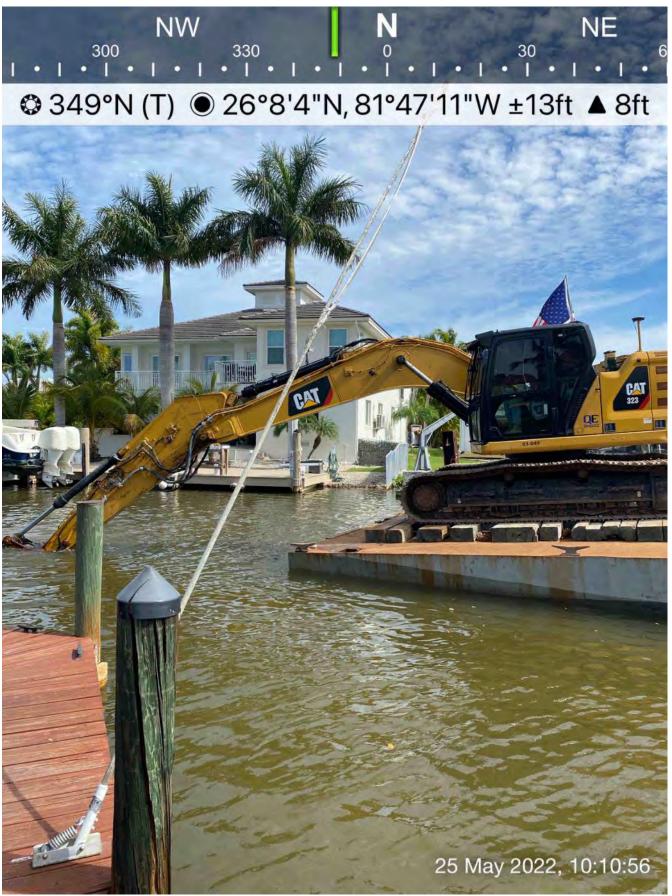
323 excavator grinding rock at station 4+50

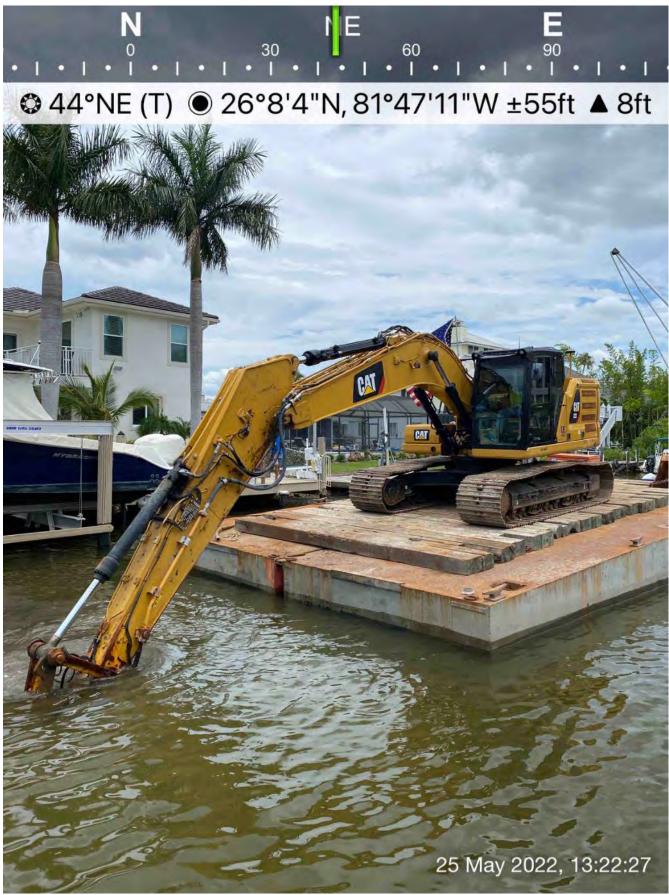
323 excavator grinding rock at station 3+50

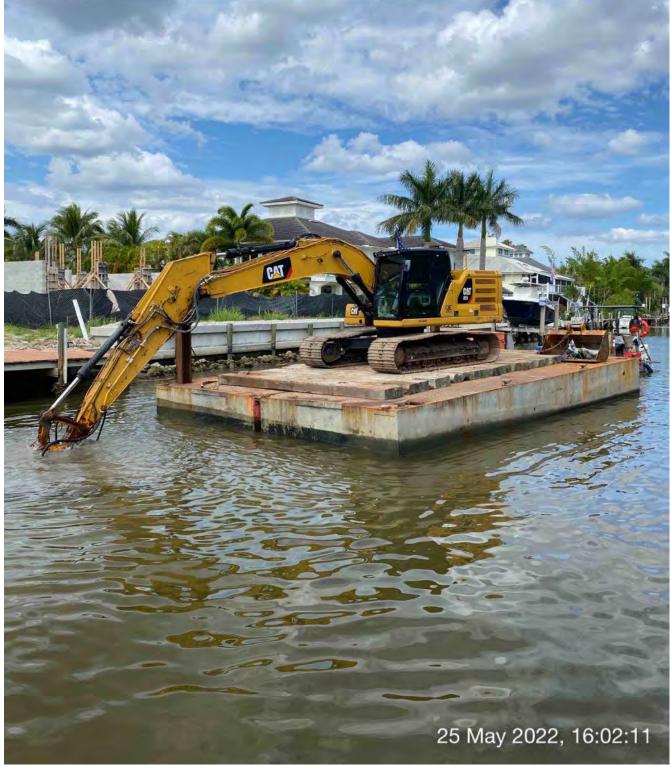
323 excavator grinding rock at station 3+00

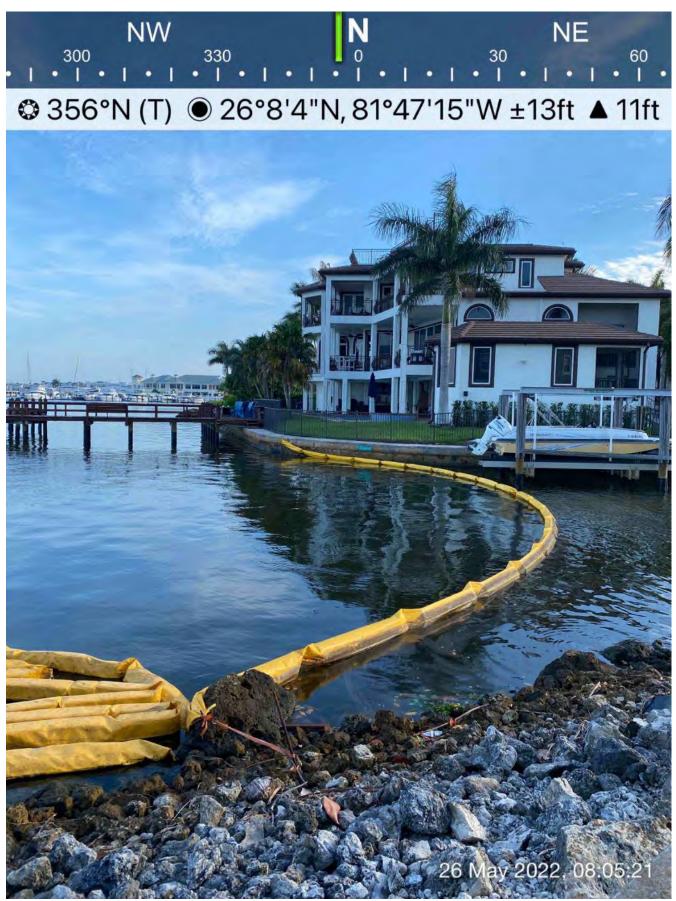
Turbidity curtain installed across mouth of Canal X-X

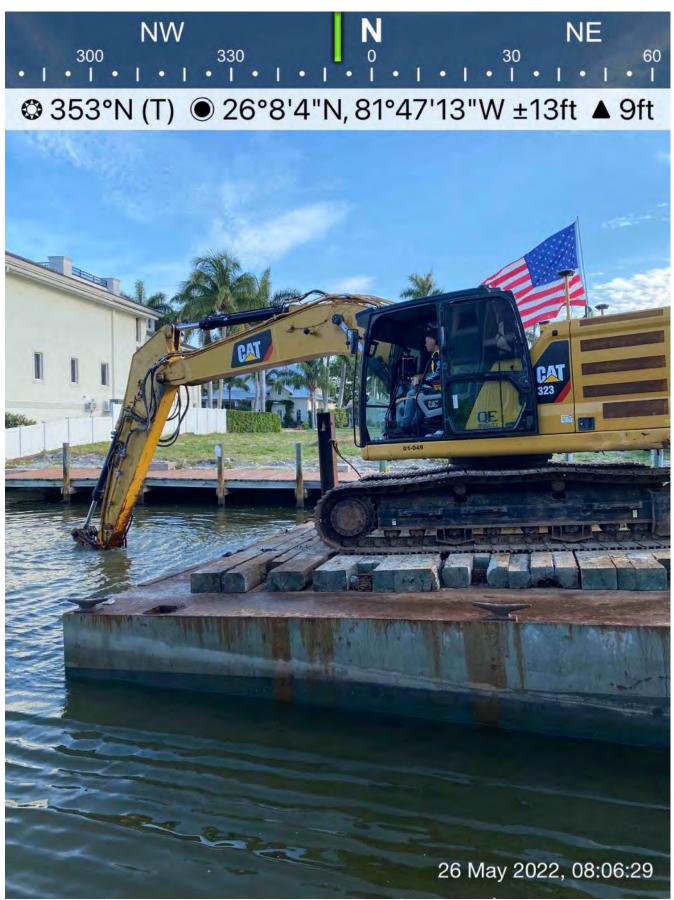
323 excavator grinding rock at station 3+00

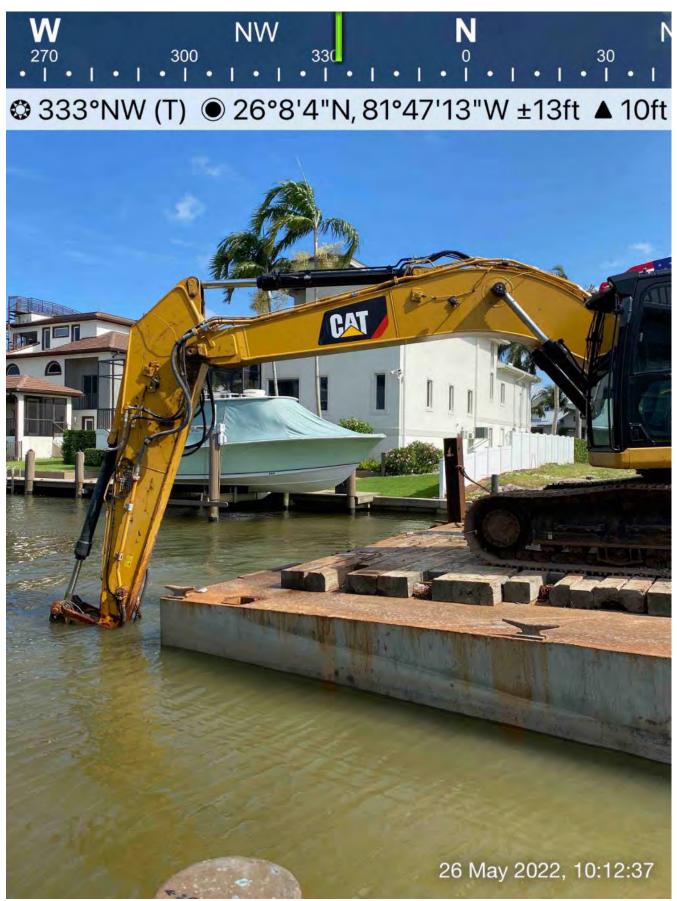
323 excavator grinding rock at station 2+50

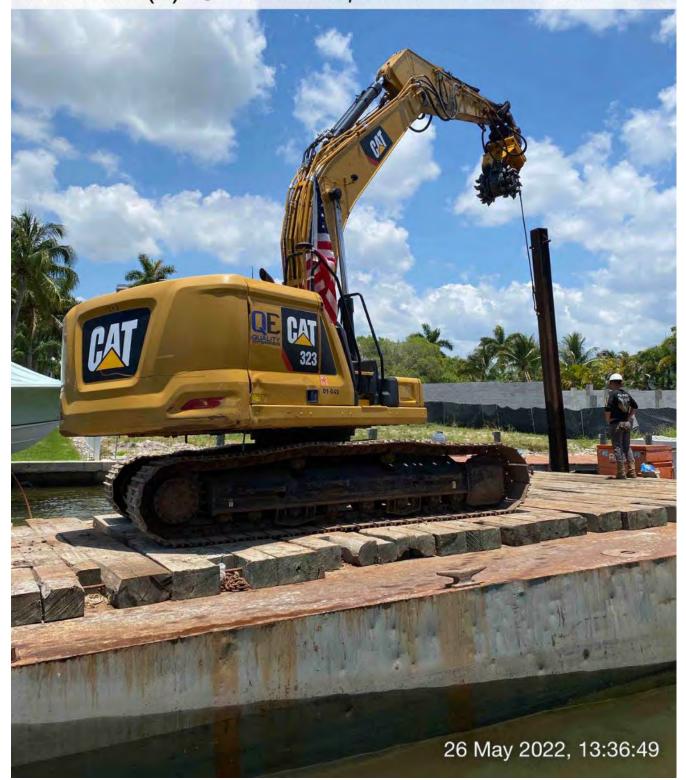
323 excavator lifting spud to allow push boat to mobilize barge at station 2+00

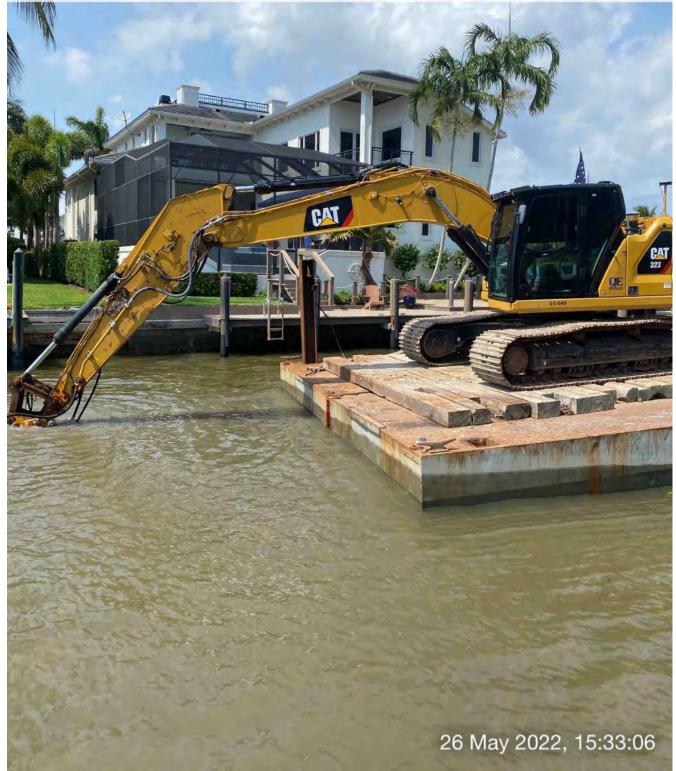
323 excavator grinding rock at station 1+75

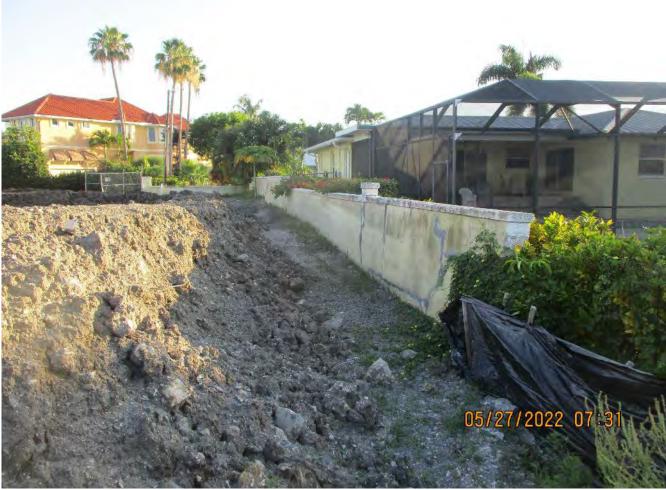
Dredged material removal and wall crack repair noted (1300/1350 Curlew Ave)

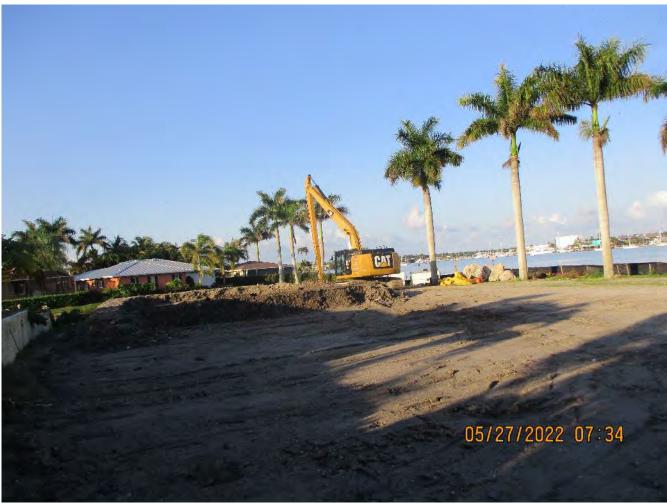
Current status of staging area/stockpile at 1300 Curlew Ave

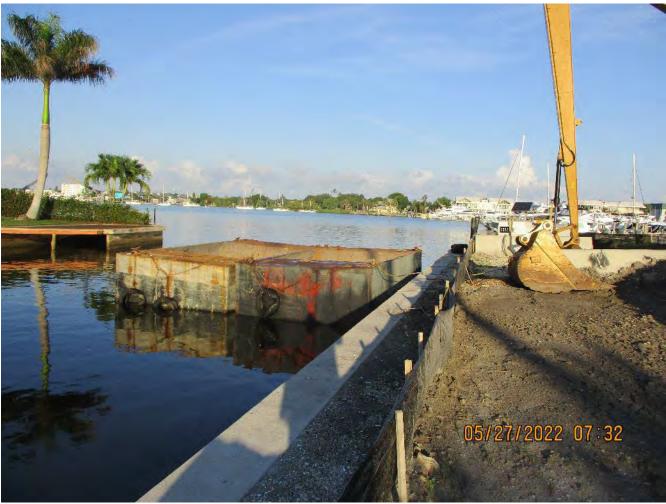
Staged hoppers at 1300 Curlew Ave. canal location

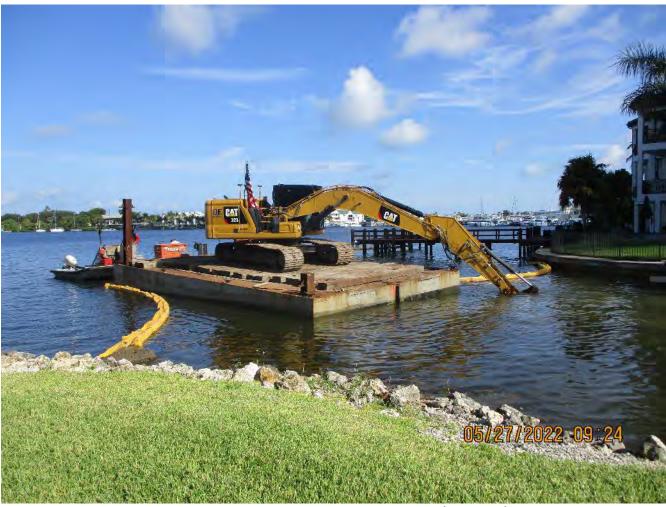
Canal bottom grinding at approx. station 1+00 (Canal X-X)

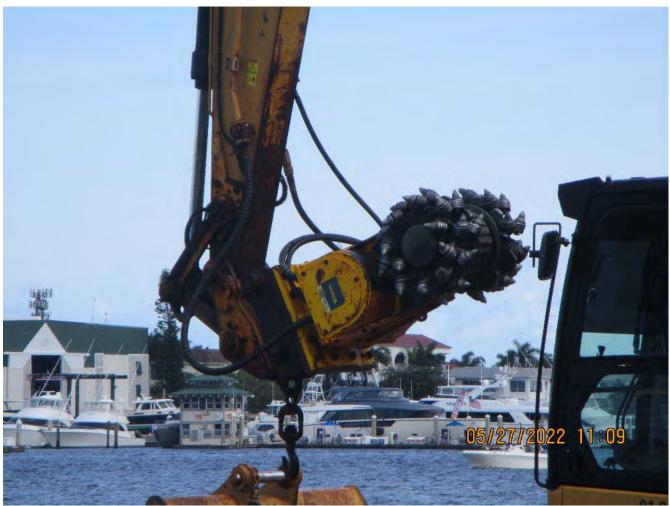
Epiroc attachment being used for today's canal bottom grinding

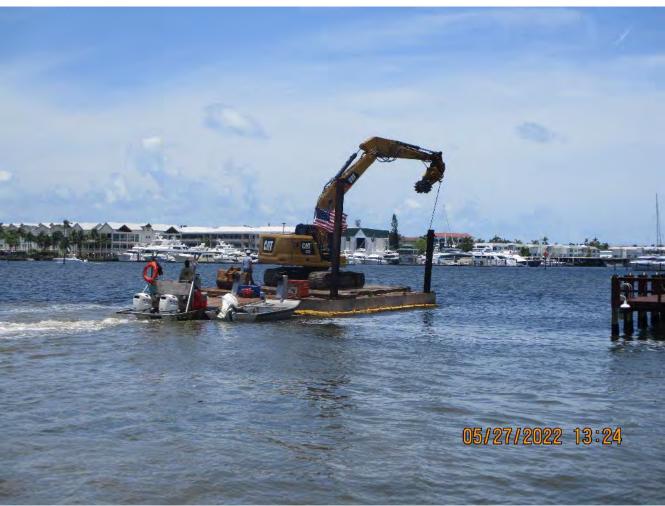
Barge being pushed back to 1300 Curlew Ave. location
