# WEEKLY SUMMARY REPORT – CONTRACT WEEK 48

21-036 EAST NAPLES BAY

## DREDGING AND ROCK REMOVAL PROJECT

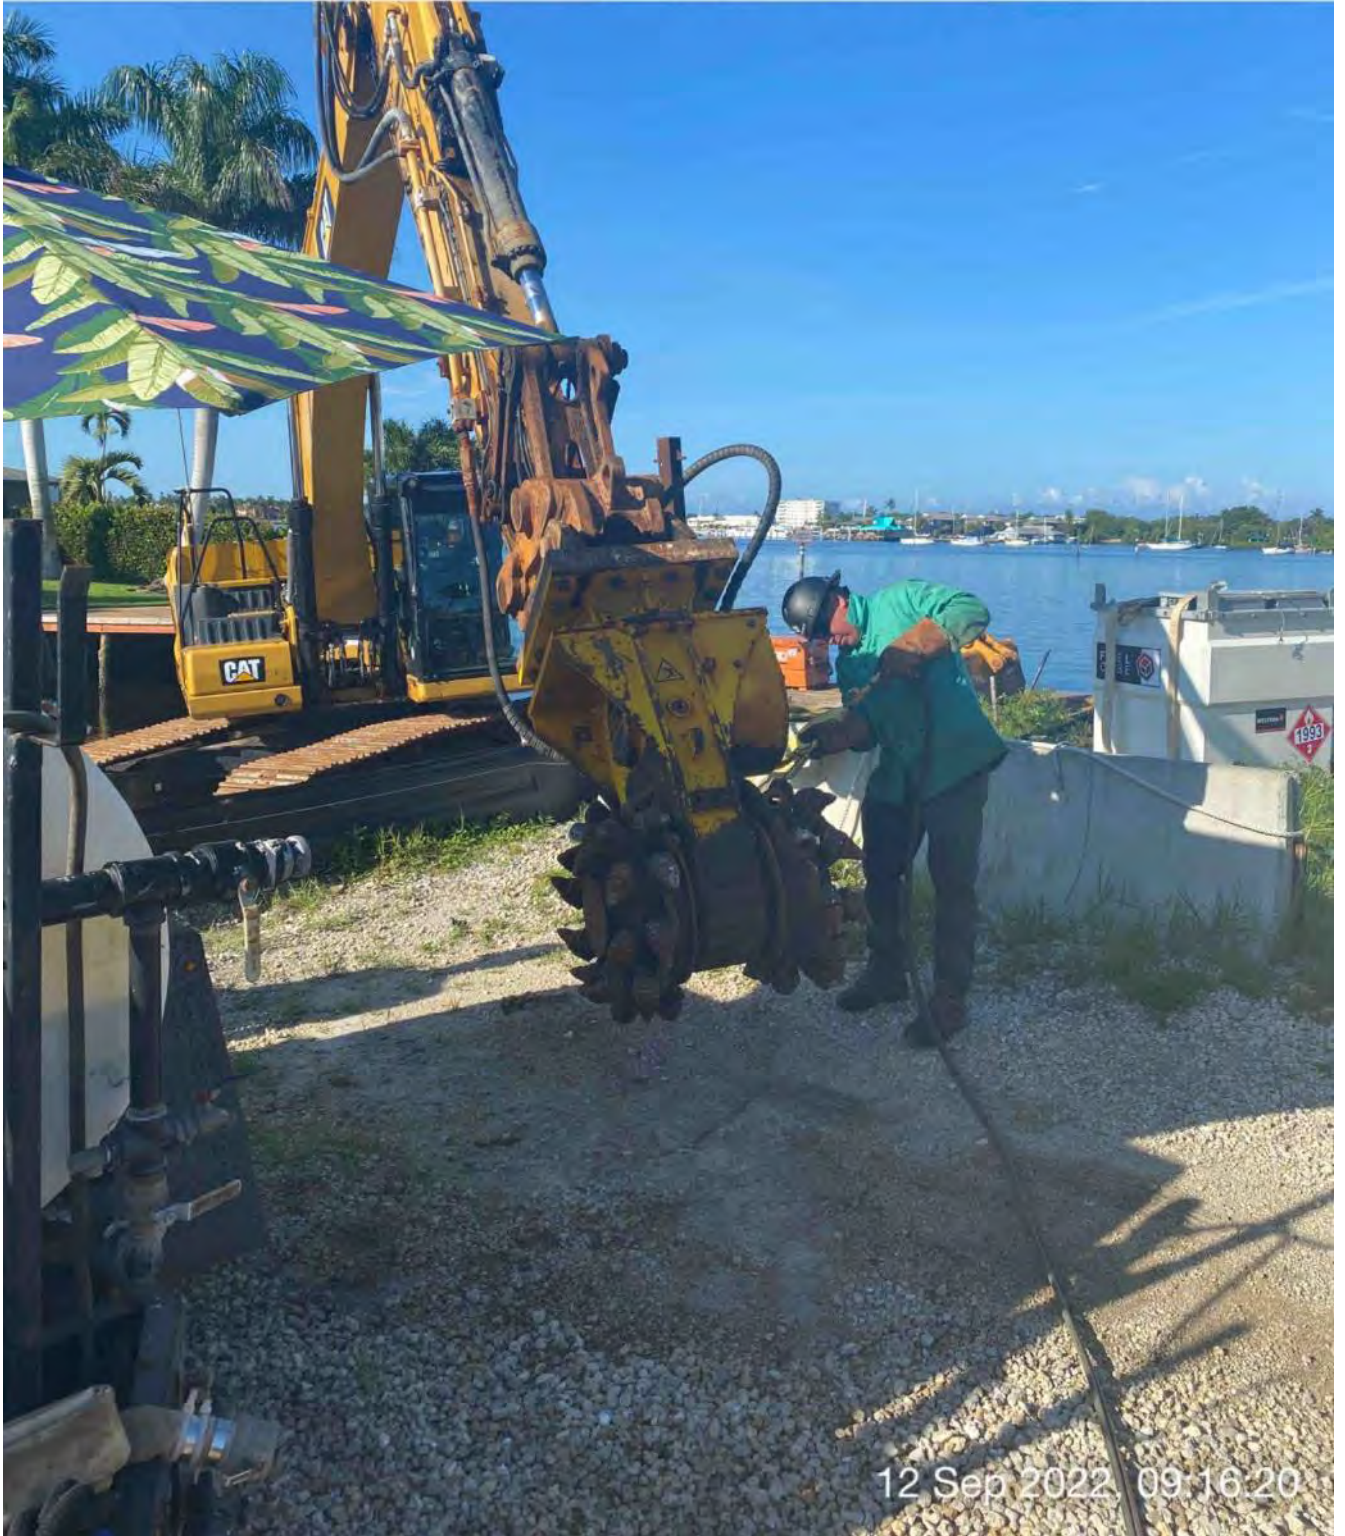
**Mechanic removing, fixing, and replacing teeth sleeves on Epiroc grinder**

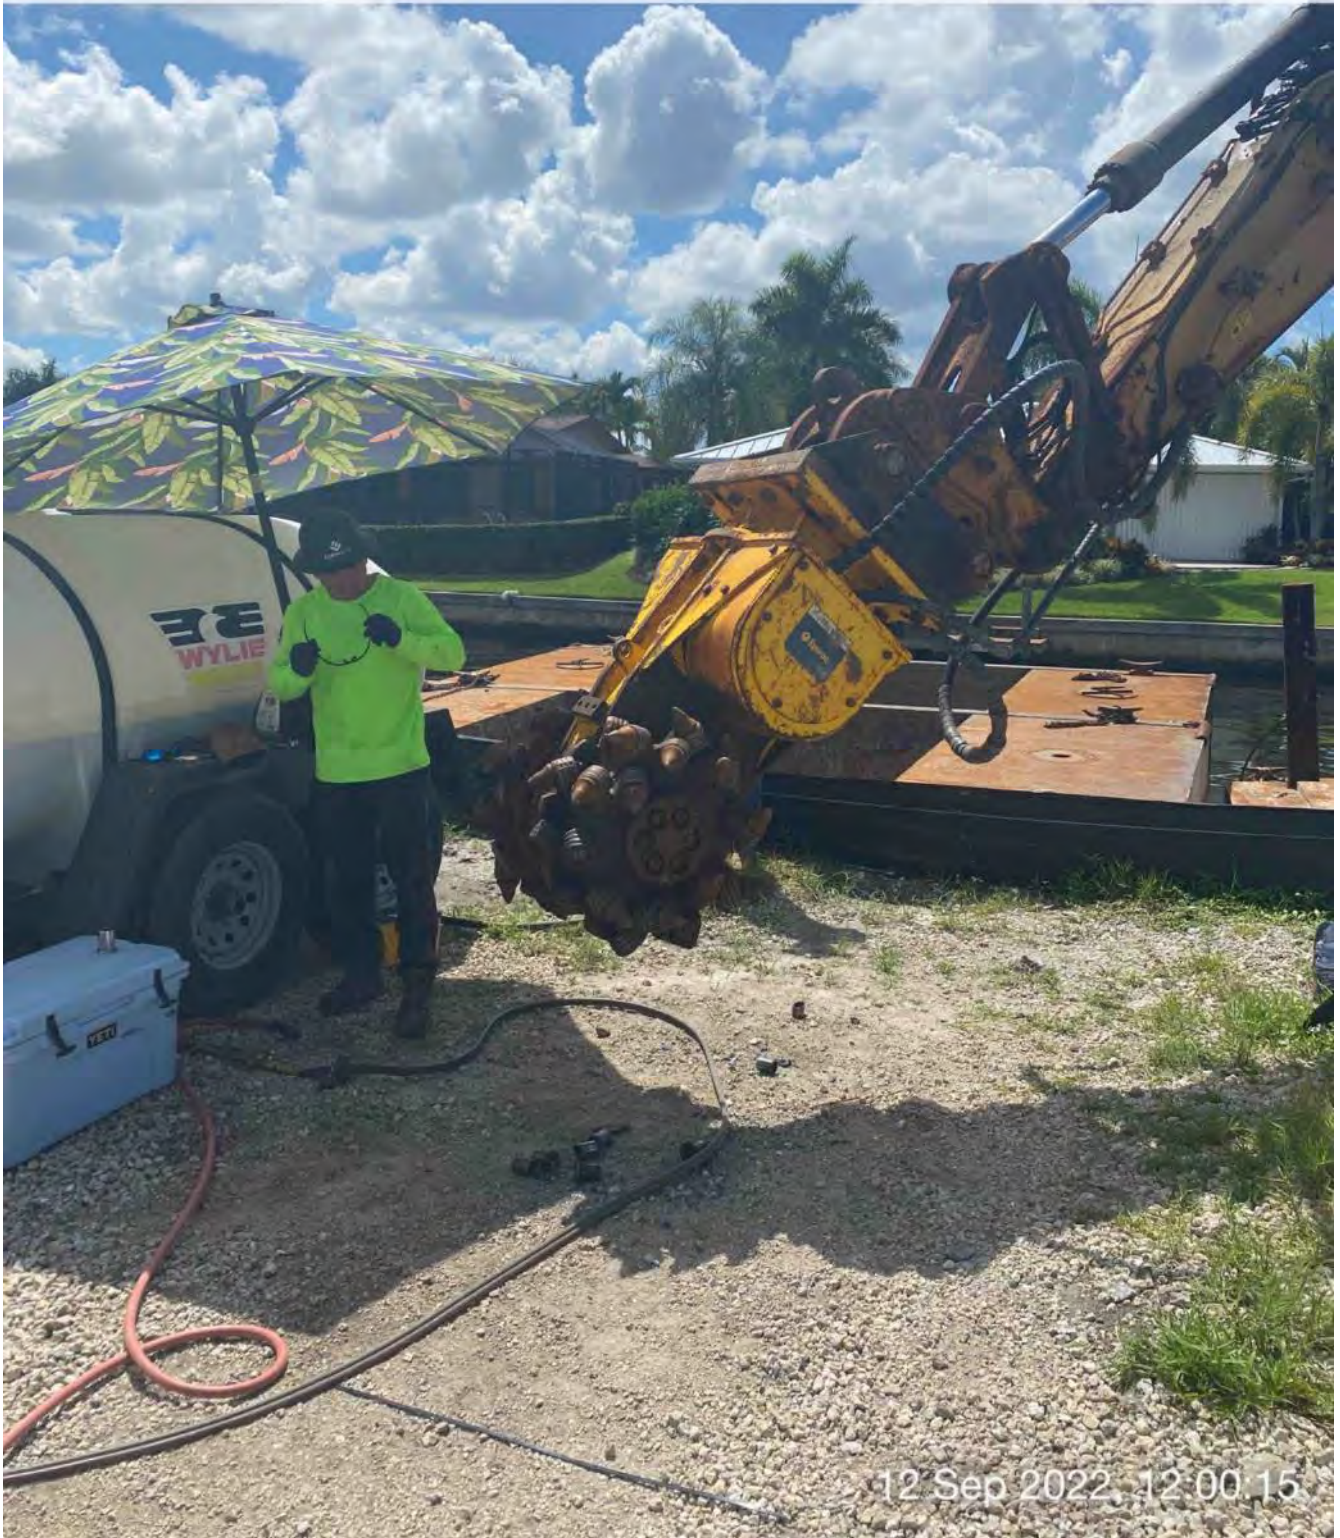
**Mechanic removing, fixing, and replacing teeth sleeves on Epiroc grinder**

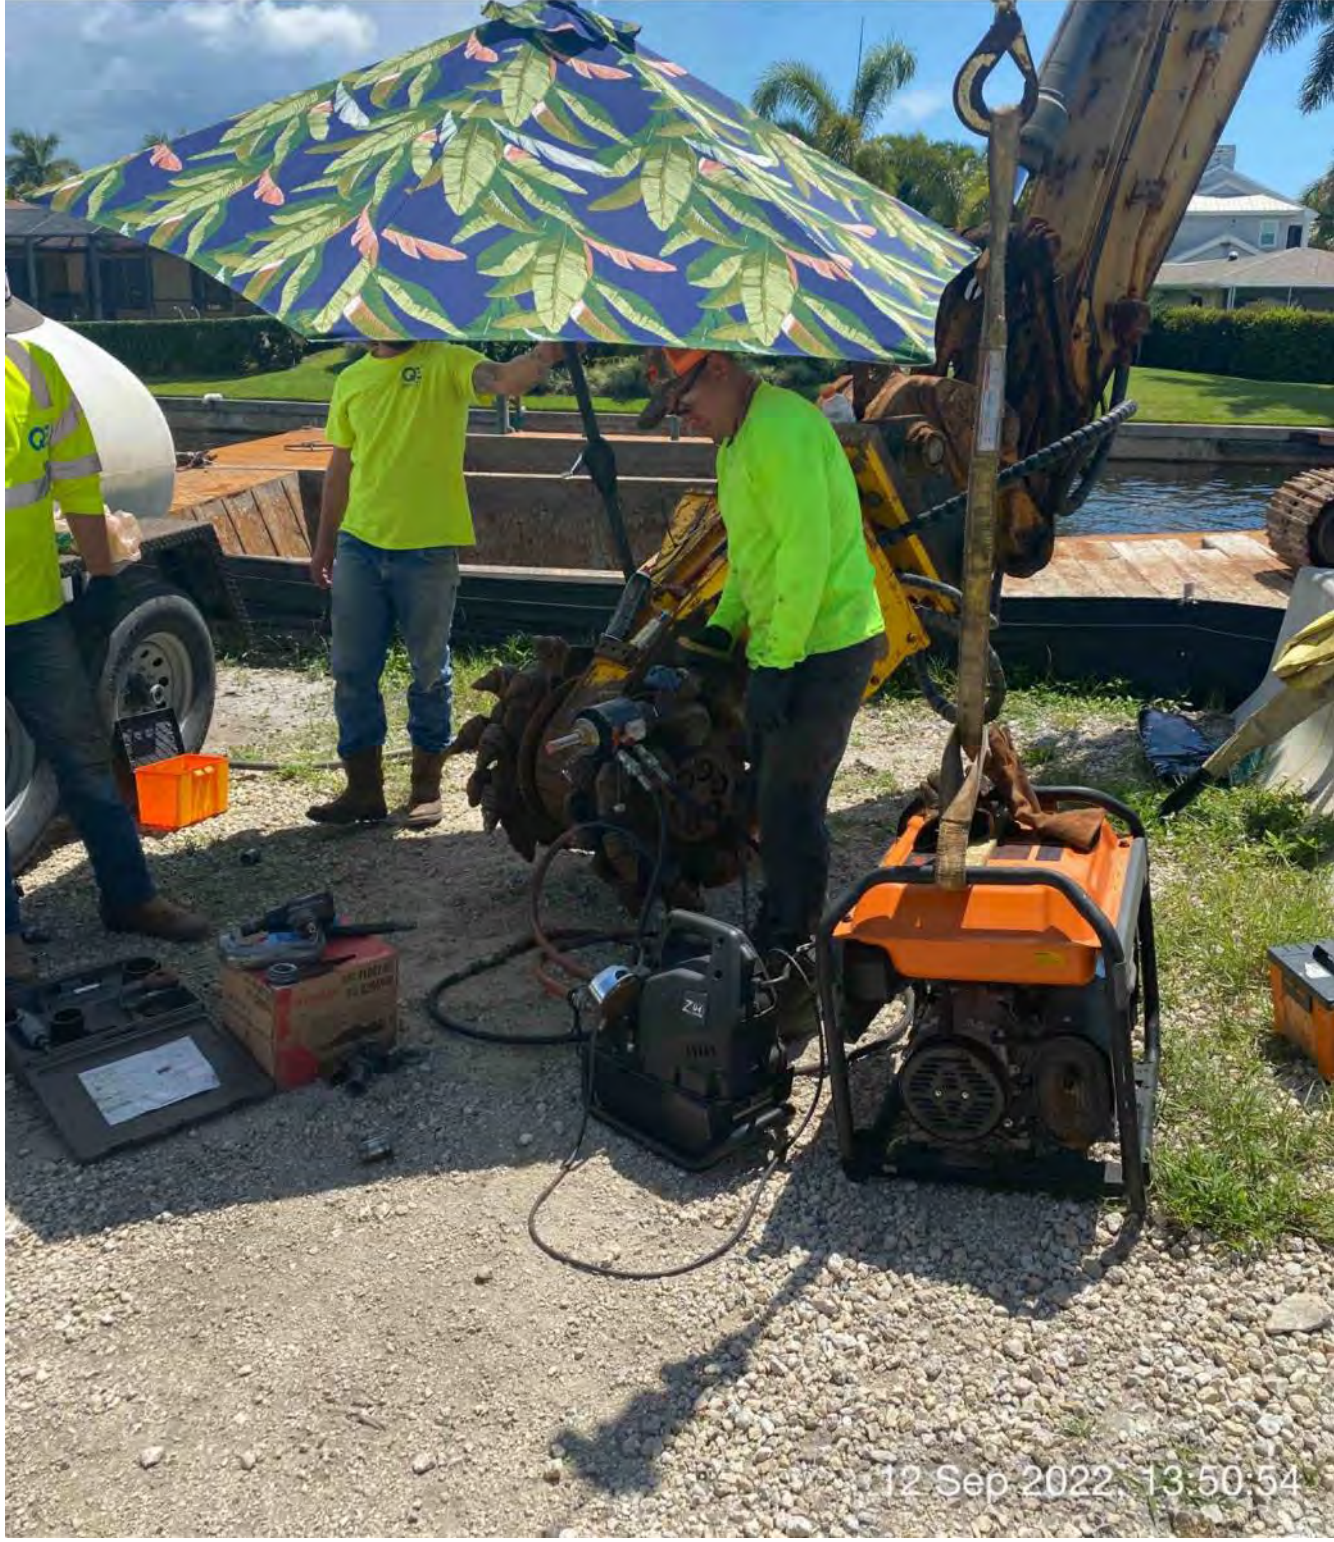
**Mechanic removing, fixing, and replacing teeth sleeves on Epiroc grinder**

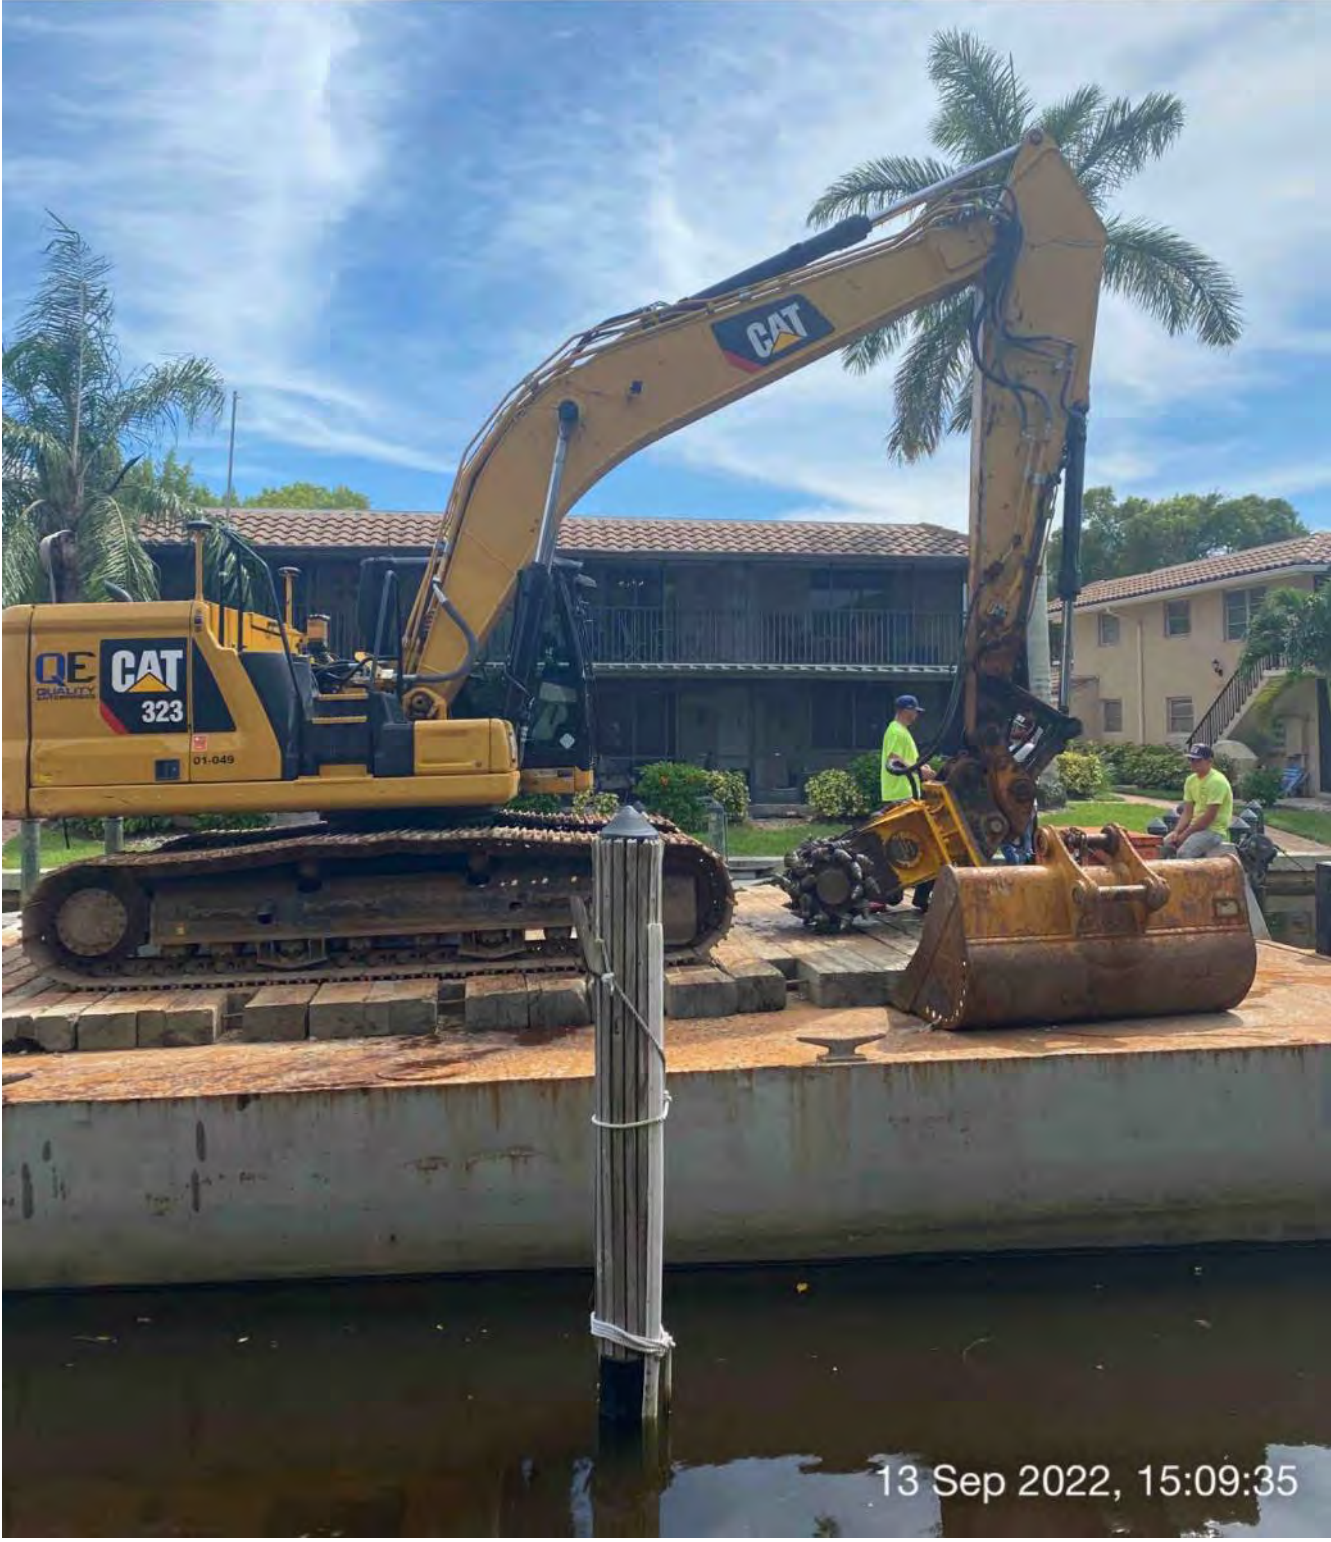
- Contractor has a barge, an excavator, a support boat, and 2 hoppers staged in Canal CC-CC between stations 1+00 and 2+00. In addition, Contractor has a long-reach excavator, a water tank, and two fuel cubes staged on the property located at 1300 Curlew Avenue, Naples, FL, 34102.
- Contractor used push boat to transport barge and 323 excavator from Canal CC-CC to Canal W-W.
- Contractor used support boat to install turbidity curtain across the mouth of Canal W-W.
- Contractor used 323 excavator to grind rock between stations 14+75 and 15+25.
- Contractor used push boat to position barge as necessary for grinding rock.
- Hydraulic hose blew on 323 excavator.
- Mechanic came to barge to fix hydraulic hose

Mechanic replacing hydraulic hose on 323 excavator

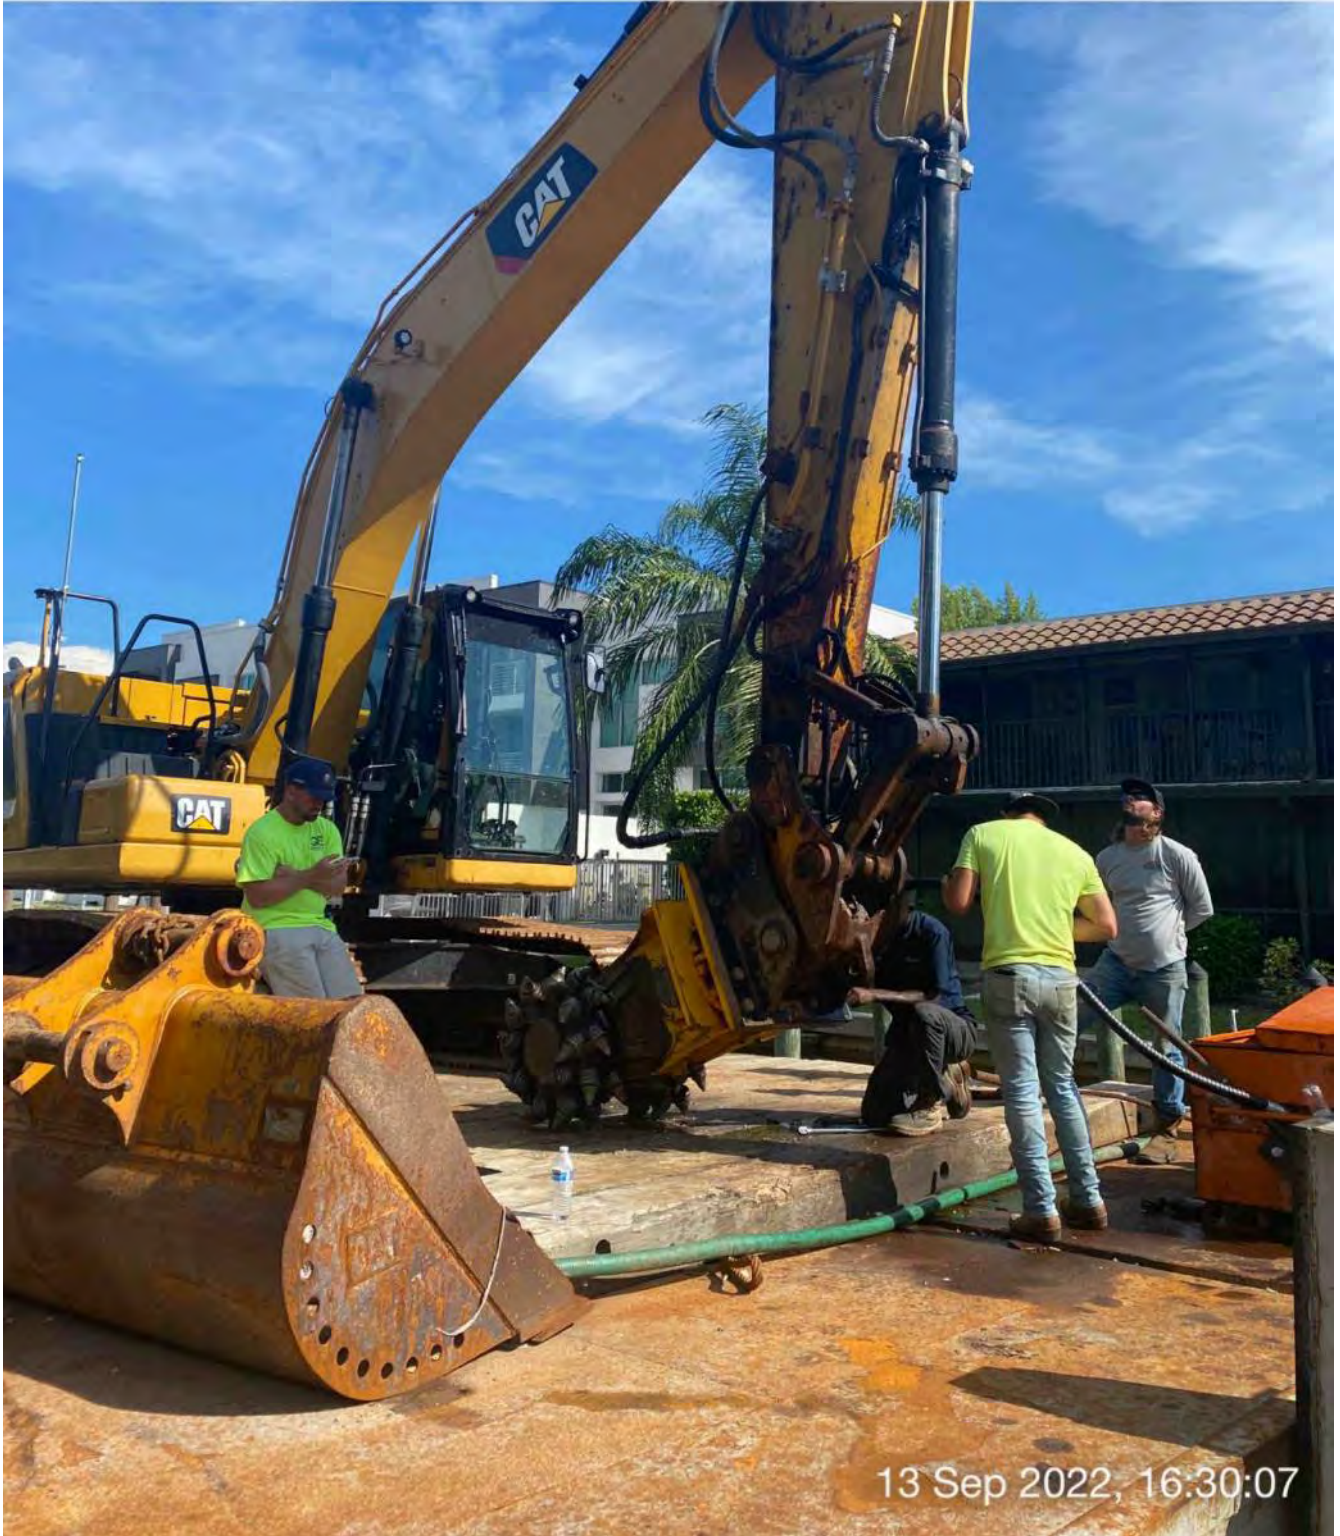
Mechanic replacing hydraulic hose on 323 excavator
