WEEKLY SUMMARY REPORT – CONTRACT WEEK 51
21-036 EAST NAPLES BAY
DREDGING AND ROCK REMOVAL PROJECT

DAILY REPORT OF CONSTRUCTION
 21-036 EAST NAPLES BAY
 DREDGING AND ROCK REMOVAL PROJECT

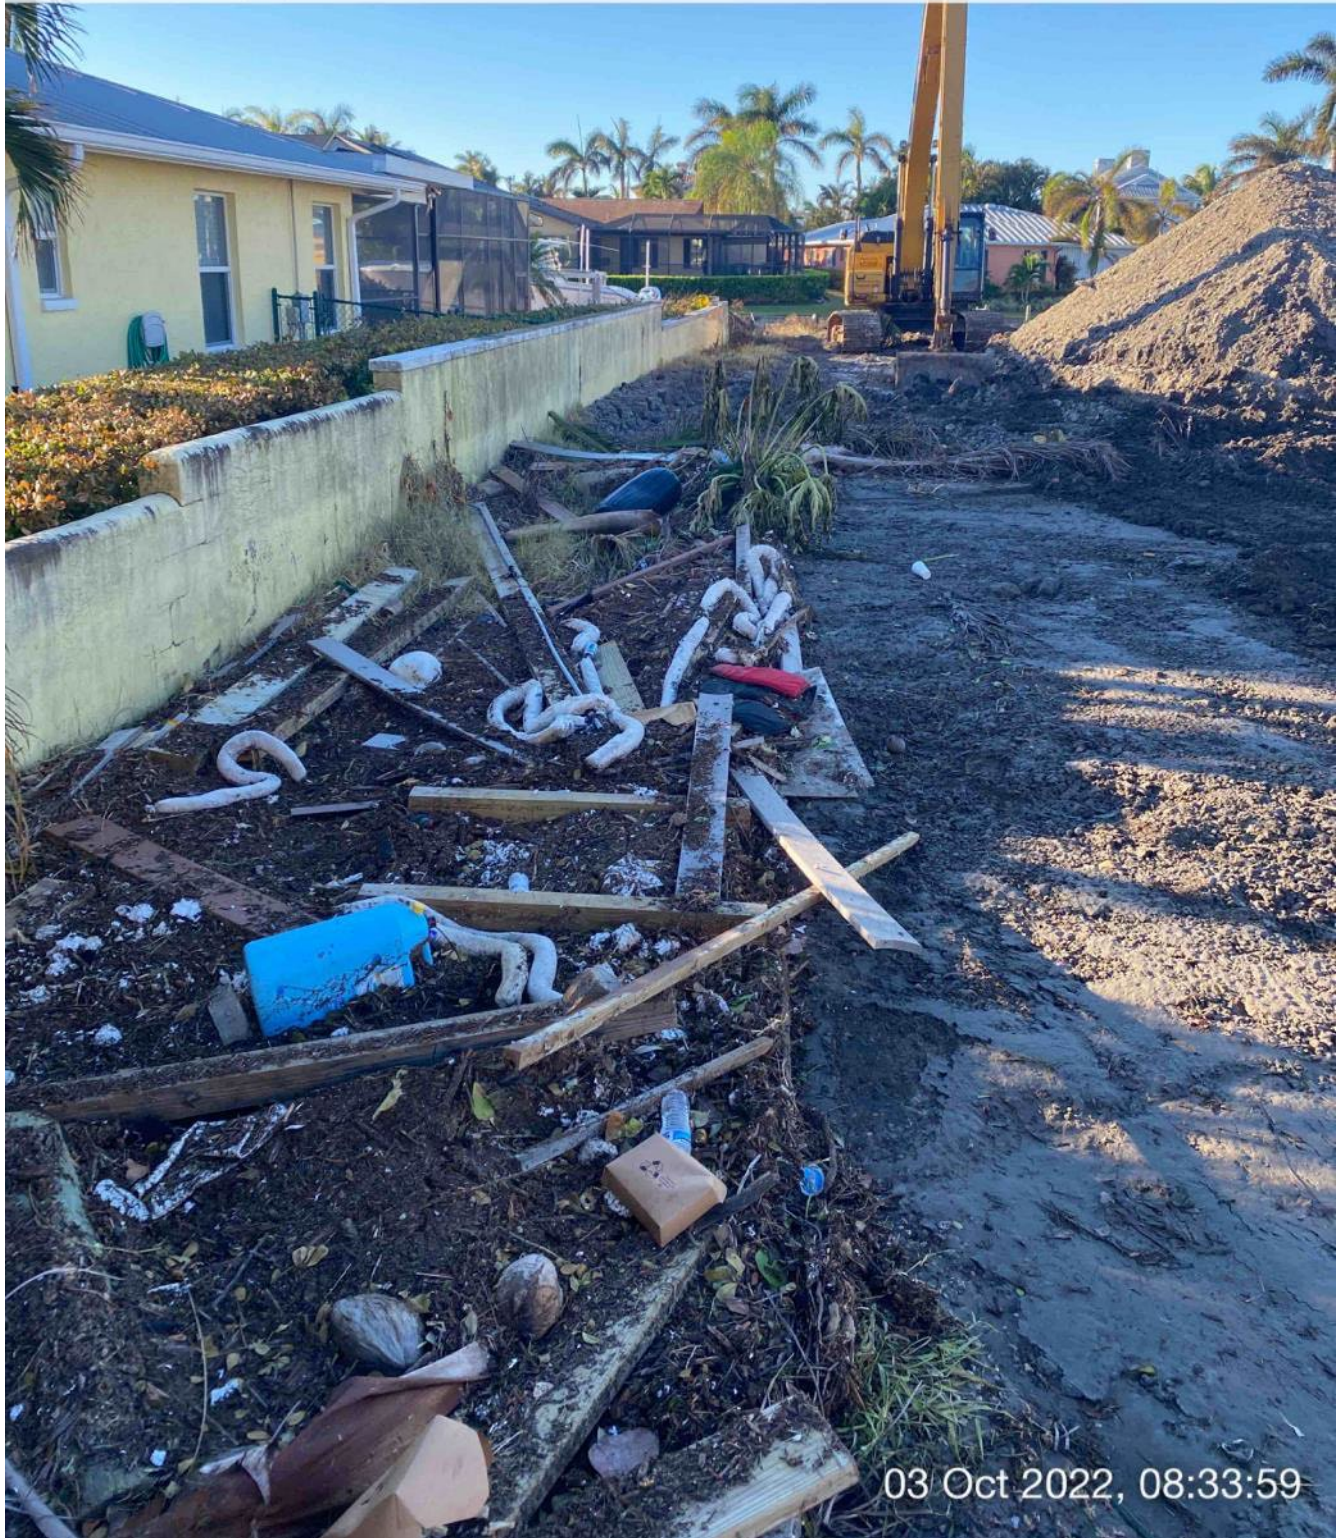
Debris washed up to east side of 1300 Curlew Avenue

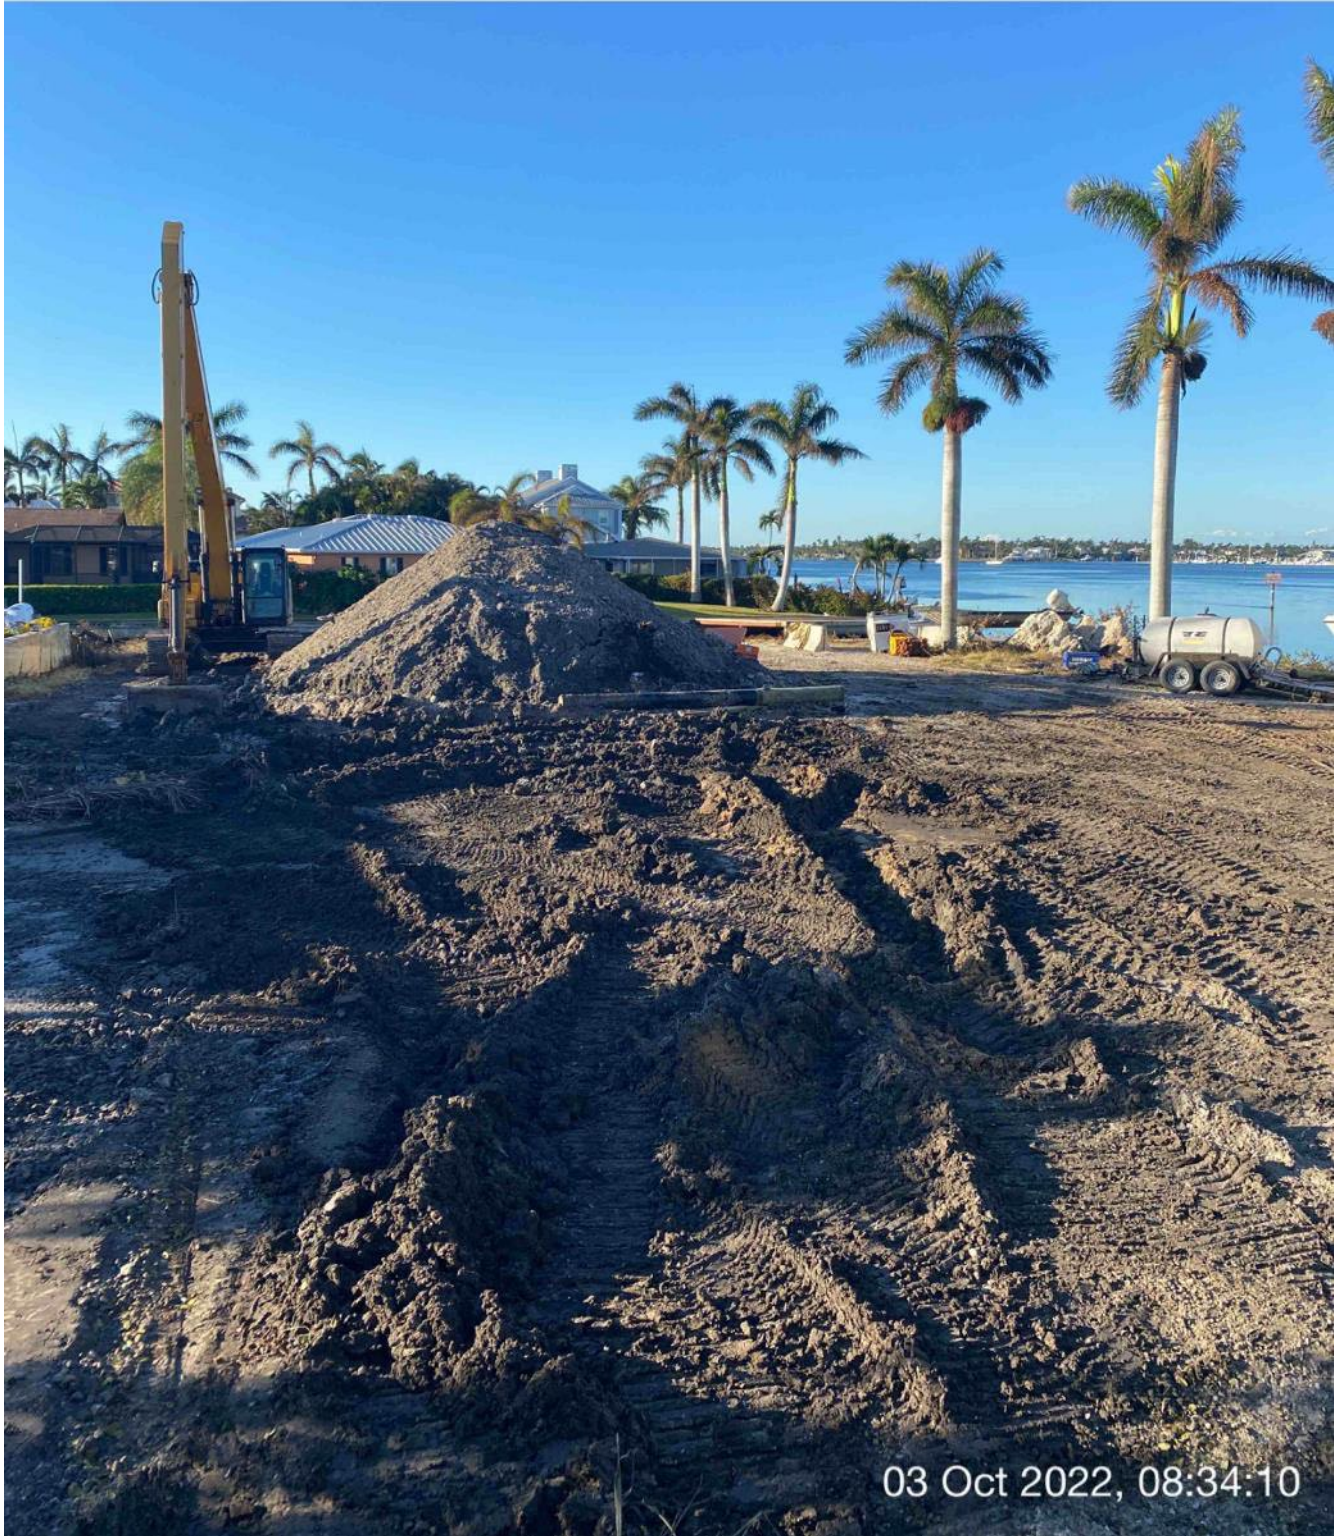
326 excavator, removed material, water tank, and support boat still on site at 1300 Curlew Avenue

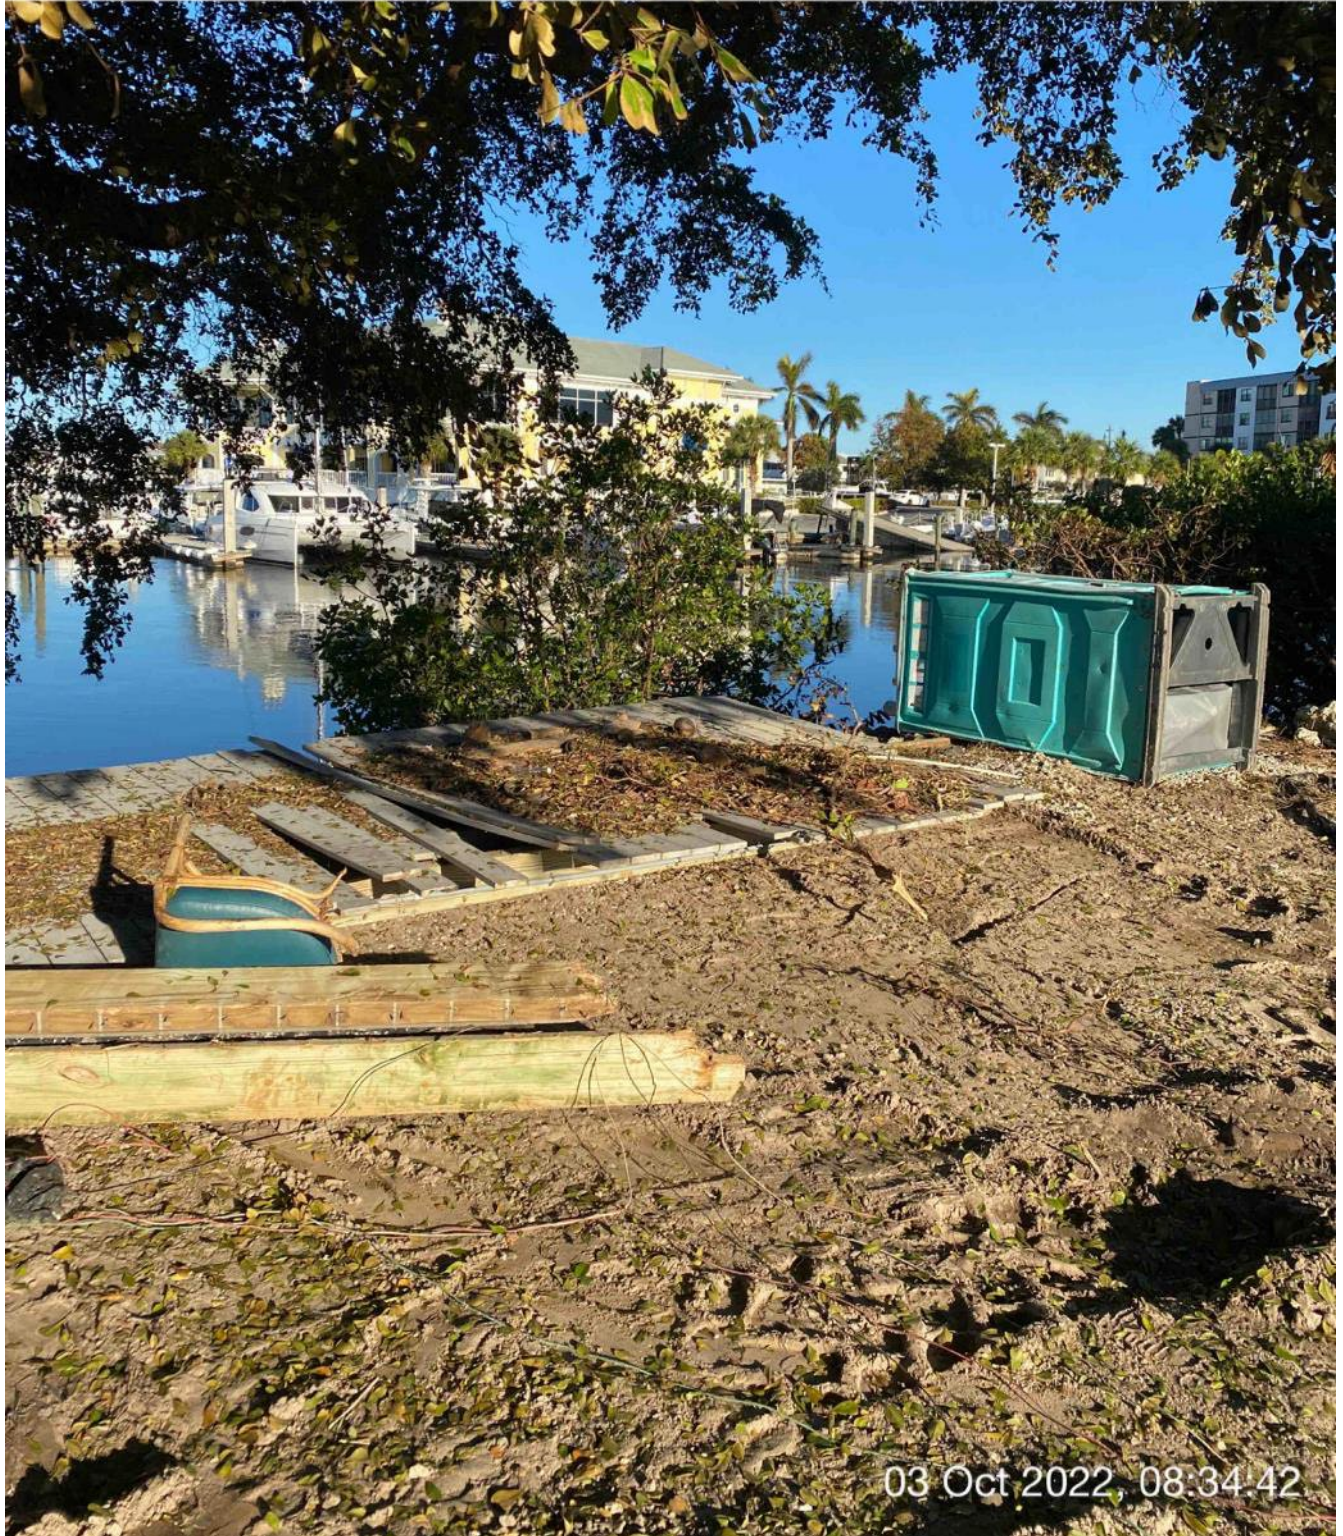
Toilet, dock section, telephone pole, and chair washed up at northwest side of 1300 Curlew Avenue

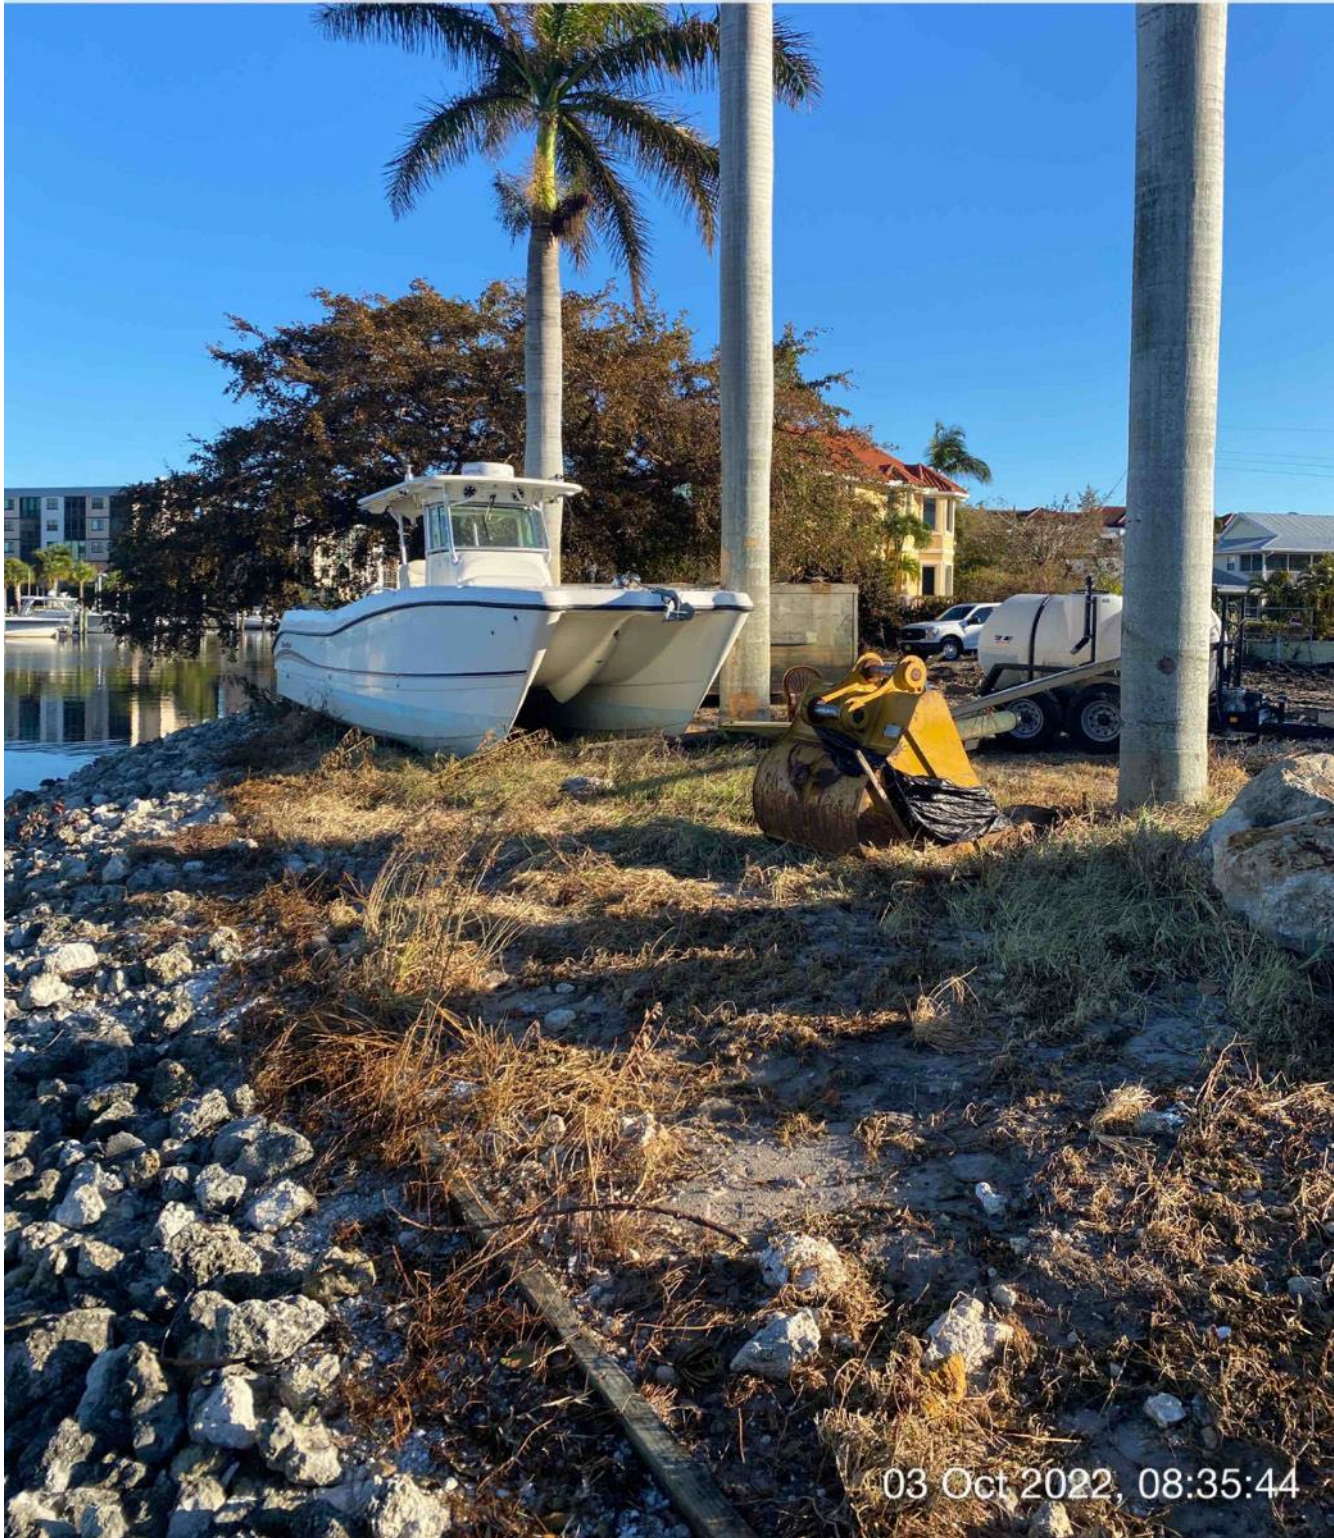
Catamaran sitting on west side of lot at 1300 Curlew Avenue

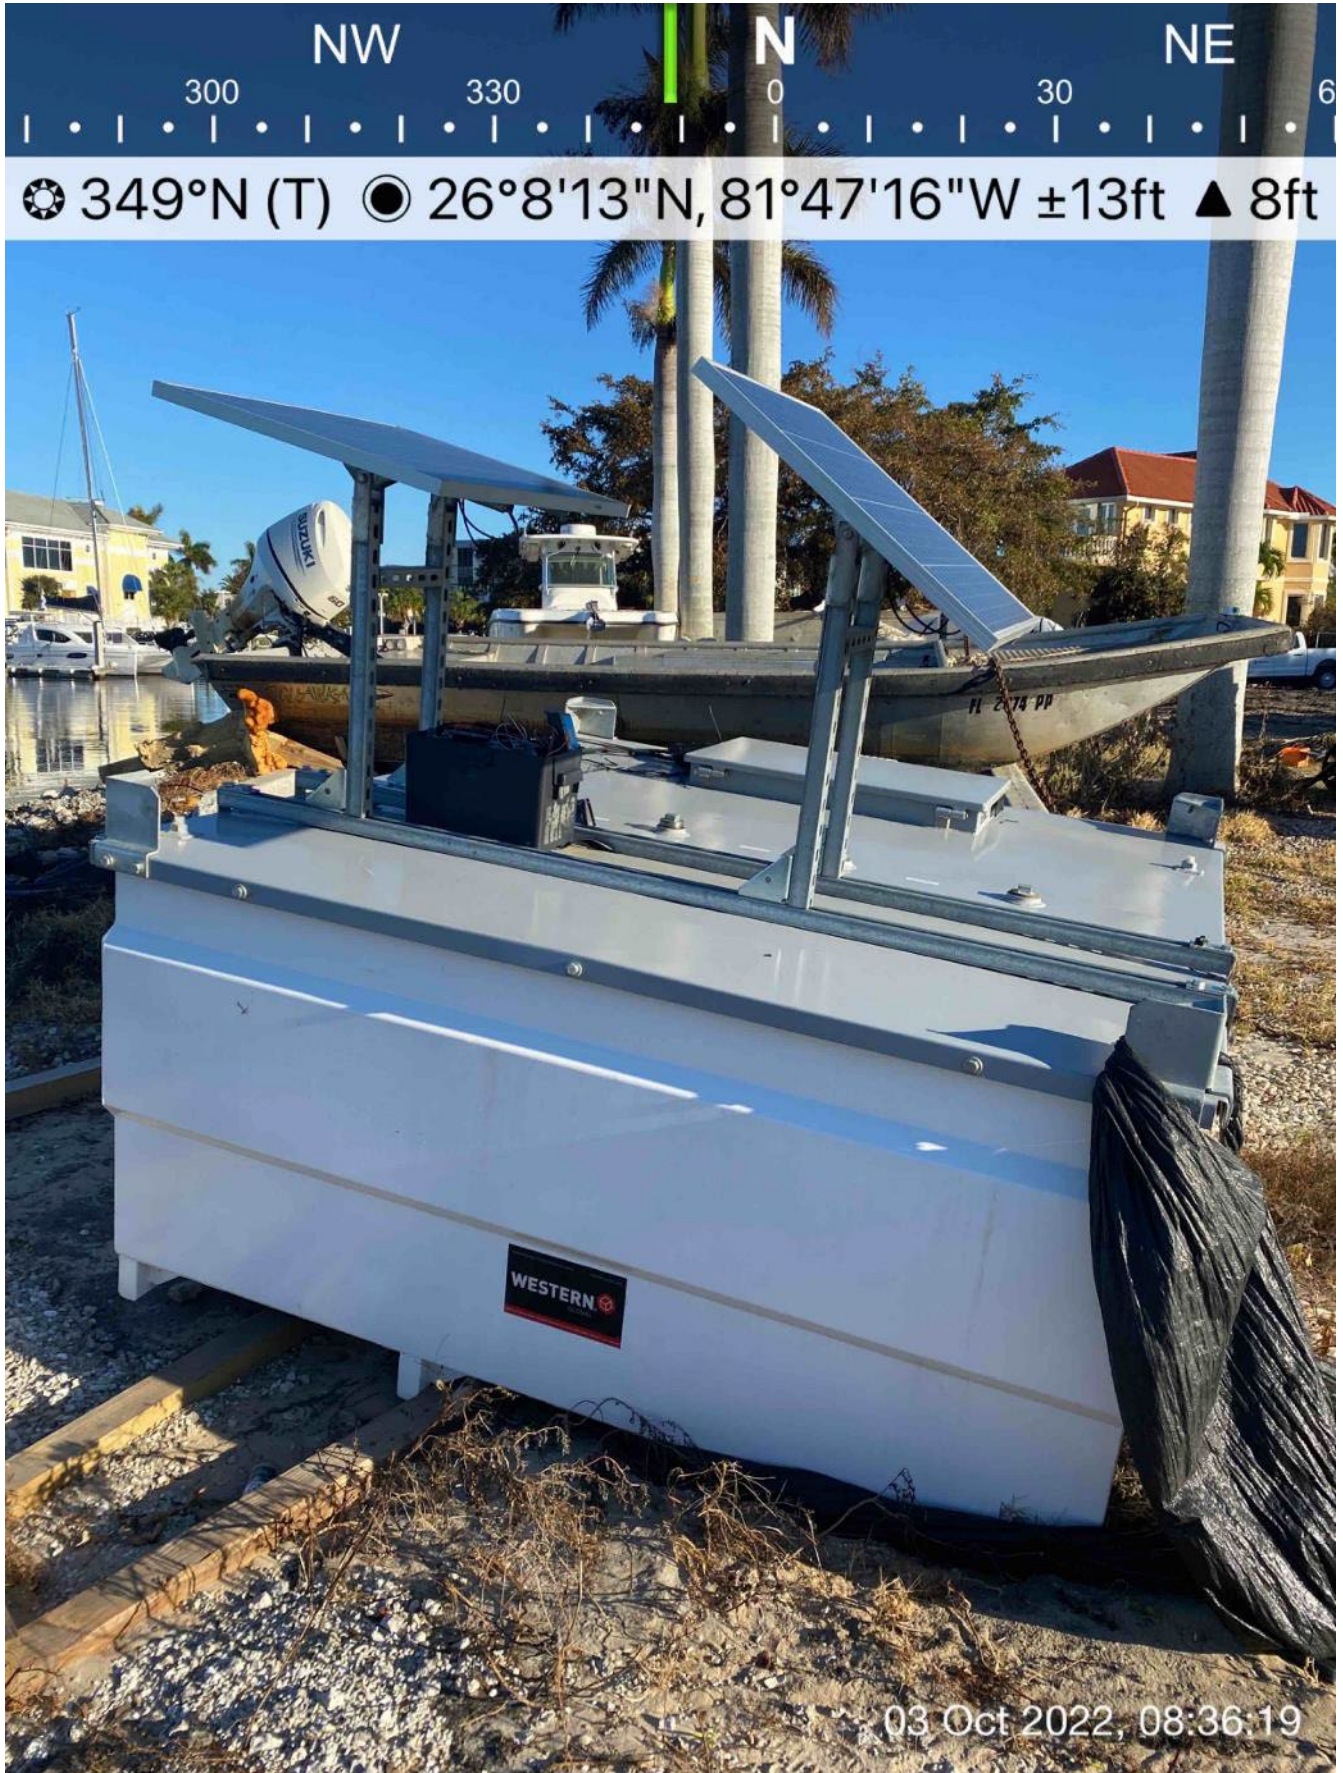
Support frame broken and large fuel cube buried into ground at southwest corner of 1300 Curlew Avenue

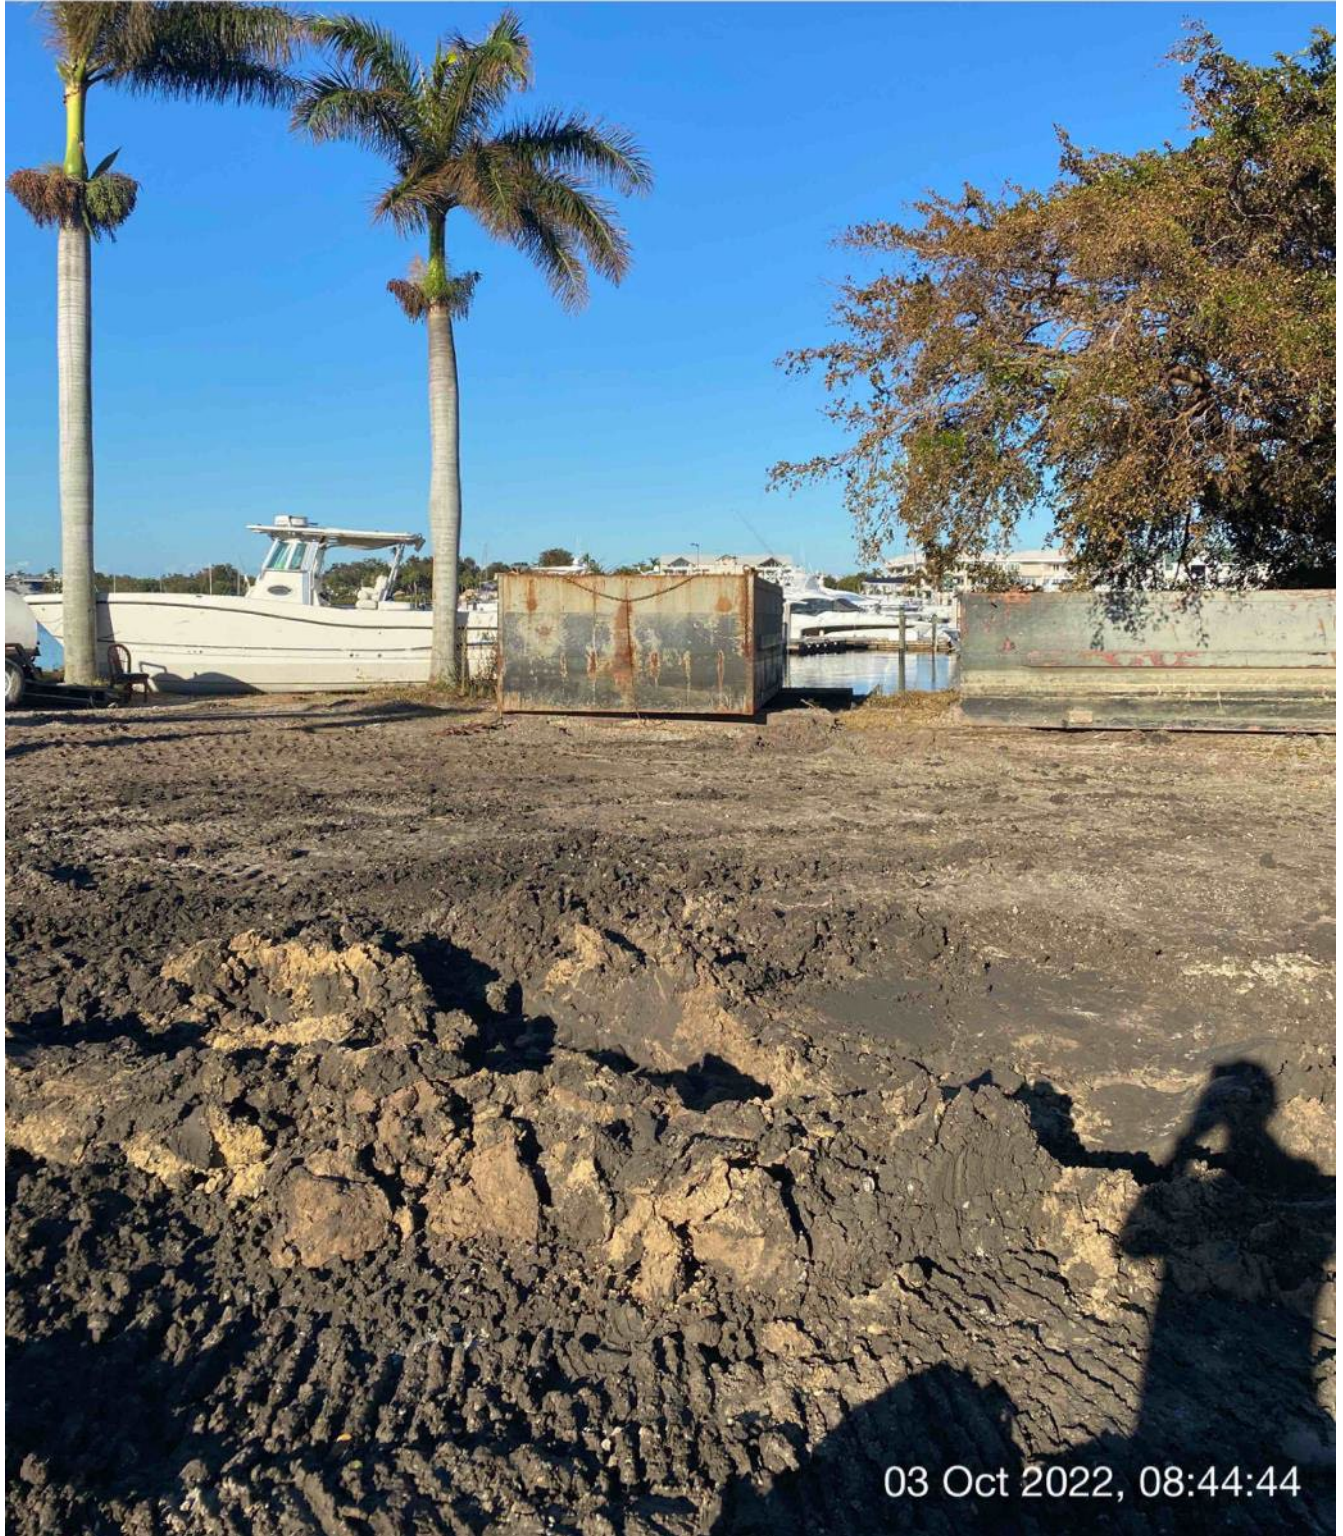
Catamaran and 2 hoppers on west side of 1300 Curlew Avenue

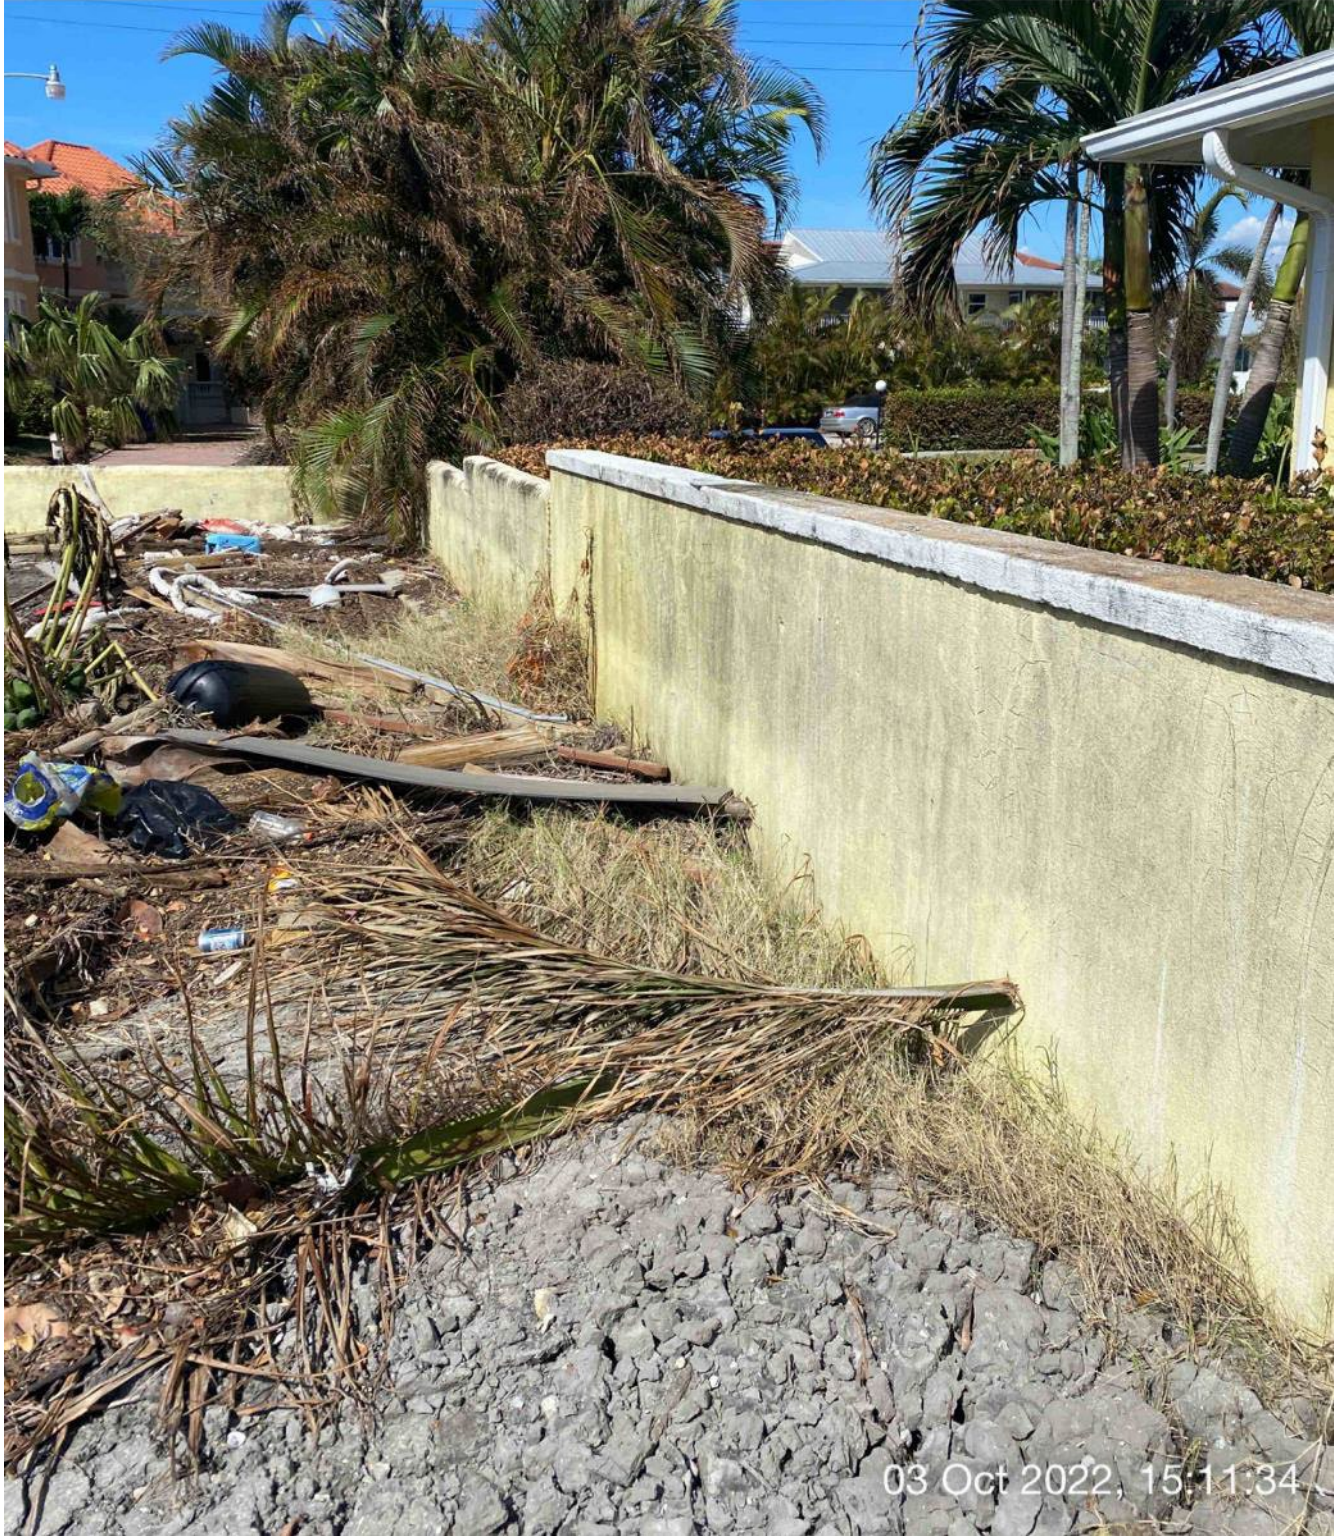
Debris and high water mark on east side wall at 1300 Curlew Avenue

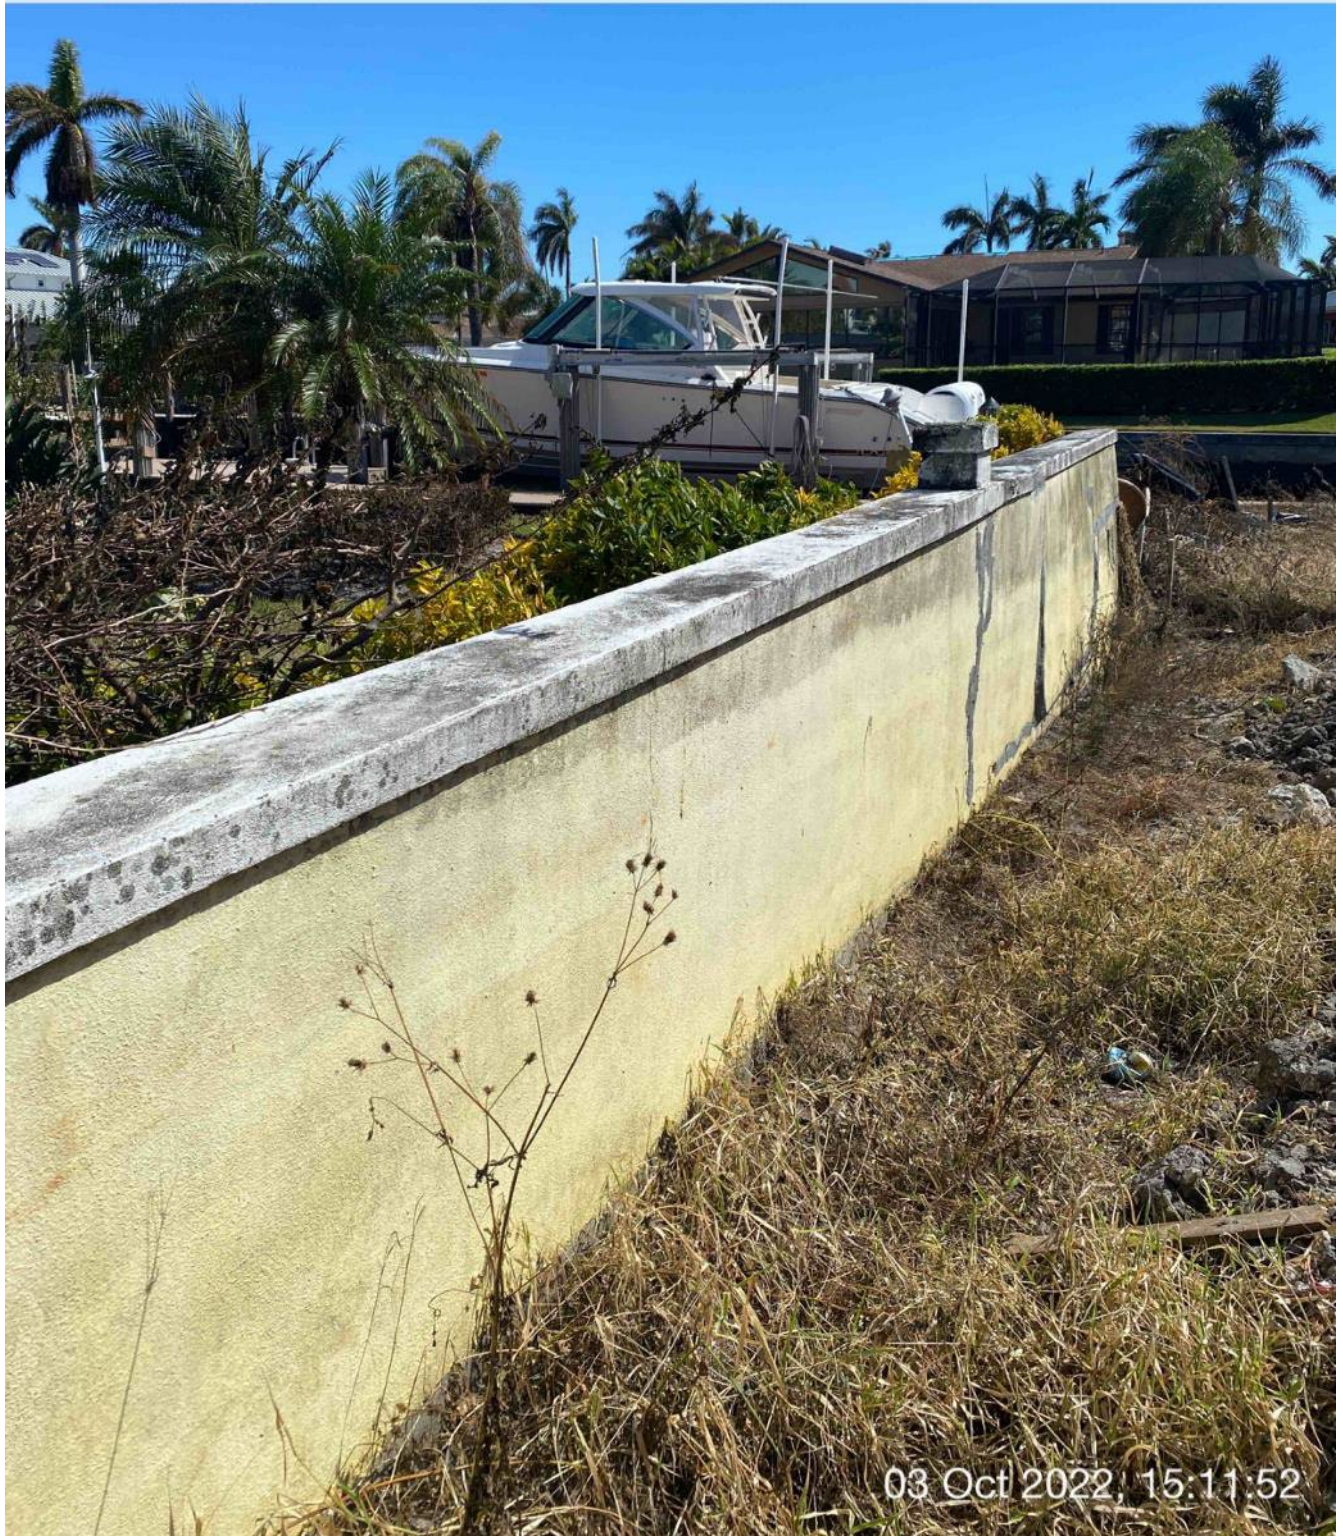
Debris and high water mark on east side wall at 1300 Curlew Avenue

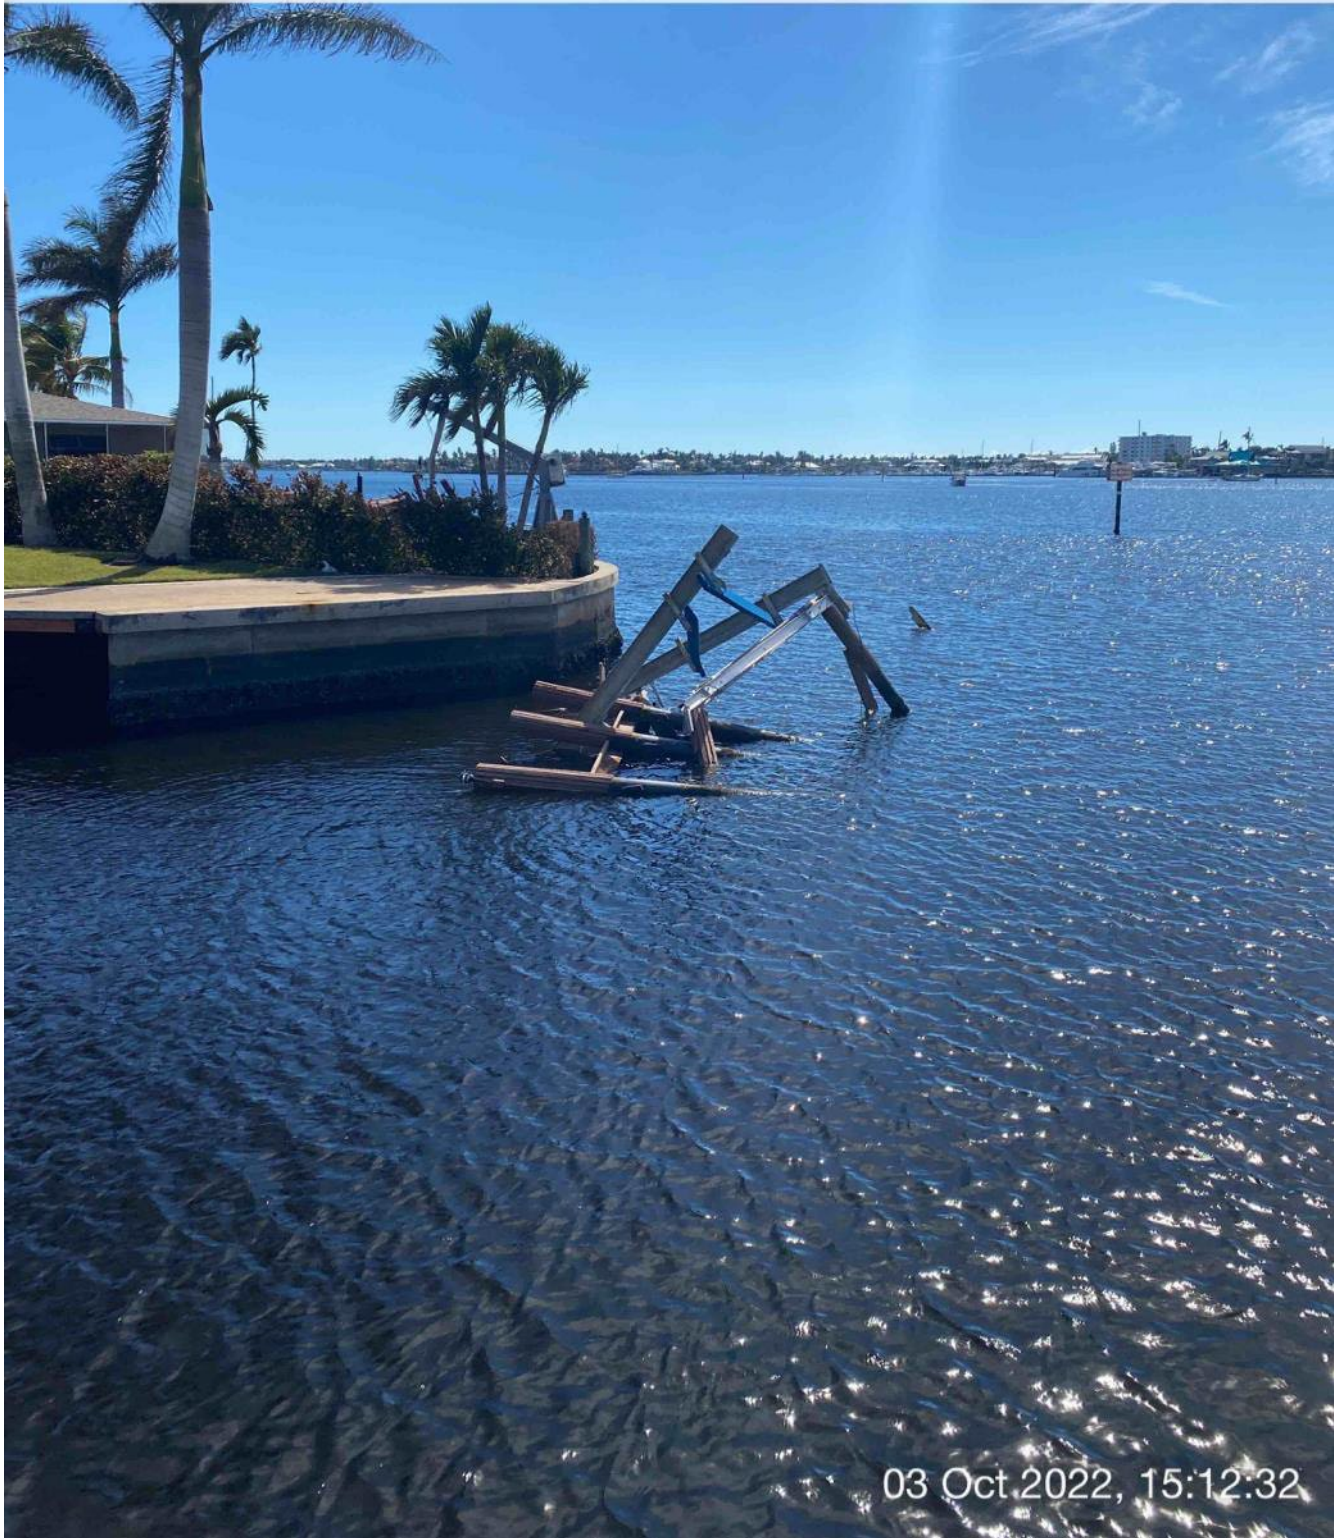
Destroyed dock section and boat lift in Canal CC-CC station 1+00

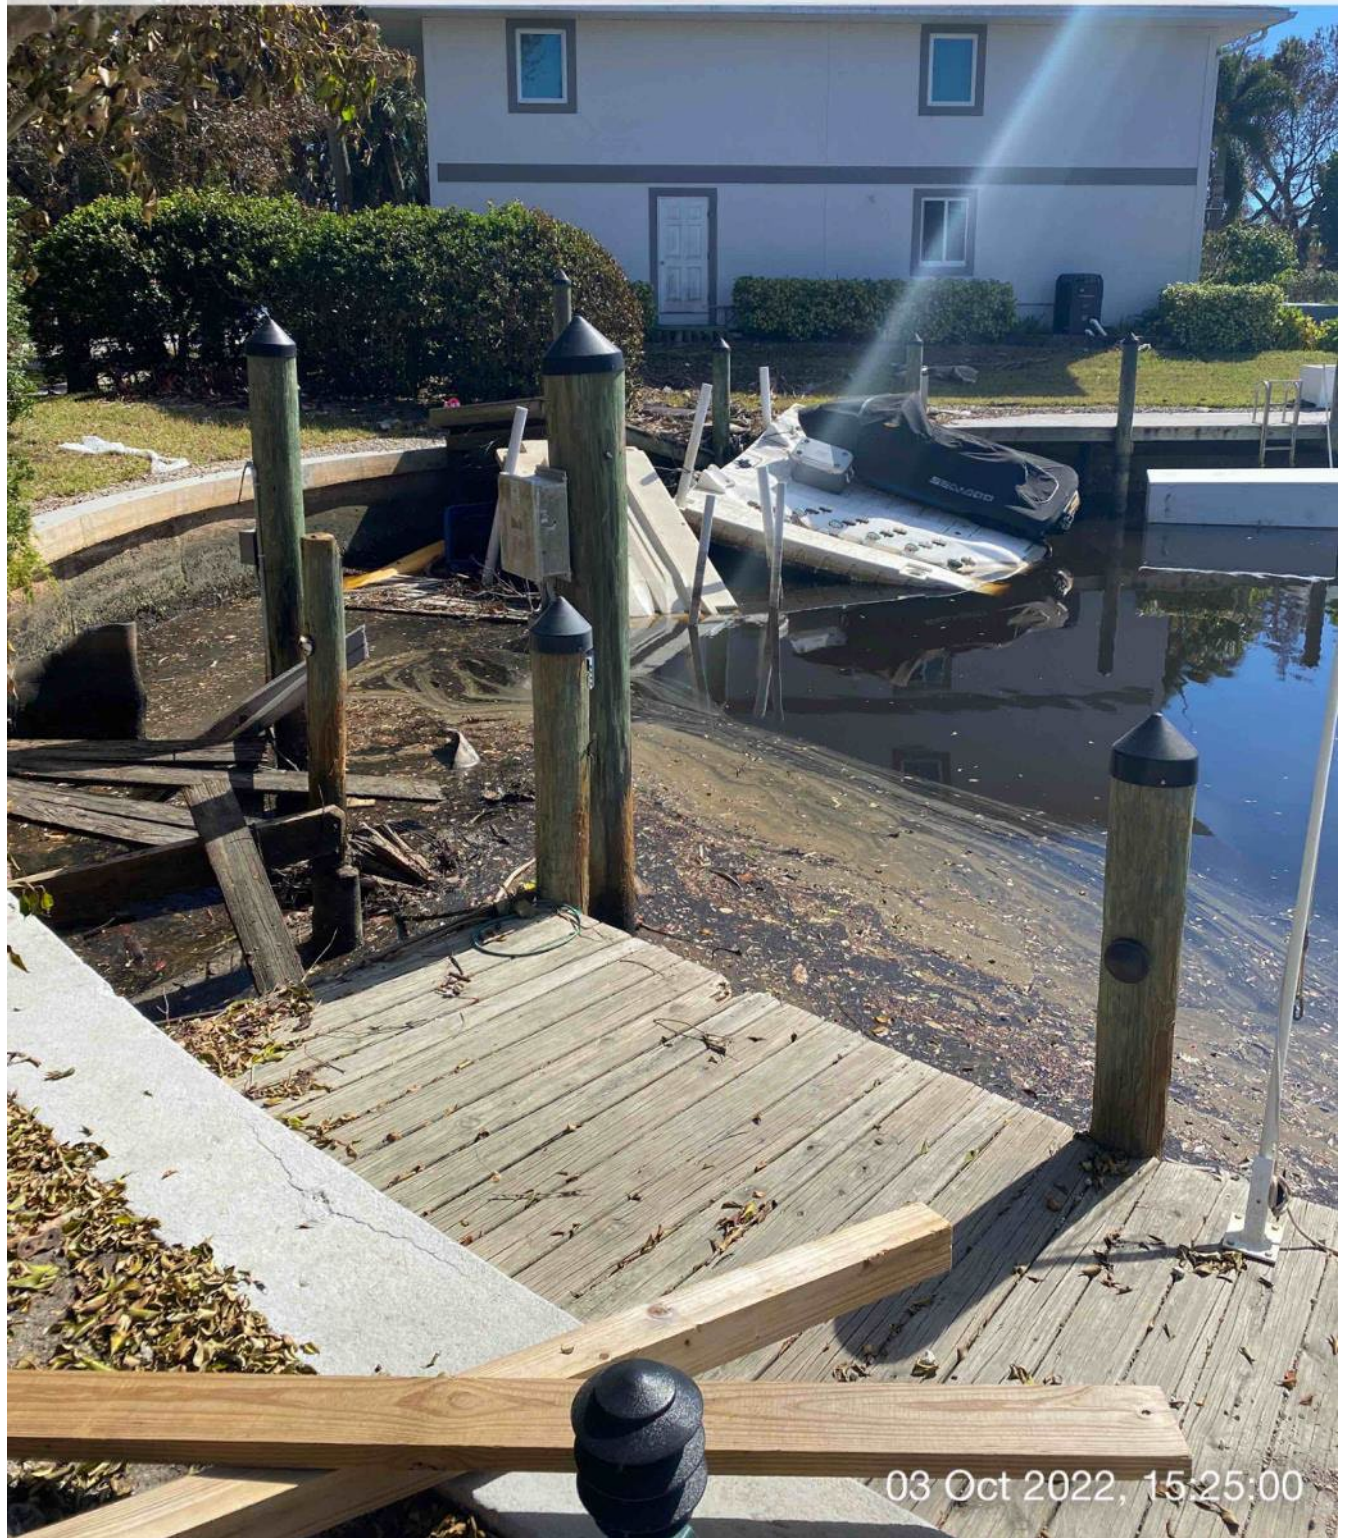
Destroyed dock and debris at station 19+30 in Canal W-W

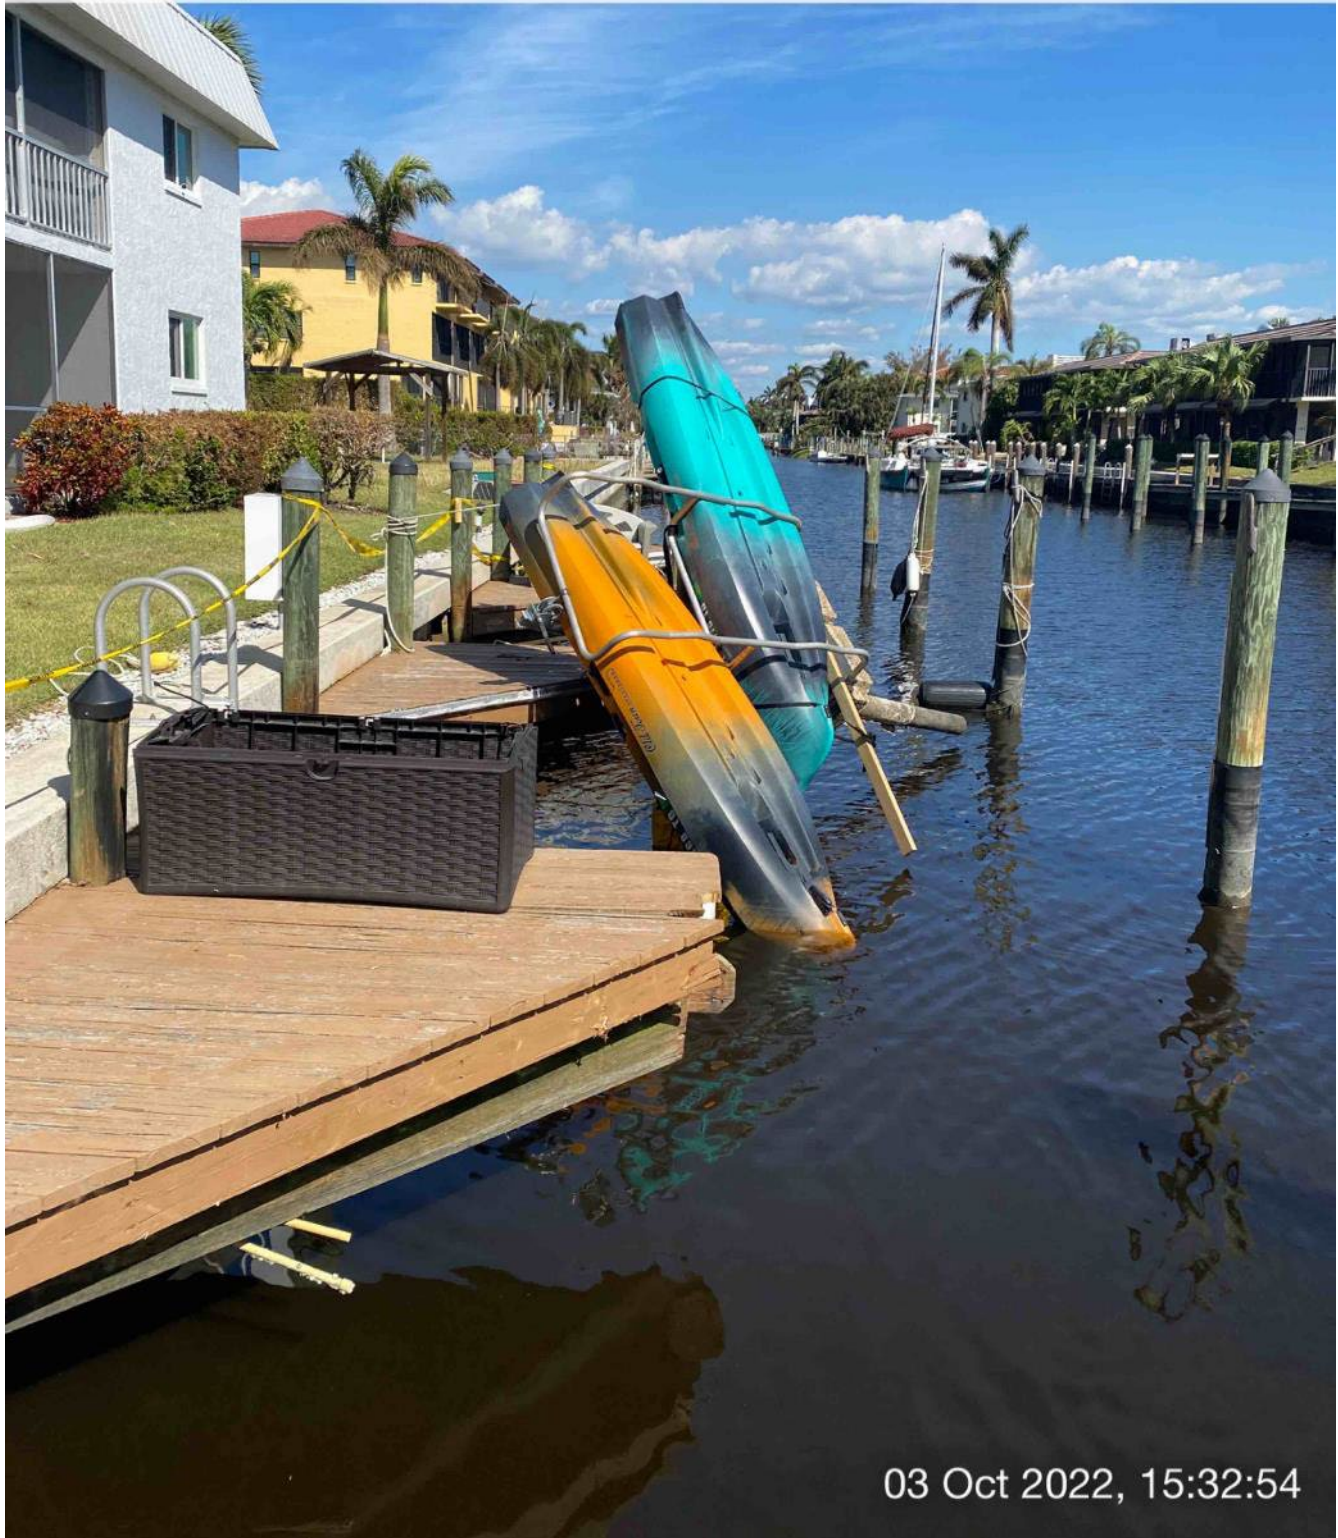
Destroyed dock at station 5+00 in Canal W-W
