WEEKLY SUMMARY REPORT – CONTRACT WEEK 51
21-036 EAST NAPLES BAY
DREDGING AND ROCK REMOVAL PROJECT

DAILY REPORT OF CONSTRUCTION
 21-036 EAST NAPLES BAY
 DREDGING AND ROCK REMOVAL PROJECT

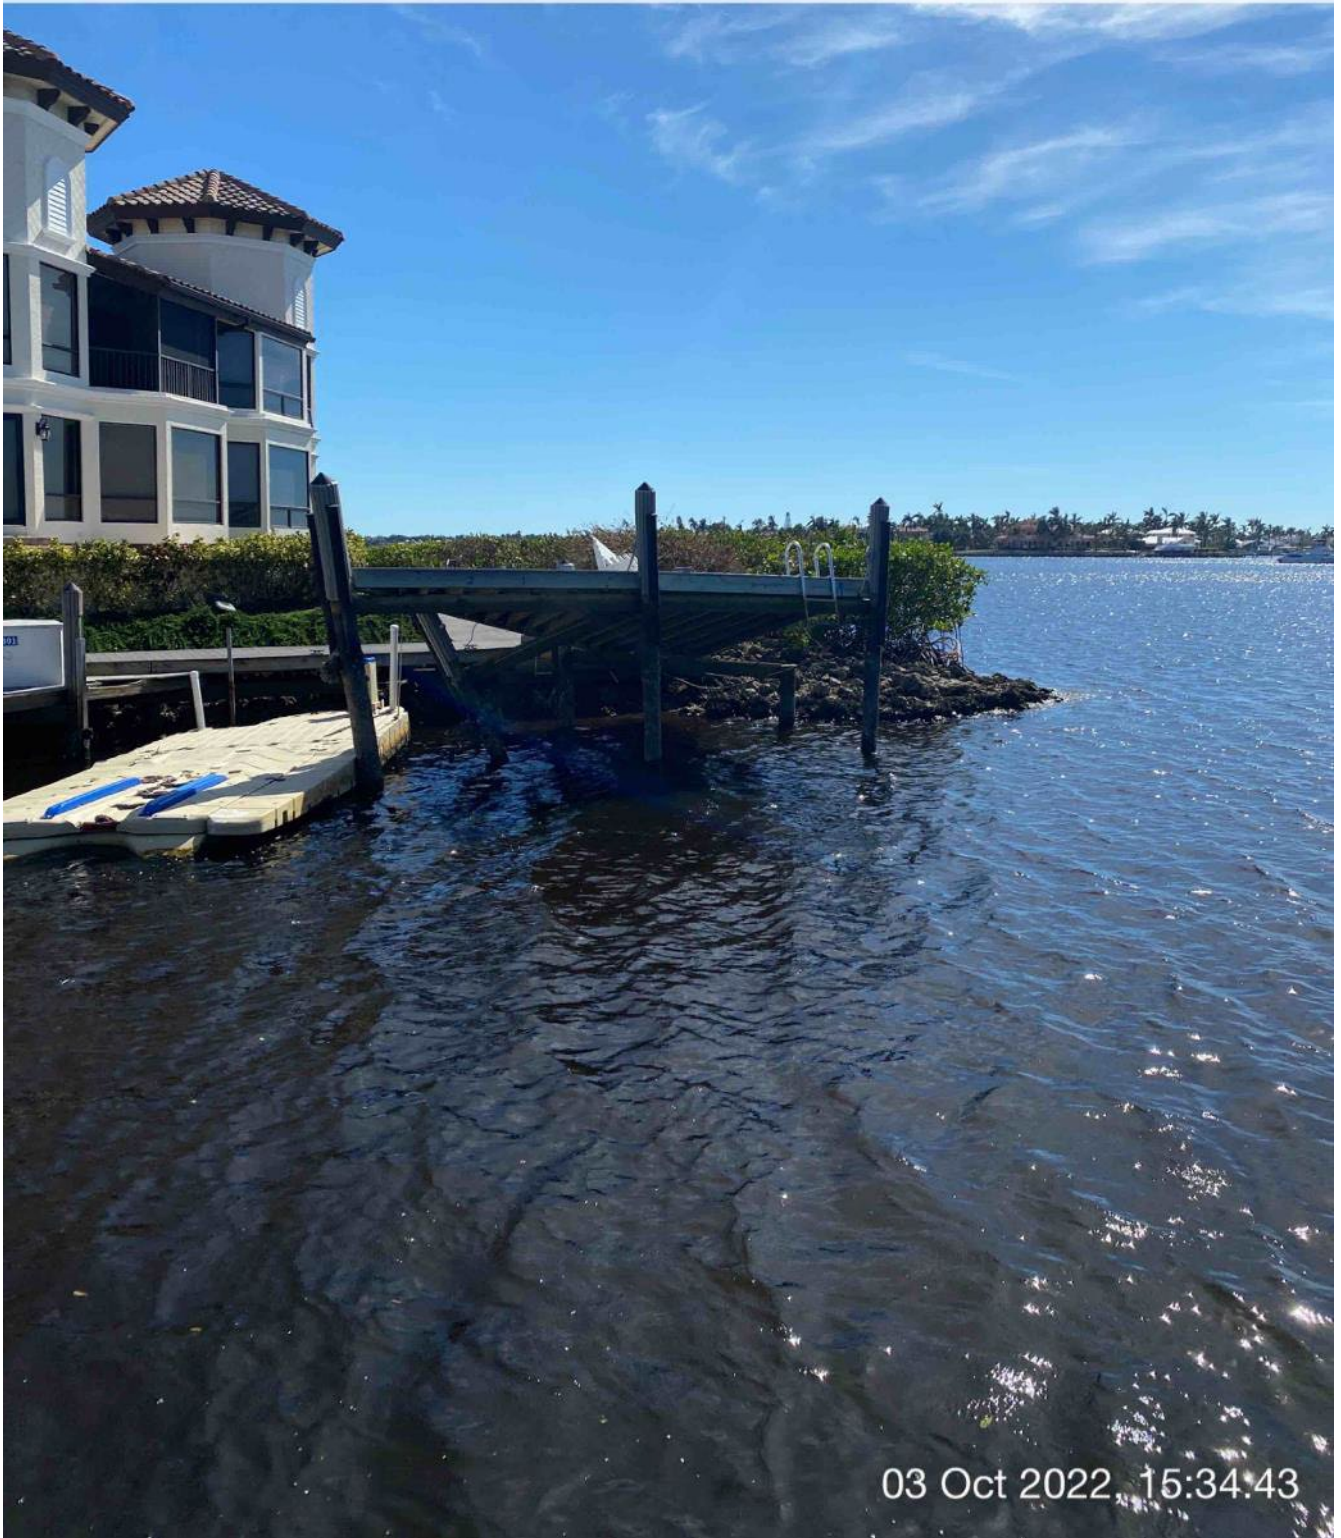
Destroyed dock at station 1+00 in Canal W-W
