FEDERAL EMERGENCY MANAGEMENT AGENCY

Above the Flood: **ELEVATING YOUR FLOODPRONE HOUSE**

MITIGATION DIRECTORATE

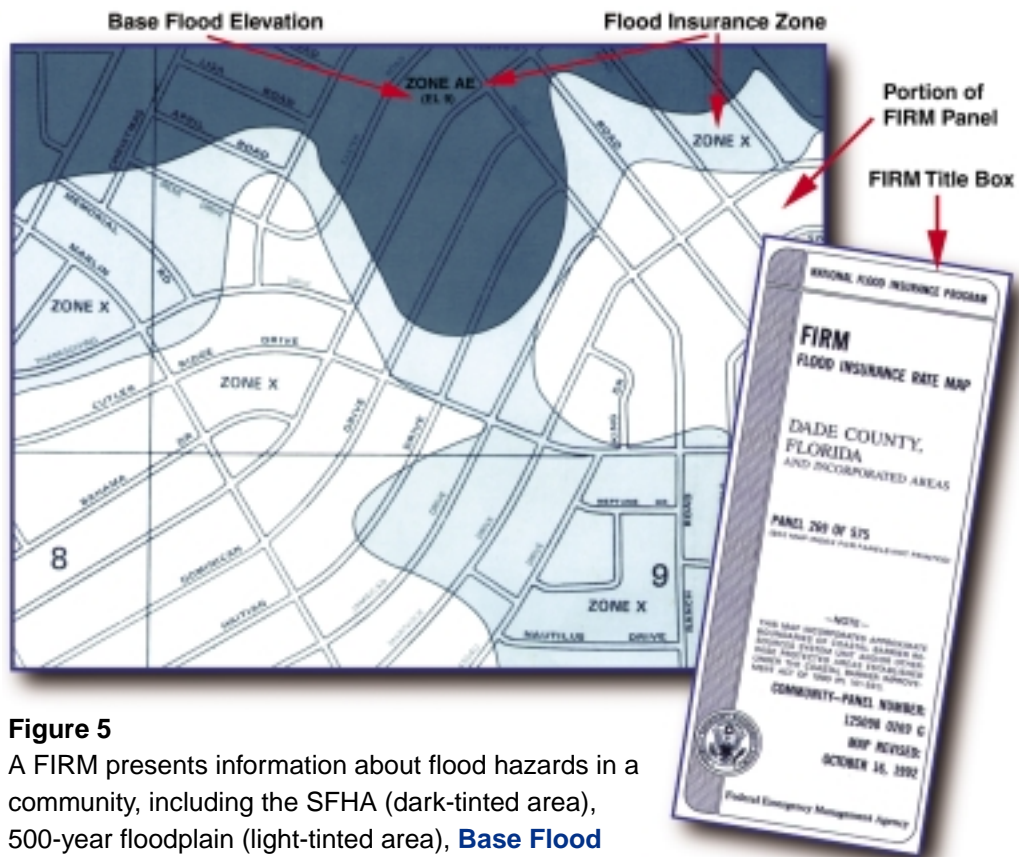
Figure 5
 A FIRM presents information about flood hazards in a community, including the SFHA (dark-tinted area), 500-year floodplain (light-tinted area), **Base Flood Elevations**, (BFEs) (number in parentheses), and flood insurance zones (AE and X in this example).

Note that the SFHA in the example in Figure 5 is designated Zone AE. This zone is only one of several applied to SFHAs under the NFIP, including V, VE, VI-V30, A, AE, A1-A30, AO, and AH. These zones indicate differences in the types and severity of flood hazards in SFHAs. For the purposes of this publication, it is sufficient to focus on the basic differences between the two main types of SFHA zones—V zones and A zones. The distinction is important because regulatory requirements associated with V zones and A zones differ significantly. As explained later in this chapter, these requirements affect the types of building elevation techniques that may be used under the NFIP.

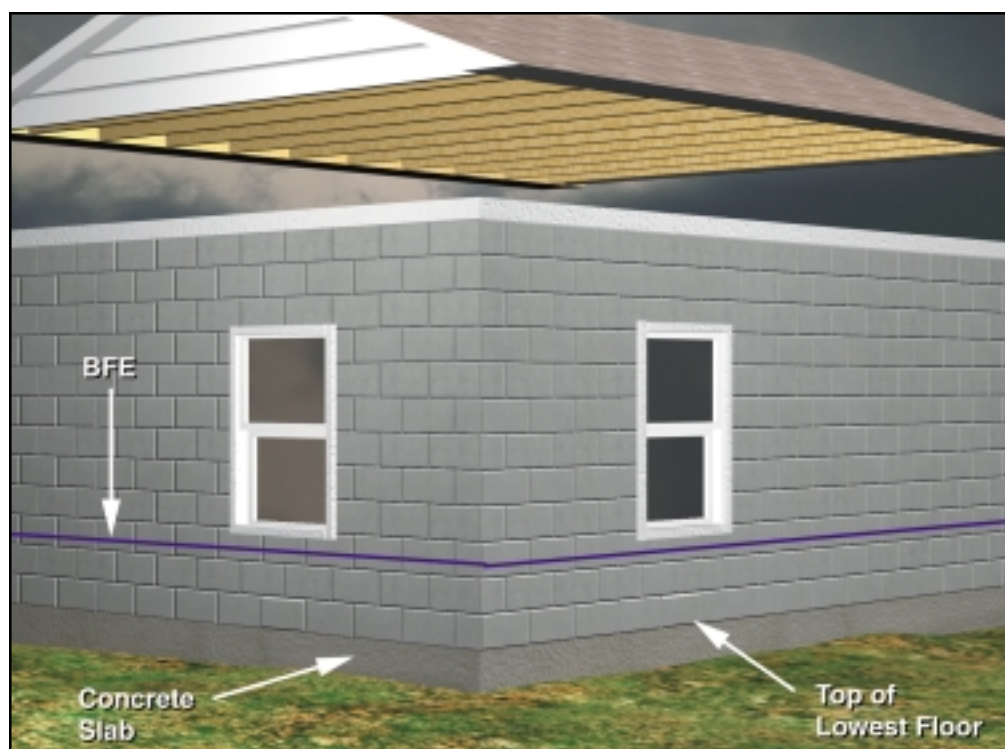
Figure 10
The first step in Technique 1 is removing the roof.

Technique 1 is appropriate for houses with concrete or masonry walls, but not for houses with other types of walls, such as those framed with wood studs, which would be more vulnerable to flood damage. This technique is usually appropriate when the depth of the base flood at the house is no more than 4 or 5 feet above grade. The elevation process begins with the temporary removal of the roof and roof framing, in a single piece if possible (Figure 10). This is commonly done with a crane. The roof is then stored on site so that it can be reinstalled later. The next step is to remove the windows and doors.

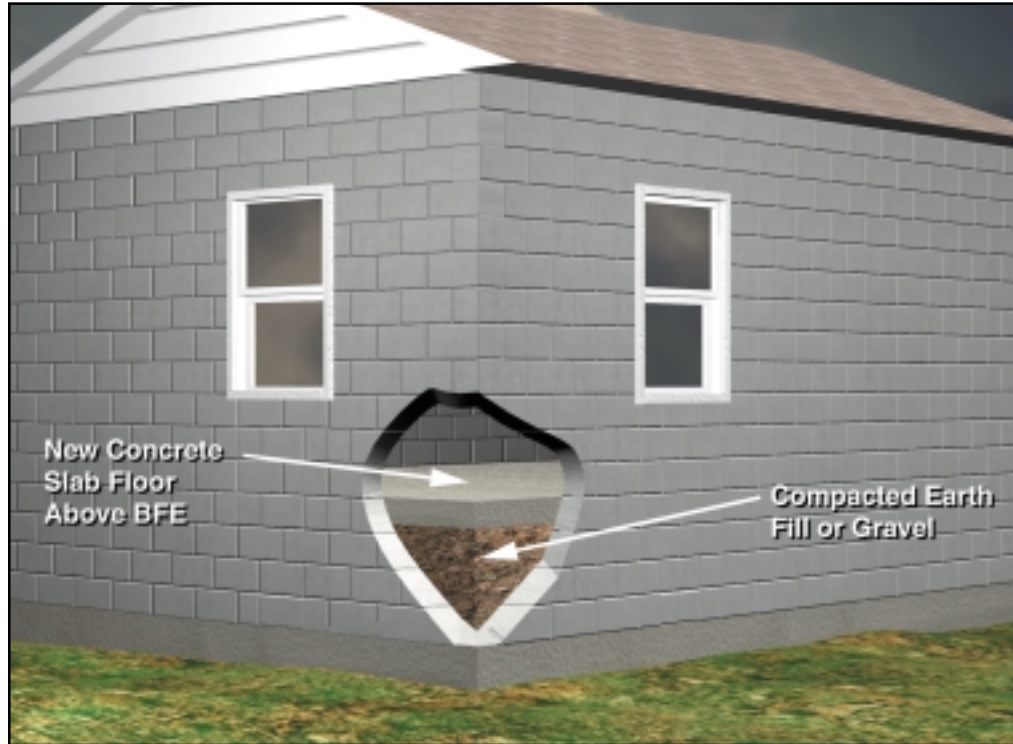
Figure 14
An alternative to building an elevated wood-frame floor is installing a new, elevated concrete slab floor on fill placed over the old slab.

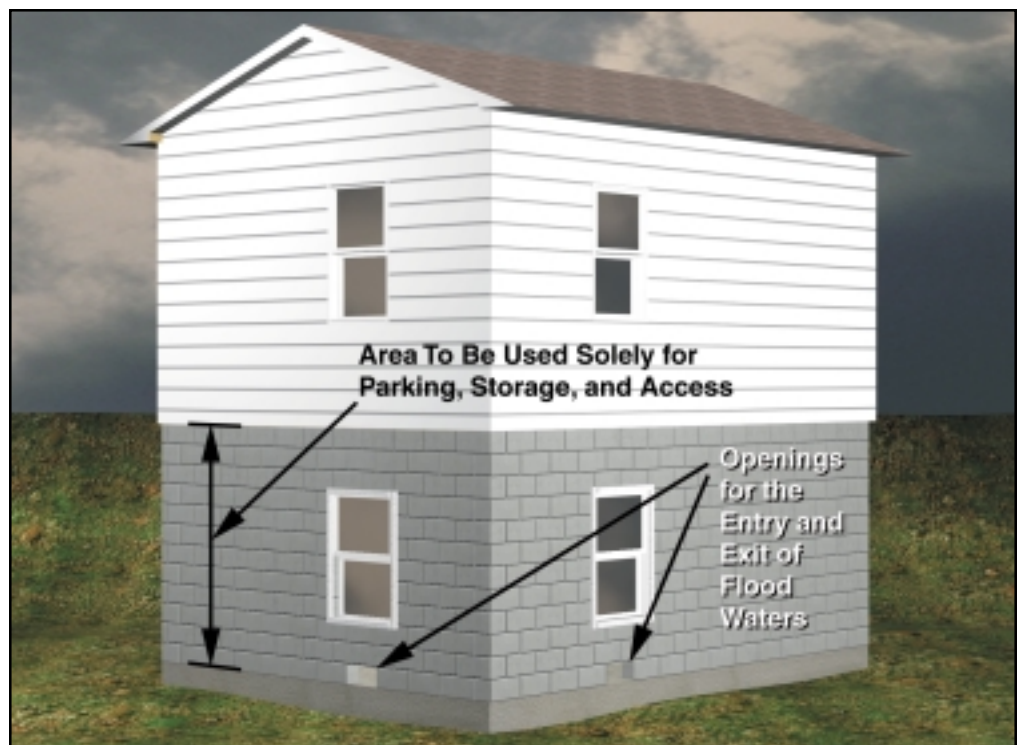
Figure 16
The new second-story walls are covered with siding or stucco.

Some homeowners prefer that the second story be constructed of masonry, but wood- or metal-framing is more common, primarily because it is lighter and less expensive. The roof is replaced, and blocks are removed from the walls to allow flood waters to enter and exit. Exterior sheathing is then added to the framed walls of the second story, the new windows are installed, and siding or stucco is applied to the sheathing (Figure 16).

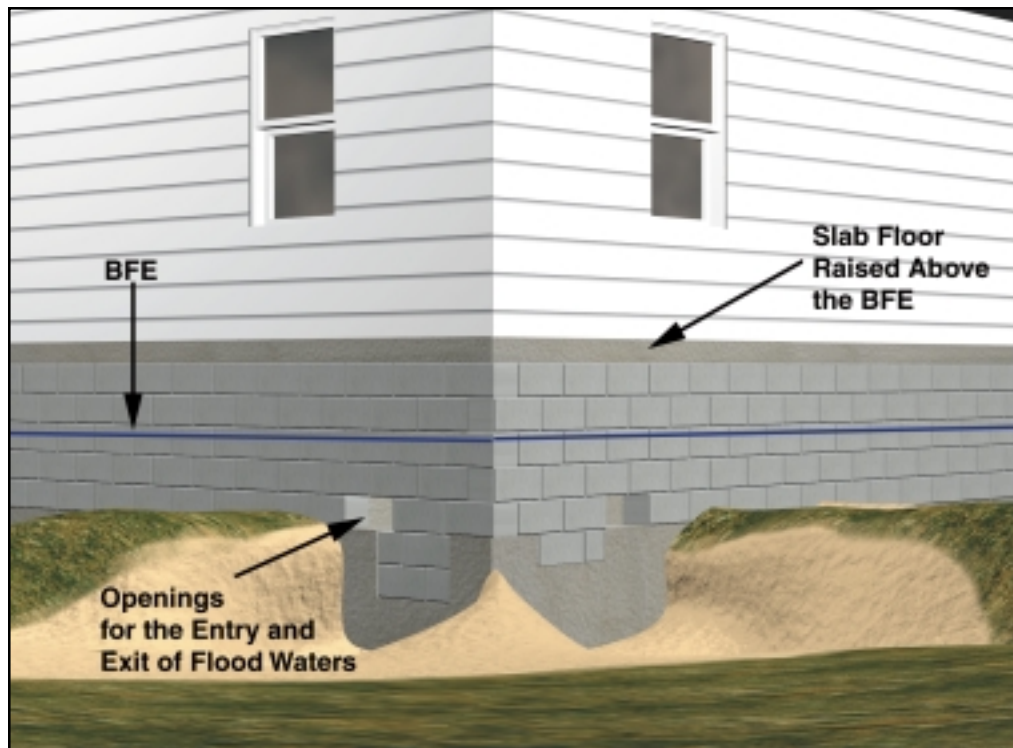
Figure 21
Elevated house and slab on new, extended foundation walls.
