# Lake Restoration Engineering and Ecological Field Report for Lake 19

**City of Naples**

**Wood Environment & Infrastructure Solutions, Inc.**

**March 06, 2020**

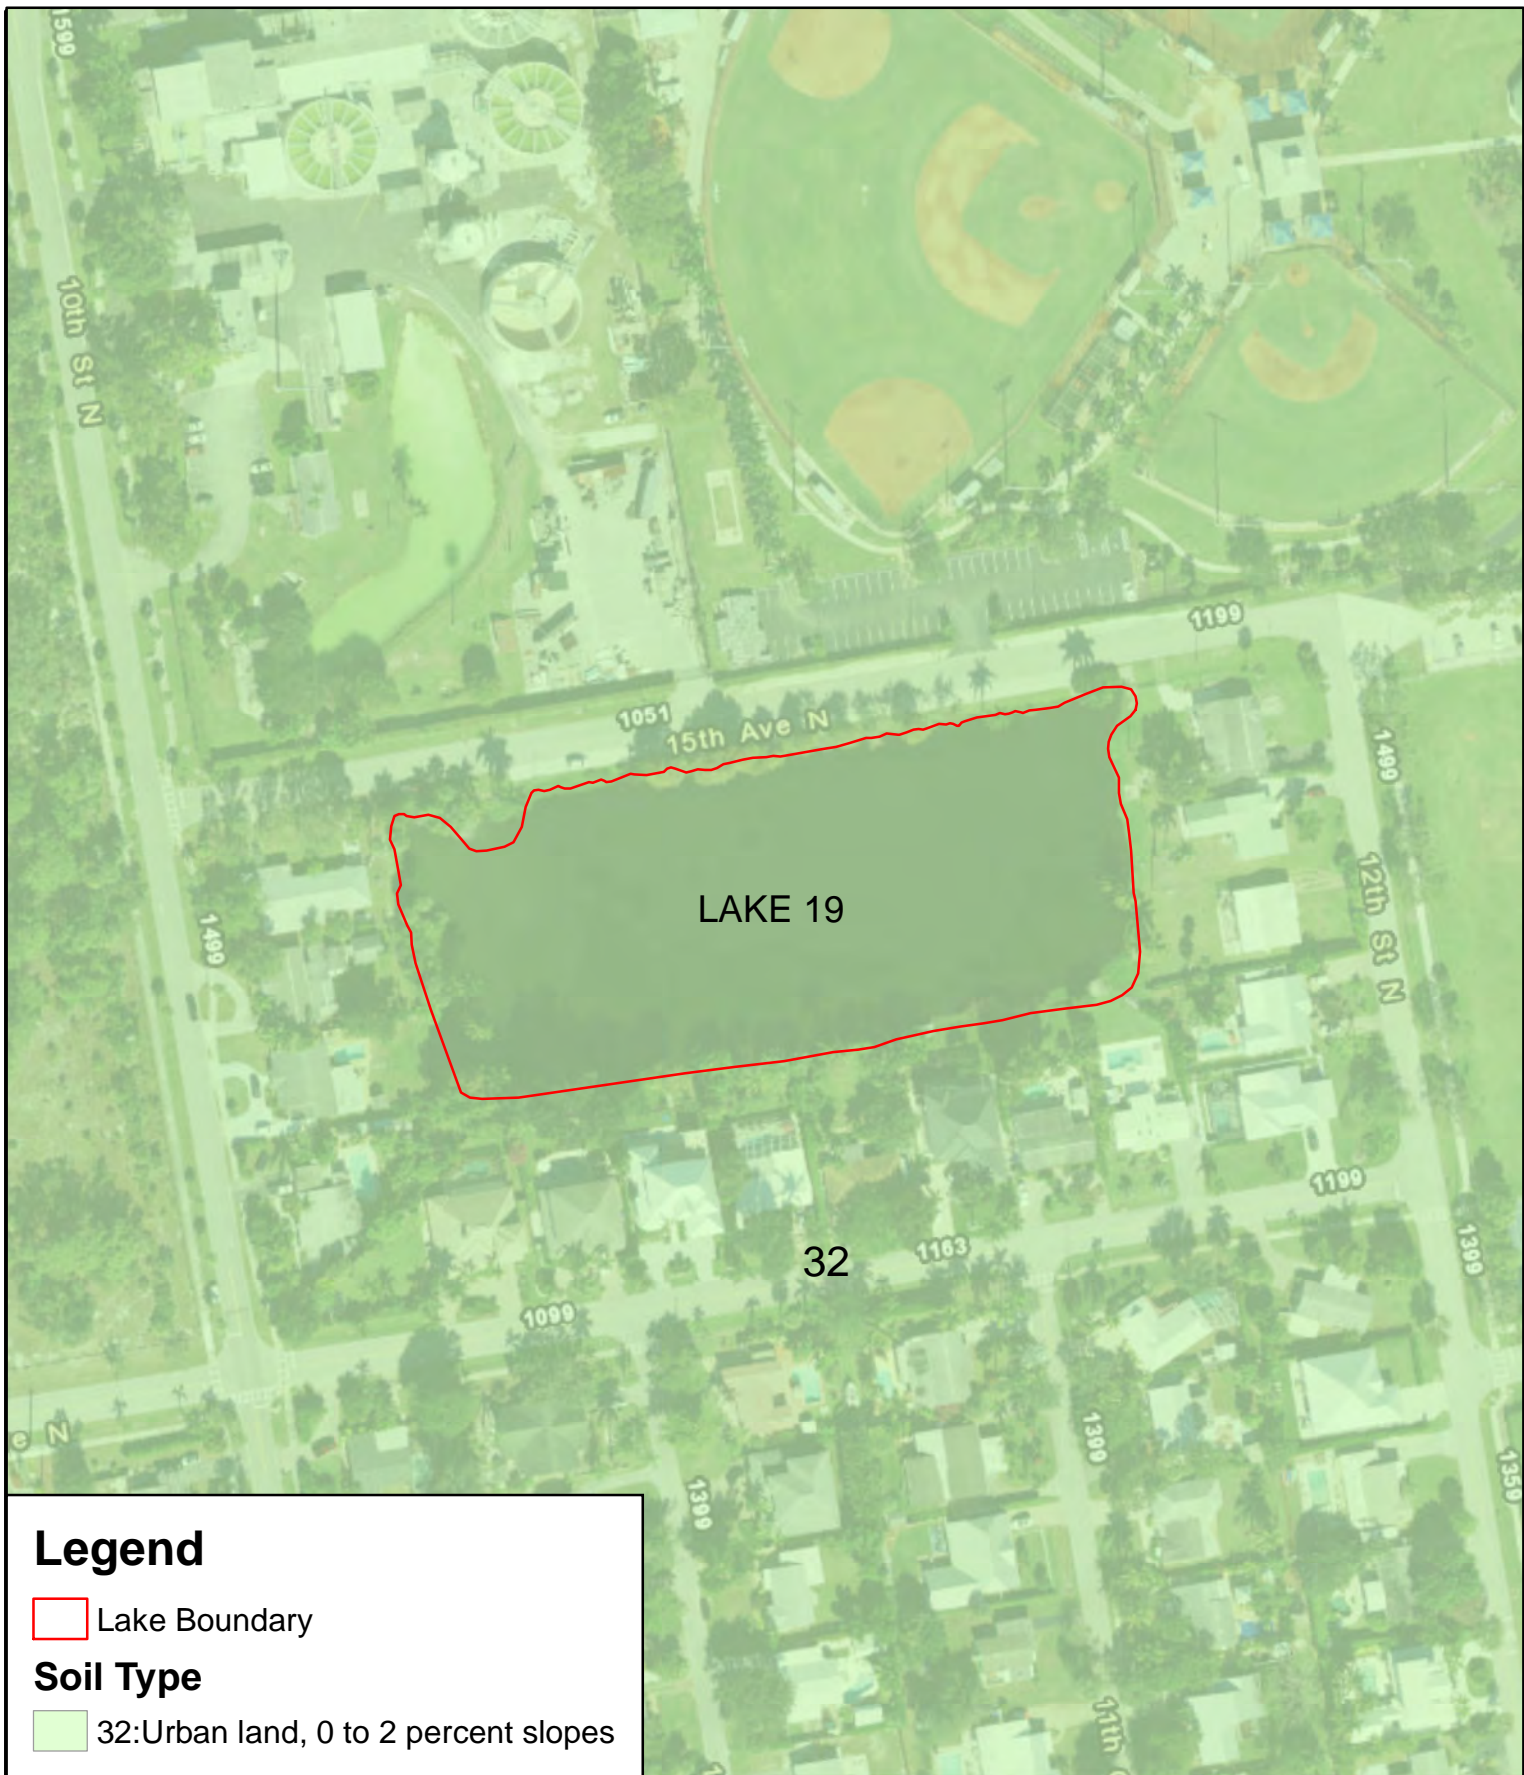
**Figure 3. Project Site Existing Soils**

- **Existing Soils:** Based on USDA NRCS coverages, soils on the Project Site are classified as Water and Urban Land, 0 to 2 percent slopes (**Figure 3**).

32: Urban land, 0 to 2 percent slopes

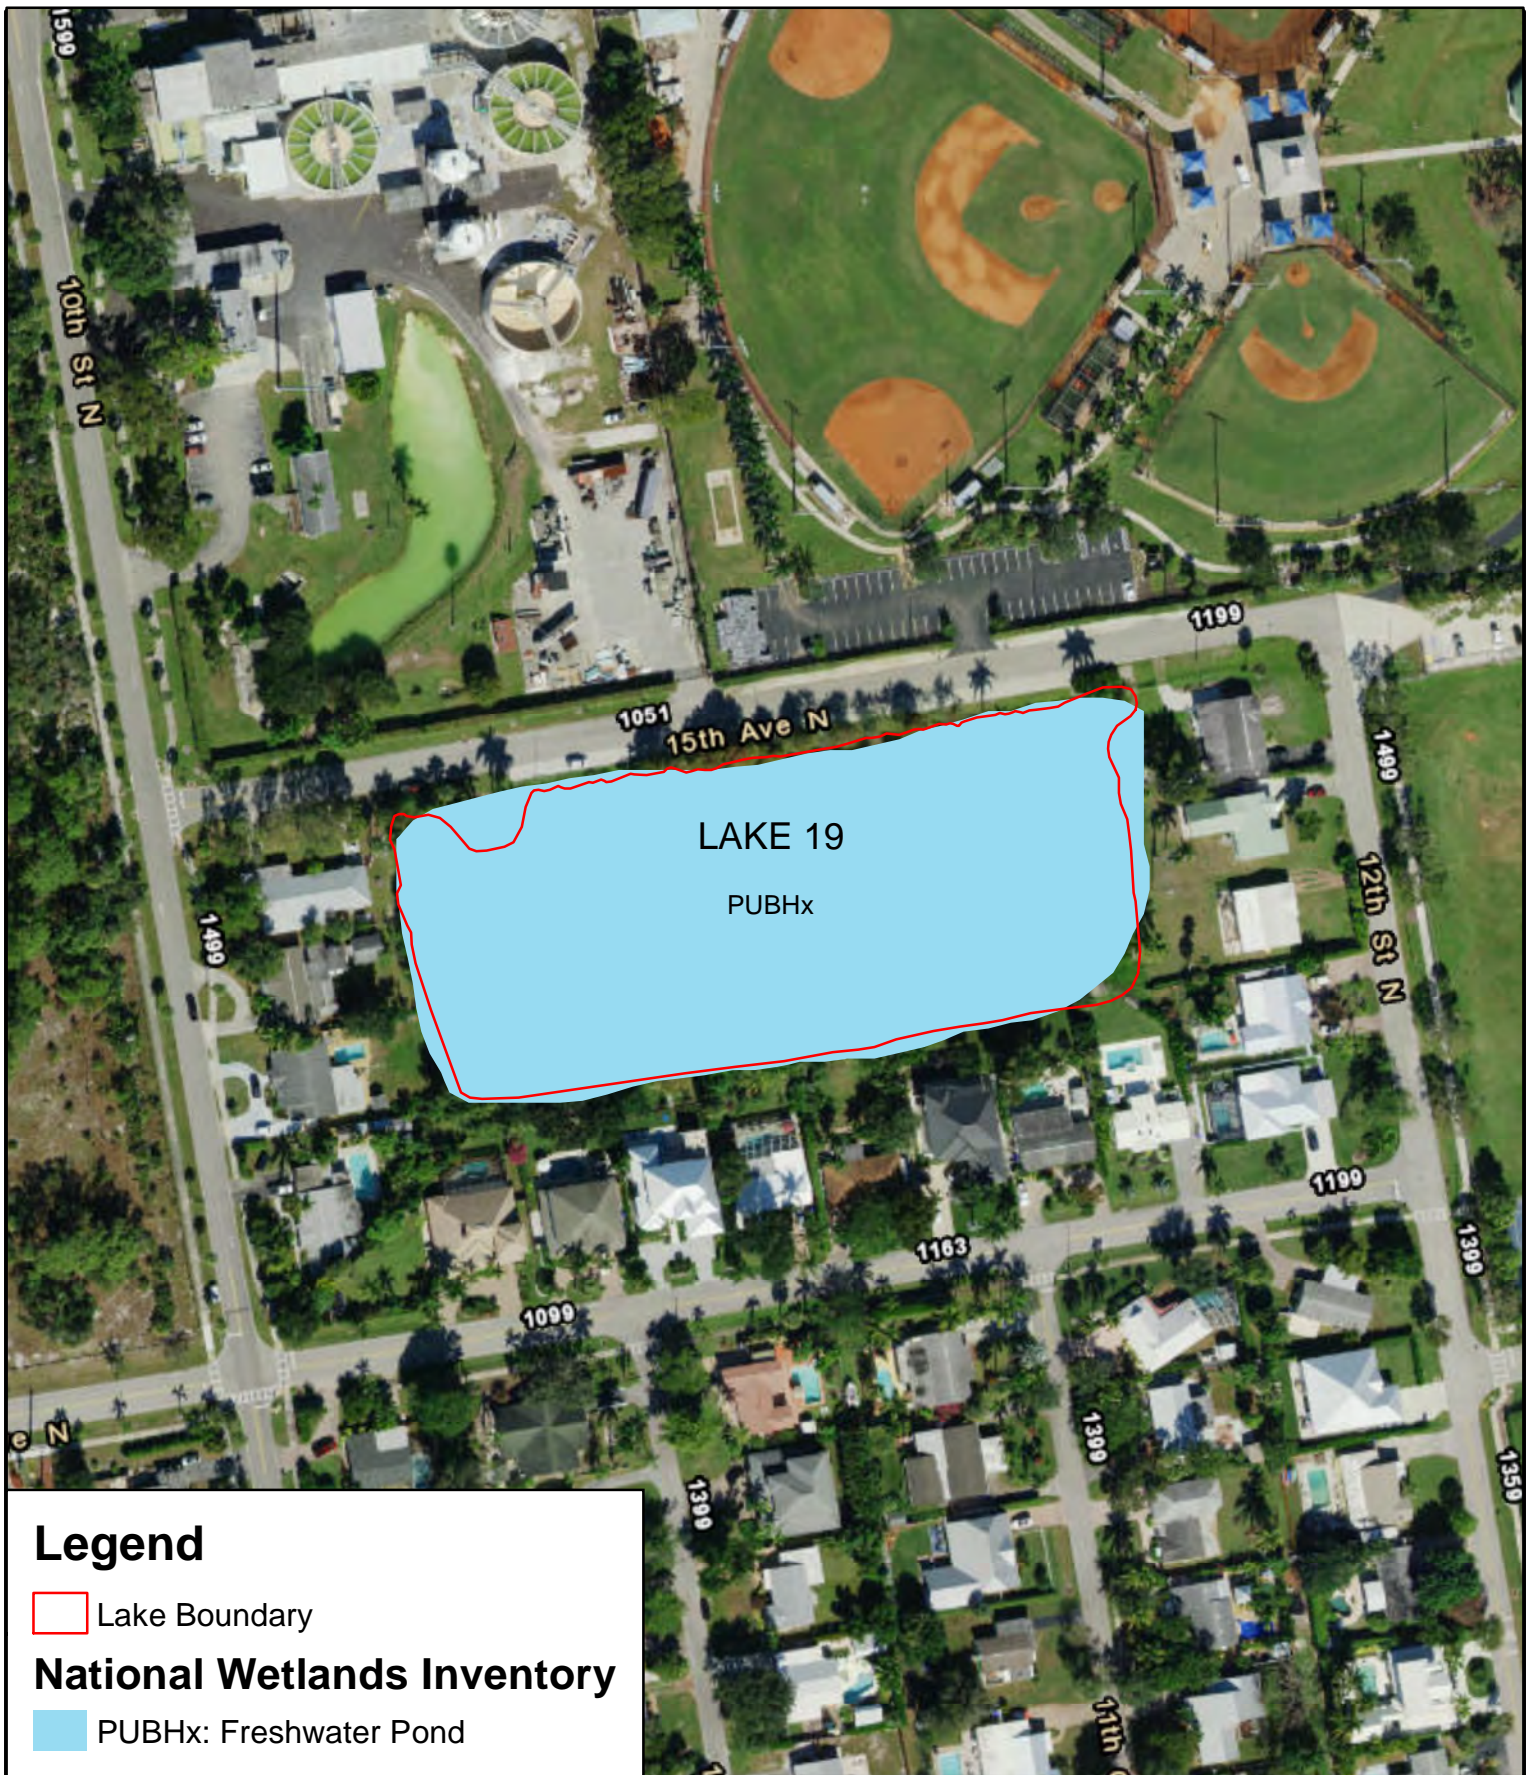
**Figure 4. Project Site USFWS NWI**

- **USFWS NWI:** USFWS NWI data (USFWS, 2020) classifies the site as a permanently flooded, palustrine system with an unconsolidated bottom that has been excavated (code PUBHx (**Figure 4**).

PUBHx: Freshwater Pond

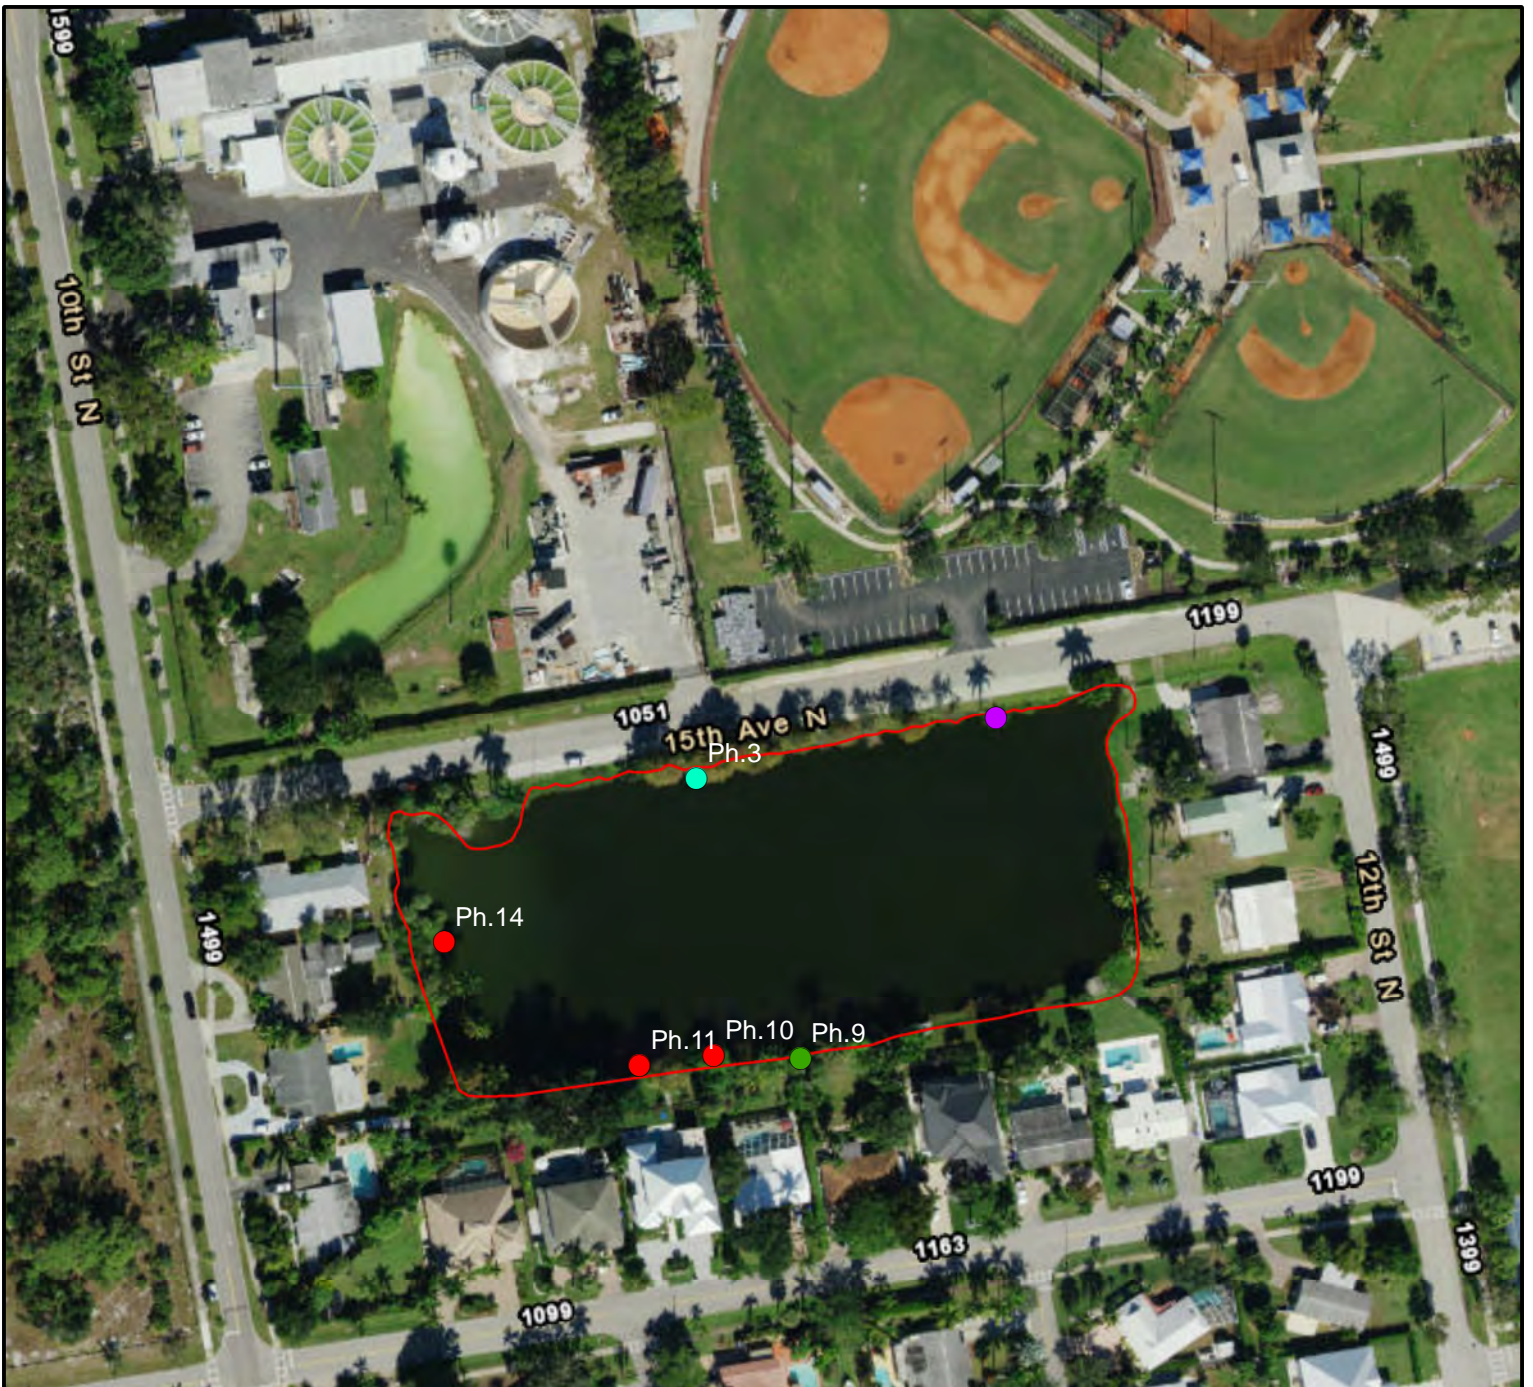
**Figure 6. Invasive Species Map**

Invasive exotic plants species were observed throughout the Project Site. **Table 1** includes Florida Exotic Pest Plant Council (FLEPPC) plant categories for invasive species observed at the Project Site. FLEPPC categorizes invasive plants as Category I or Category II. Category I invasive exotic species are those species that are altering native plant communities by displacing native species, changing community structures or ecological functions, or hybridizing with natives. Category II invasive species are those that have increased in abundance or frequency but have not yet altered Florida plant communities to the extent shown by Category I species. Invasive exotic species observed at the project site included Brazilian pepper, elephant ear, Queensland umbrella-tree, torpedo grass, umbrella flat sedge, and wedelia. The Brazilian pepper was observed along the south edge of the lake. The umbrella flat sedge was observed in clumps located at the northeast corner southwest end of the lake. Wedelia was found along the north shore (**Figure 6**).

- Brazilian Pepper (*Schinus terebinthifolius*)
- Elephant Ear (*Colocasia esculenta*)
- Queensland Umbrella-tree (*Schefflera actinophylla*)
- Umbrella Flat Sedge (*Cyperus involucratus*)

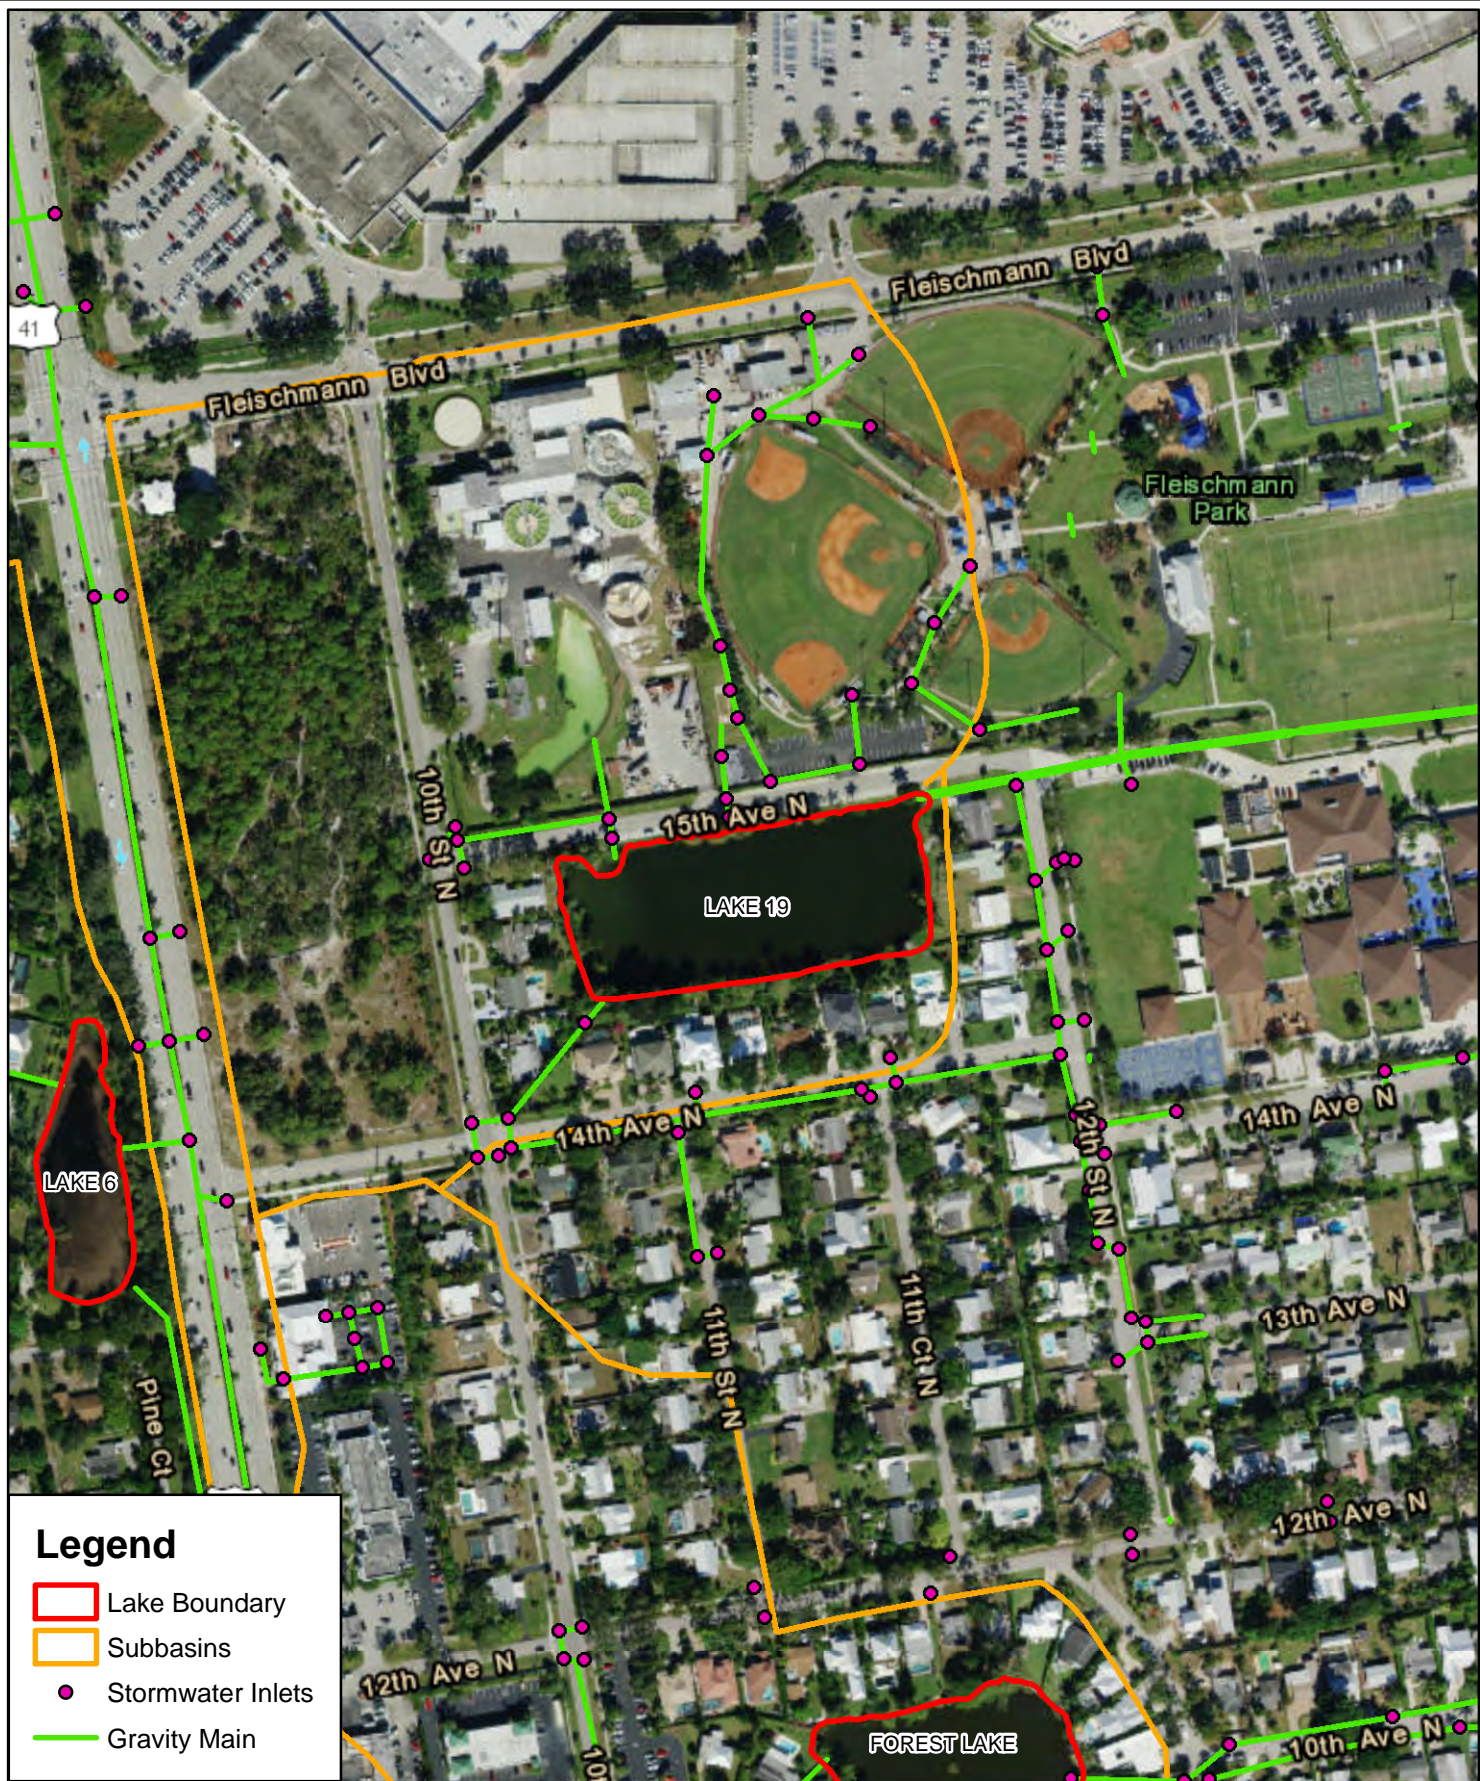
**Figure 7. Existing subbasin and stormwater infrastructure**

- Lake Boundary
- Subbasins
- Stormwater Inlets
- Gravity Main

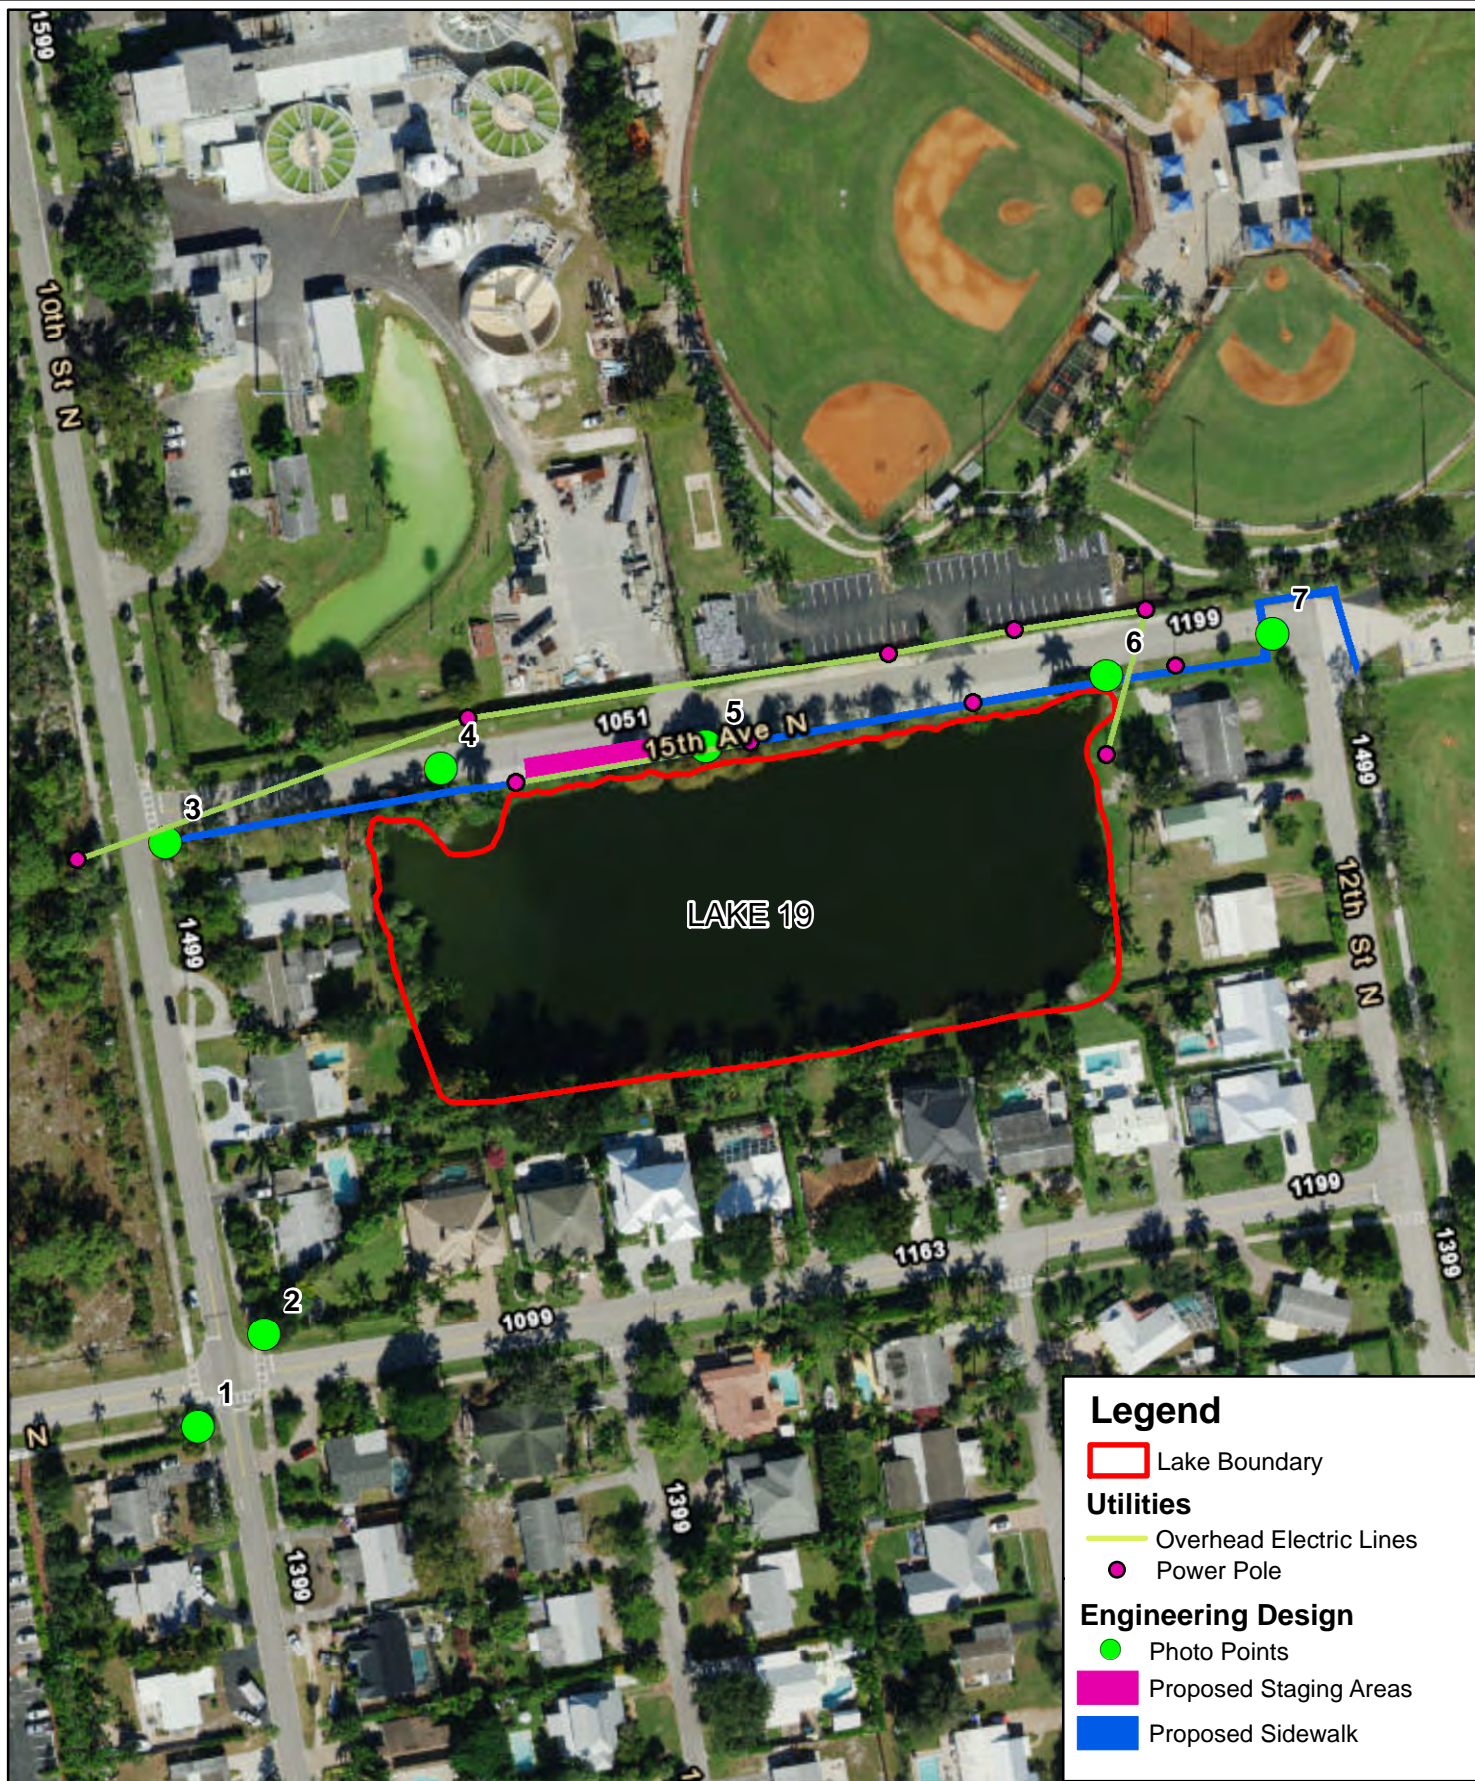
**Figure 8. Engineering field points, proposed infrastructure, and utility impacts**

- Lake Boundary
- Utilities**
- Overhead Electric Lines
- Power Pole
- Engineering Design**
- Photo Points
- Proposed Staging Areas
- Proposed Sidewalk

- The overhead electric lines along the north side of 15<sup>th</sup> Ave N will need to be evaluated to ensure proper offsets are implemented to avoid impacts during construction.
- The light poles and overhead lines along the south side of 15<sup>th</sup> Ave N will need to be evaluated to see about disconnecting during construction to avoid impacts.
- The proposed staging area will require a detailed maintenance of traffic and hauling plan to ensure safe accessibility for the traffic using 15th Ave N and 10th St N.

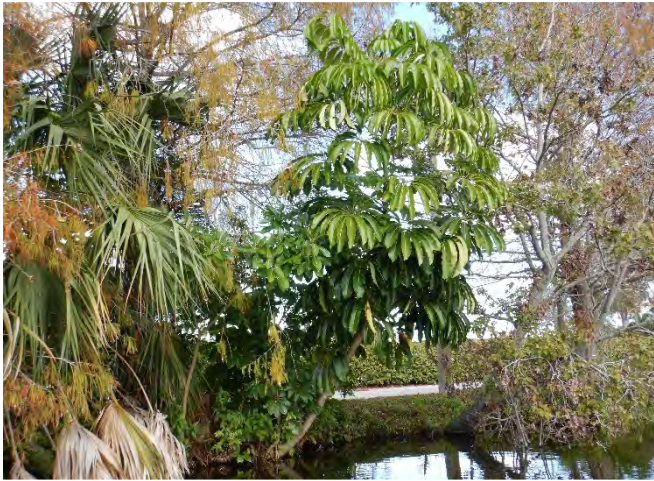
3. Lake 19: Queensland umbrella-tree growing within the planted cypress

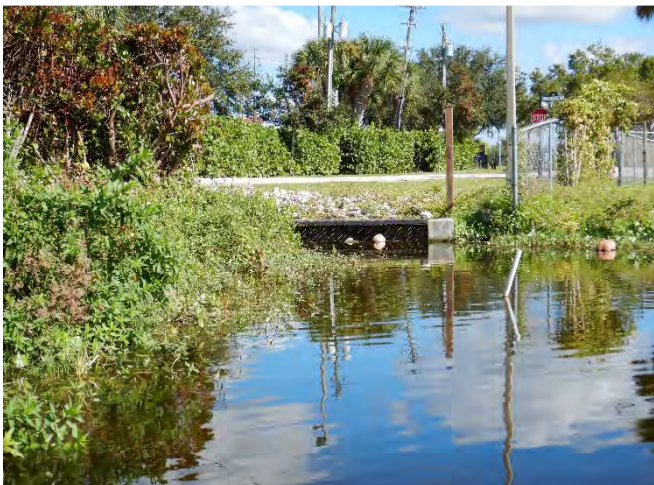
5. Lake 19: Outfall on northeast corner of lake

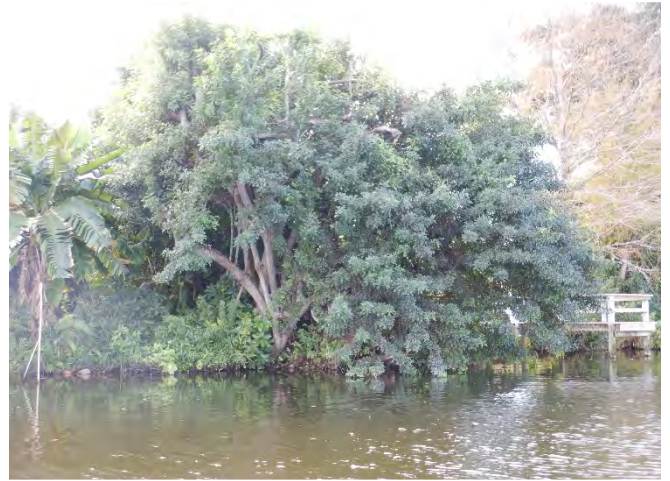
10. Lake 19: Brazilian pepper on south shore

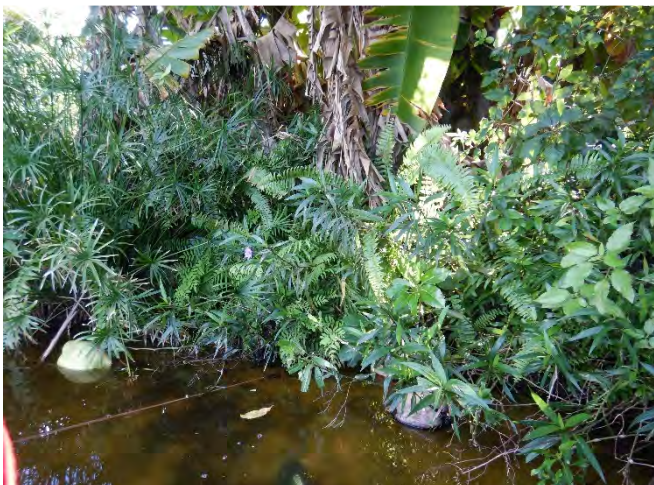
11. Lake 19: Vegetation under Brazilian pepper tree including Brazilian pepper saplings

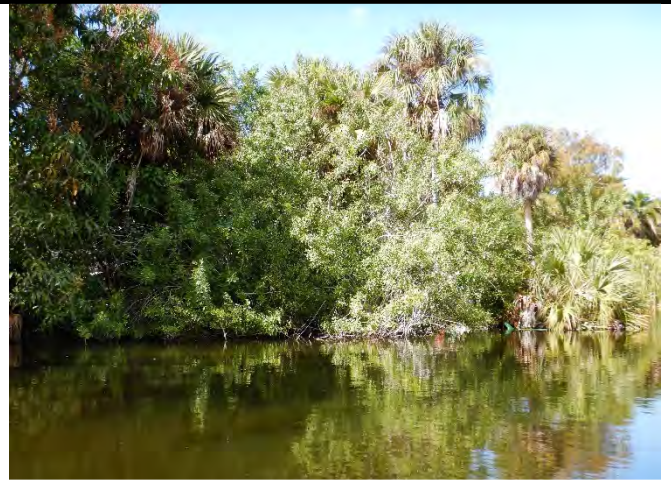
14. Lake 19: View of large area of Brazilian pepper on the west shore

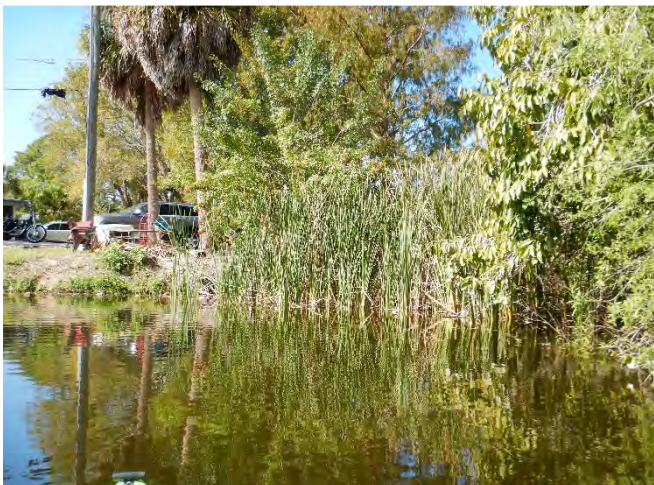
17. Lake 19: Cat-tail in northwest corner of lake

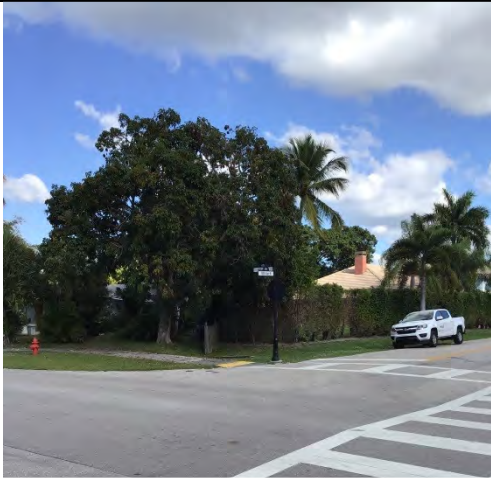
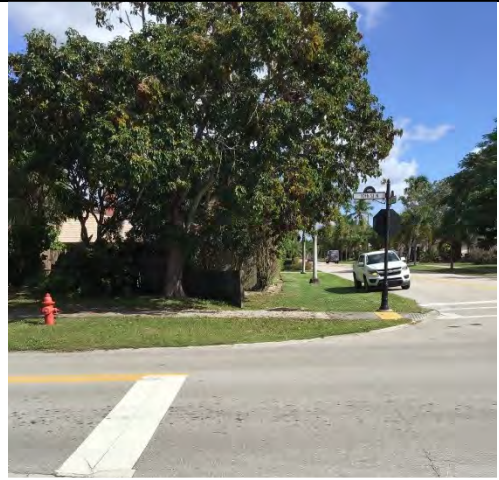
1. Lake 19: Stormwater Inlets capturing runoff from 10<sup>th</sup> St N

2. Lake 19: Stormwater Inlets capturing runoff from 10<sup>th</sup> St N

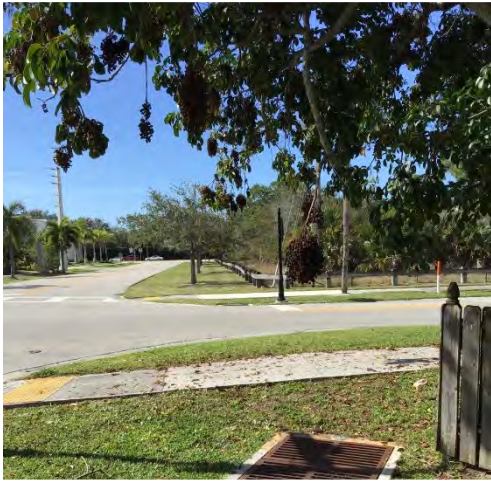
3. Lake 19: Stormwater Inlet capturing runoff from 10<sup>th</sup> St N and 14<sup>th</sup> Ave N. 30" reinforced concrete pipe discharging into Lake 19

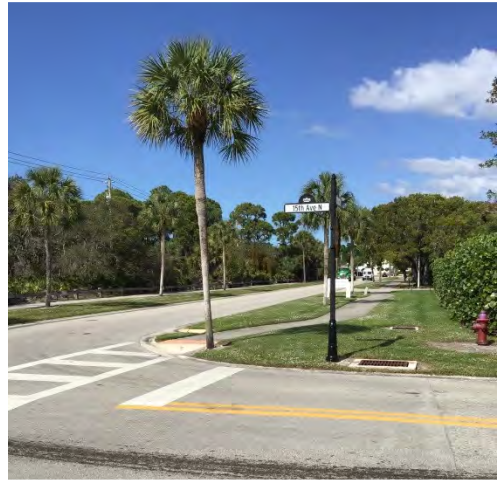
4. Lake 19: Stormwater Inlets capturing runoff from 10<sup>th</sup> St N and 15<sup>th</sup> Ave N

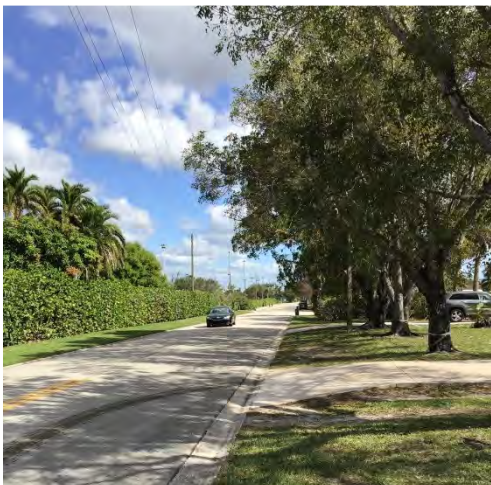
5. Lake 19: Proposed sidewalk footprint

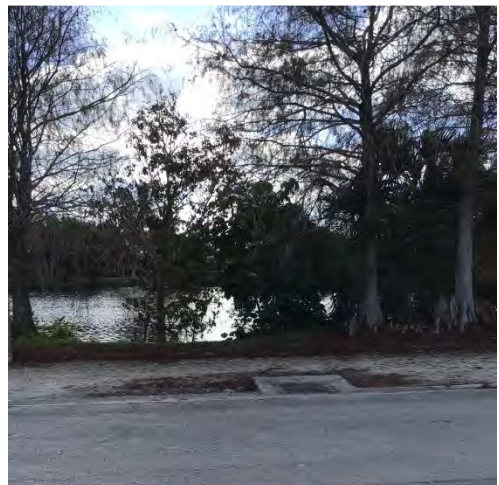
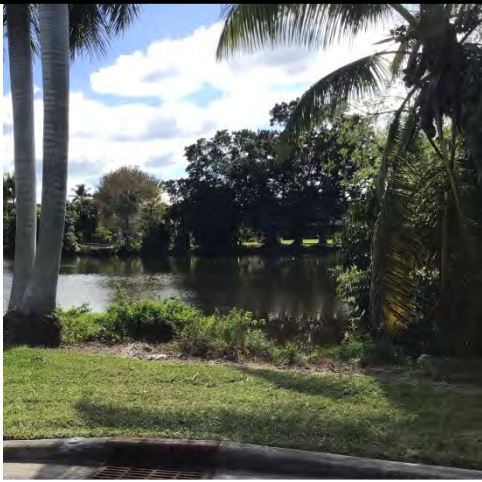
6. Lake 19: Curbside Inlet capturing runoff from 15<sup>th</sup> Ave N. 24" reinforced concrete pipe discharging into Lake 19.

7. Lake 19: Curbside Inlet capturing runoff from 15<sup>th</sup> Ave N. 24" reinforced concrete pipe discharging into Lake 19.

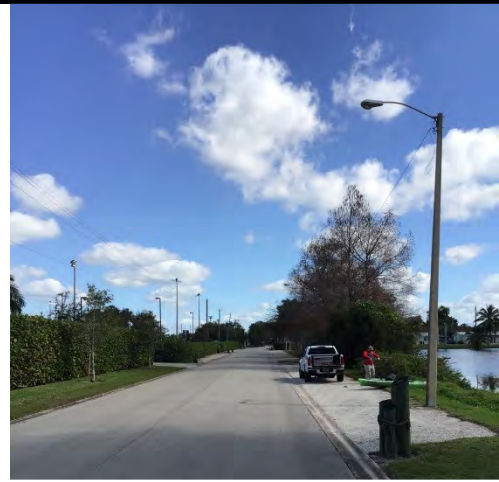
8. Lake 19: Proposed staging area for dewatering activities

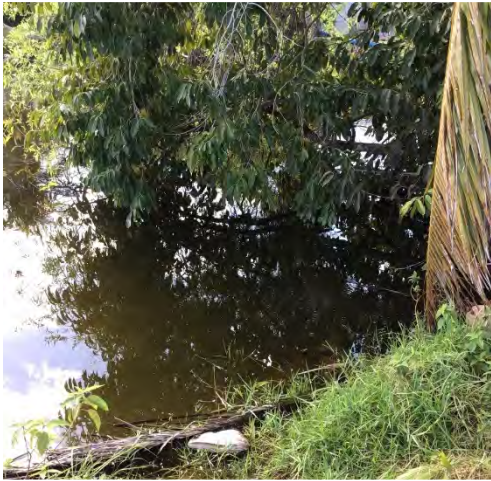
9. Lake 19: 24" reinforced concrete pipe discharging into Lake 19.

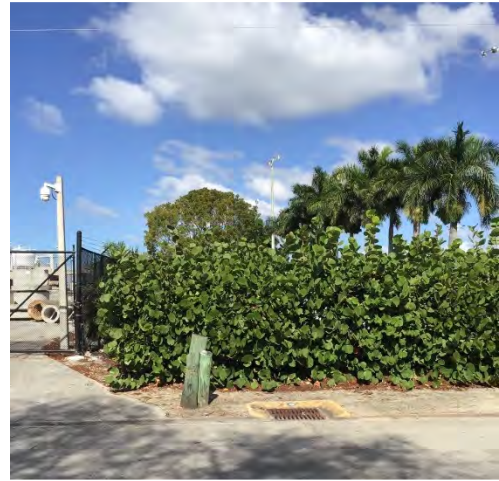
10. Lake 19: Stormwater Inlet capturing runoff from 15<sup>th</sup> Ave N. 18" reinforced concrete pipe discharging into Lake 19.

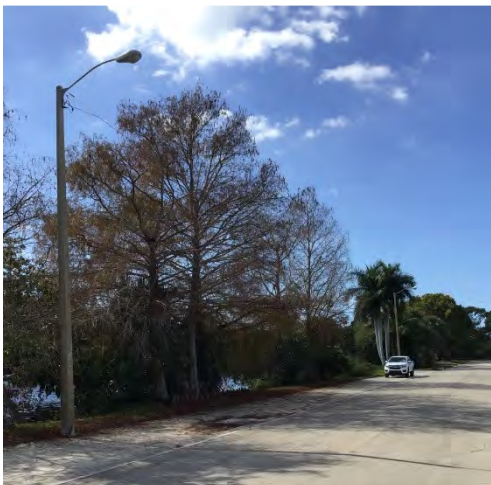
11. Lake 19: Light poles with overhead and underground utilities. Proposed staging area for dewatering activities

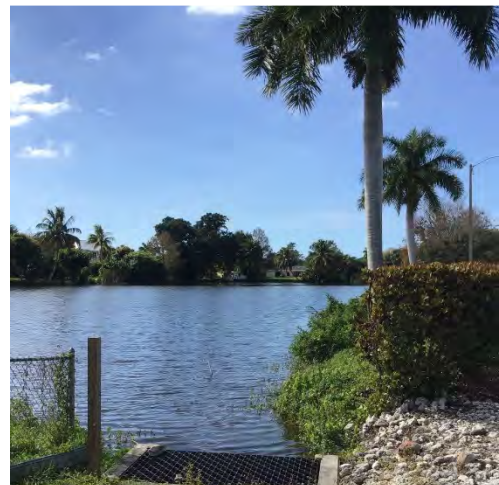
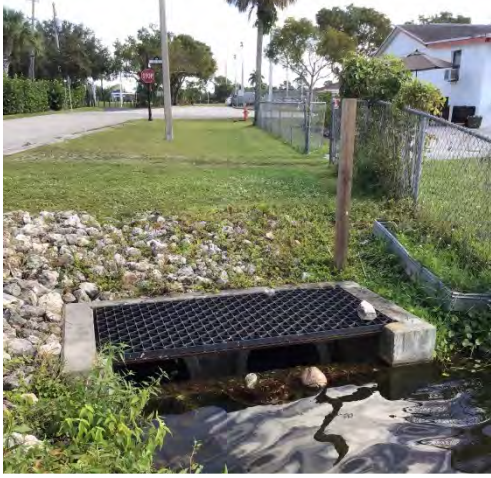
12. Lake 19: Stormwater grate outfall with weir with 2 - 30" reinforced concrete pipe discharging from Lake 19.

13. Lake 19: Stormwater grate outfall with weir with 2 - 30" reinforced concrete pipe discharging from Lake 19.

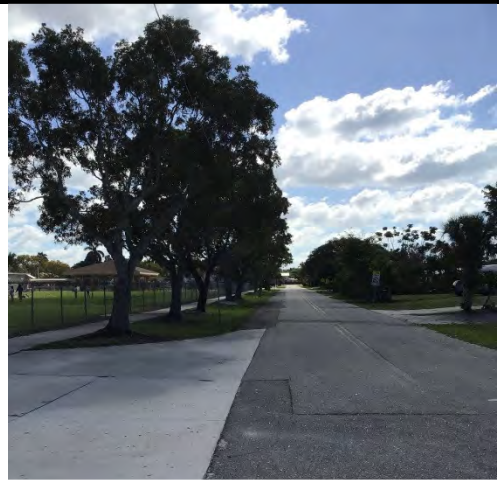
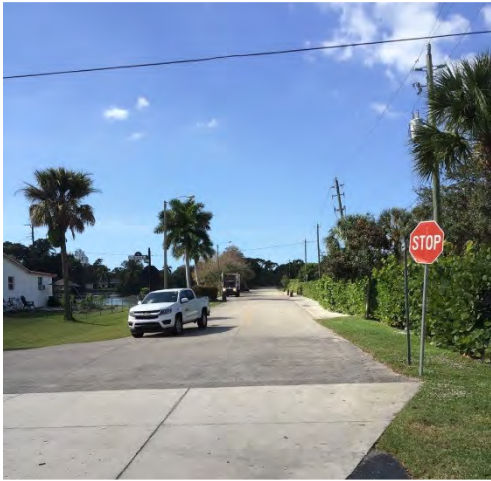
14. Lake 19: Potential cross walk location to tie into the proposed sidewalk along 12<sup>th</sup> St N.

15. Lake 19: Potential cross walk location to tie into the proposed sidewalk along 12<sup>th</sup> St N.
