## **Draft Final report**

### **Sediment assessment of Lakes 11 and 31 (City of Naples)**

**Final report submitted to:**  
City of Naples

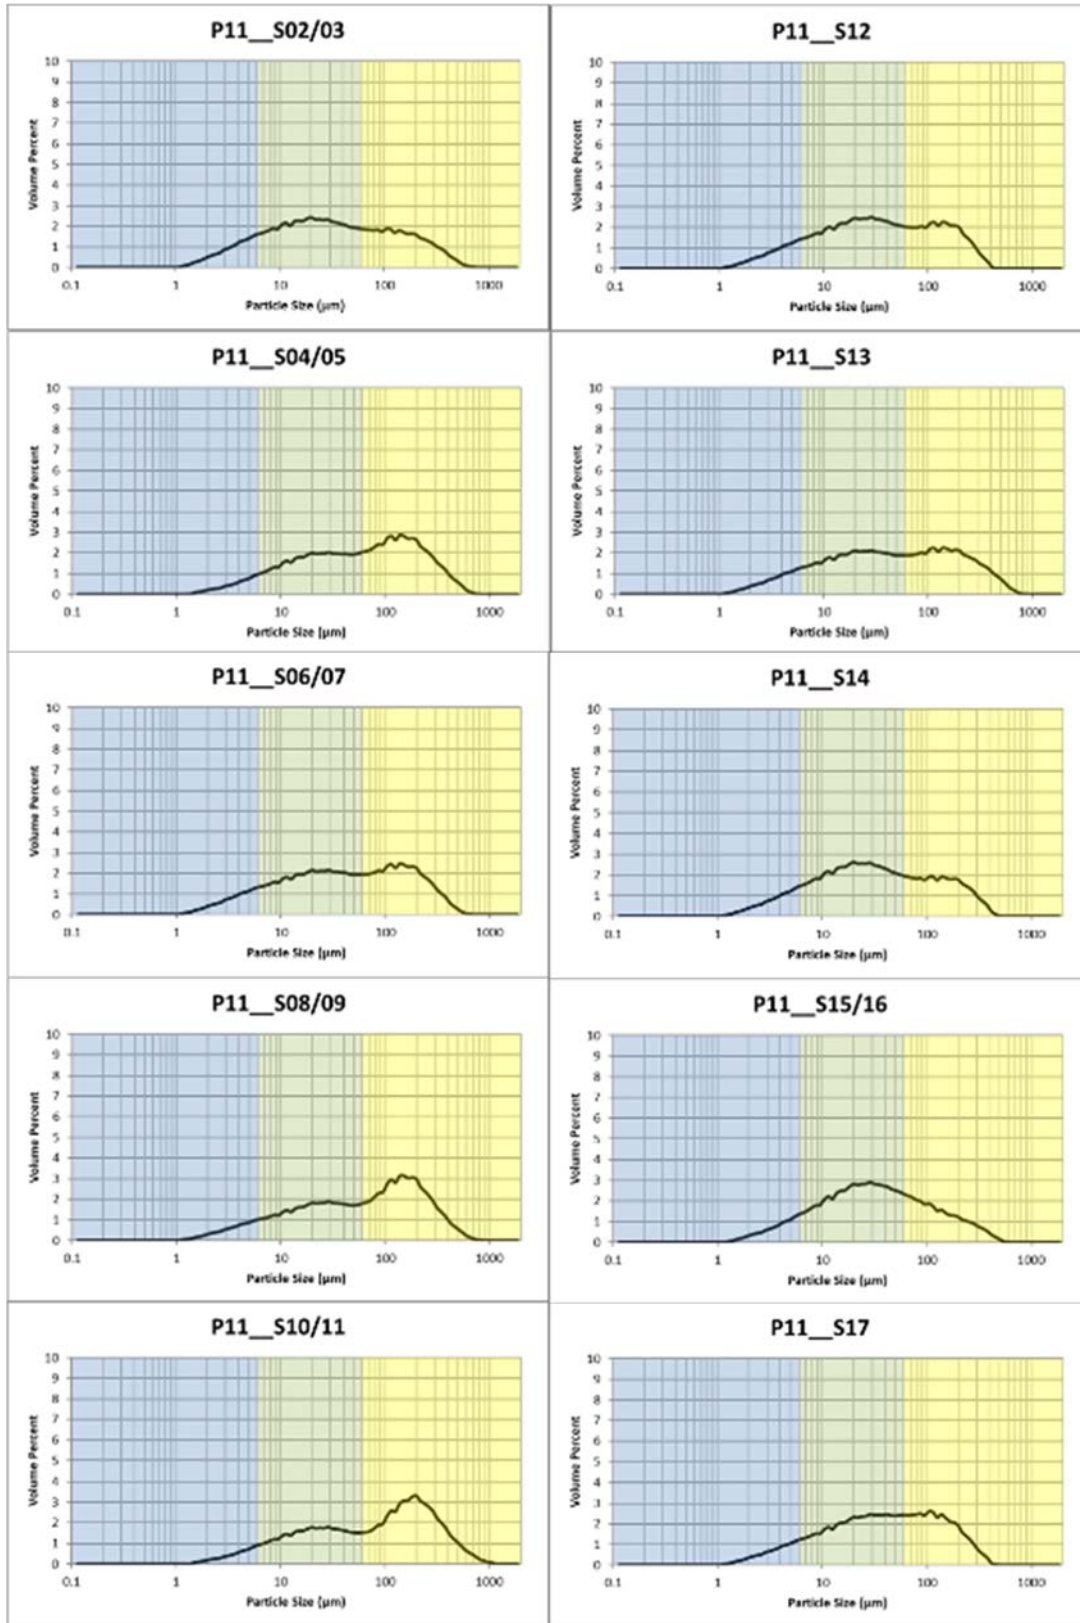
Sediment textures class in lake 11 varied from silt loam to loam and fine sandy loam. There were discrepancies between the D values measured with the Malvern and the wet sieving. Wet sieving shows that, in average, 60 percent of the particulate was less than  $0.15 \pm S.D. 0.05$ mm in size. It was most often not possible to get the size of the particulate for the D30 (average  $0.12 \pm S.D. 0.04$ mm) or it was impossible to determine the D10 because most of the particles were very fine and thus went through the size 200 (i.e., 0.074mm pore size) sieve. The Malvern provides the following averages of  $0.23 \pm S.D. 0.05$ mm,  $0.07 \pm S.D. 0.03$ mm,  $0.02 \pm S.D. 0.00$ mm and  $0.006 \pm S.D. 0.001$ mm for  $D_x(90)$ ,  $D_x(60)$ ,  $D_x(30)$  and  $D_x(10)$  respectively. Liquid limits were in average  $59.7 \pm S.D. 9.2\%$  and the plasticity limit was  $39.1 \pm S.D. 5.3\%$  for a plasticity index of  $20.7 \pm S.D. 6.7\%$ .

FIGURE 3. Grain size distribution of the sediment in lake 11.

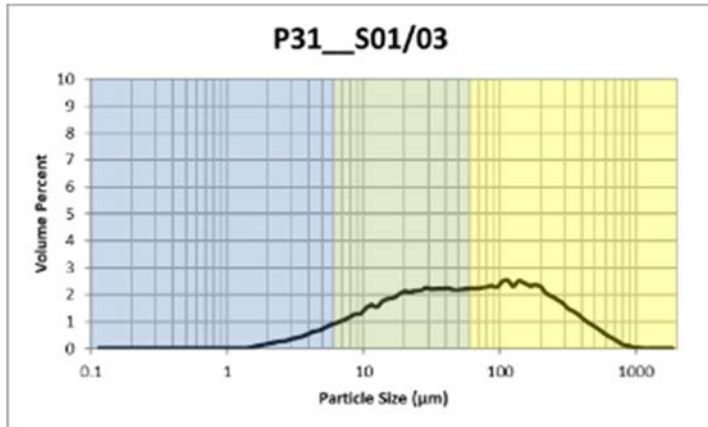
The sediment texture class for lake 31 was sandy loam and its D60 and D30 were 0.27mm and 0.15mm while D10 could not be determined. The Malvern figures were 0.29mm, 0.09mm, 0.02mm and 0.01mm for Dx(90), Dx(60), Dx(30) and Dx(10) respectively. The liquid limit was in average 47.1% and the plasticity limit was 33.6% for a plasticity index of 13.5%.

FIGURE 4. Grain size distribution of lake 31.
