# Pier Substructure

## City of Naples / Naples Pier

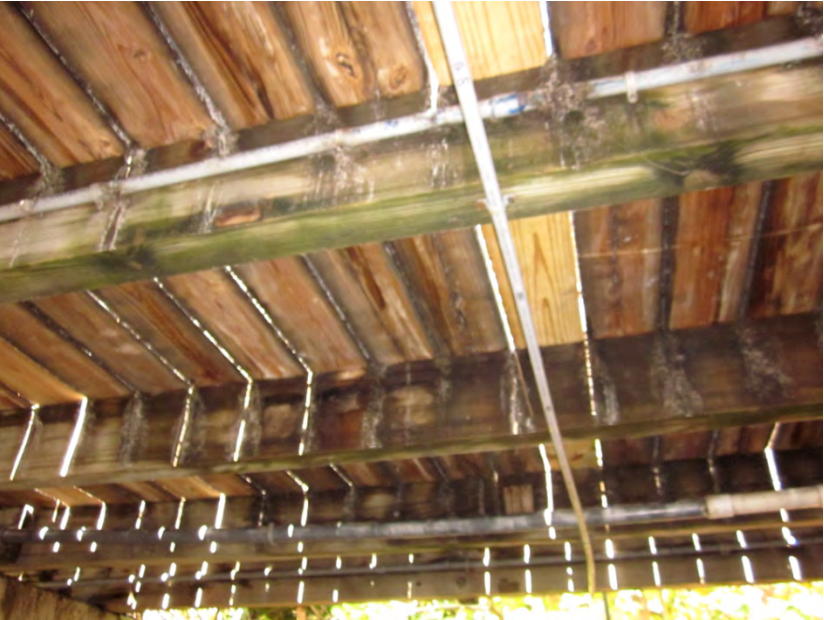
| Photo | Descriptions/Comments |
|---|---|
| | <p><b>Description:</b> View of the decking underside in between Pier# 2 and Pier #3. The underside surface and the stringers appear to be in satisfactory condition. Note water piping and electrical conduits strapped to the stringers.</p> |

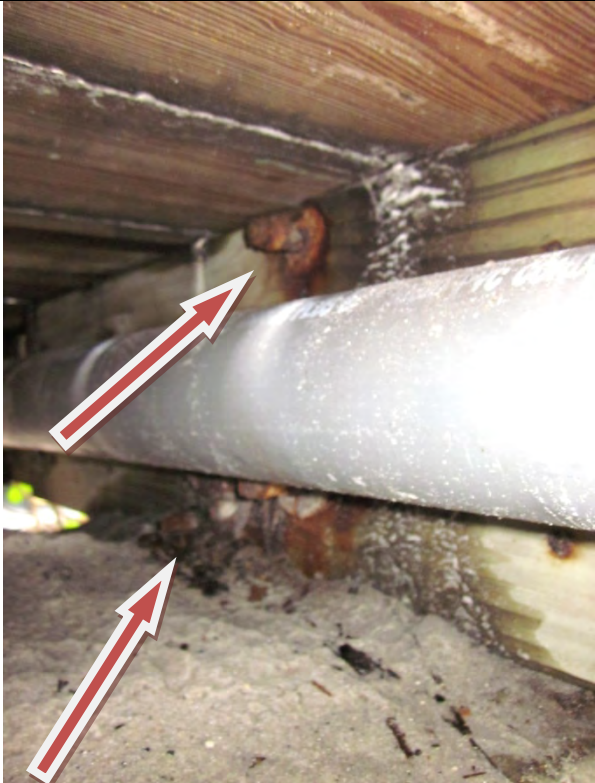
| Photo | Descriptions/Comments |
|---|---|
| | <p><b>Issue:</b> Electrical conduits and small water pipes are strapped to the stringers with plastic straps or in some cases plastic hangers. Note the corroding washers and complete loss of hex-nuts, of both of the thru-bolt connectors, to corrosion, at the base of a rail post over Pier #3. The anchor bolt and clip angle appear to have completely corroded away as well.</p> <p><b>Resolution:</b> Perform regular inspection and replace severely corroded washers and hex-nuts.</p> |

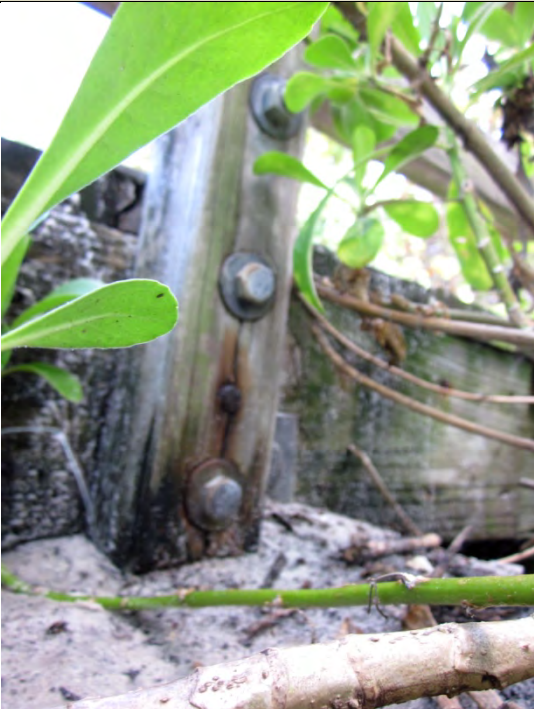
| Photo | Descriptions/Comments |
|---|---|
| | <p><b>Description:</b> The thru-bolt connectors at the base of this rail post on the outside appear to be sound and free from corrosion, with the exception of the single nail in the middle.</p> |

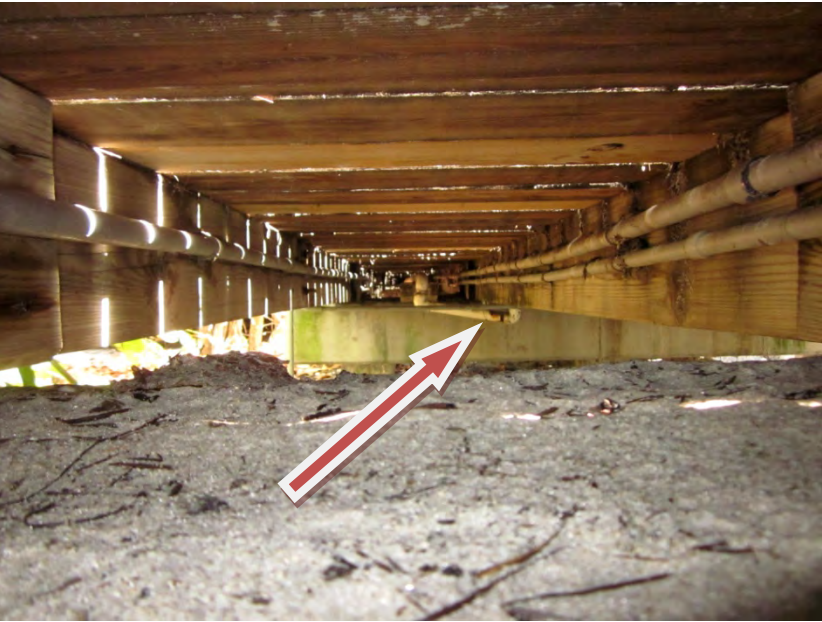
| Photo | Descriptions/Comments |
|---|---|
| | <p><b>Issue:</b> View of the decking underside between the deck board span, looking back at Pier #3. Deck board underside and stringers appear satisfactory. There is an area of concrete spall along the edge of the pile cap beyond. Note water piping on right and electrical conduit on left.</p> <p><b>Resolution:</b> Patch the spall spot with epoxy concrete to prevent further corrosion of the pile cap reinforcing bars.</p> |

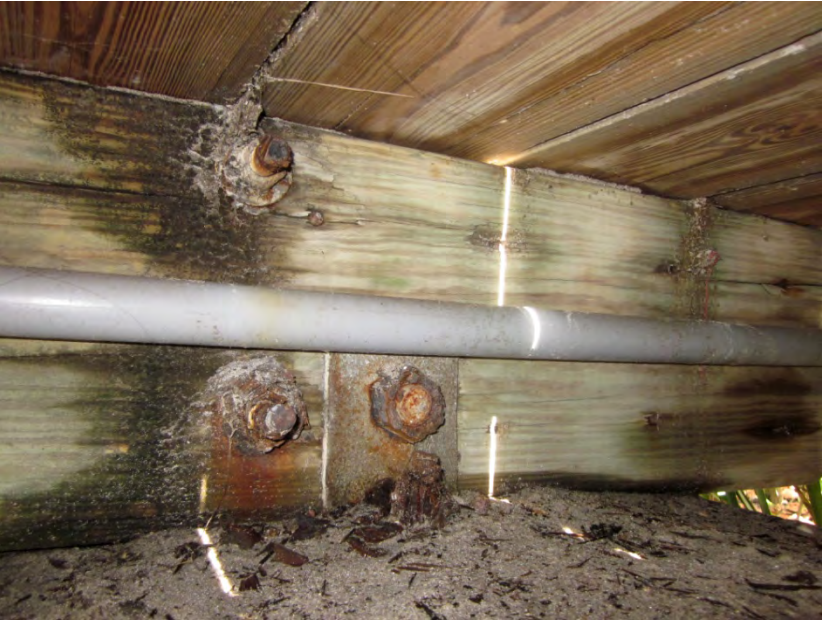
| Photo | Descriptions/Comments |
|---|---|
| | <p><b><u>Issue:</u></b> The rail post thru-bolt connectors and anchor bolt/ clip angle assembly on this side are undergoing severe corrosion as well.</p> <p><b><u>Resolution:</u></b> Perform regular inspection and replace severely corroded washers and hex-nuts. In some case the galvanized clip angle may need replacement as well.</p> |

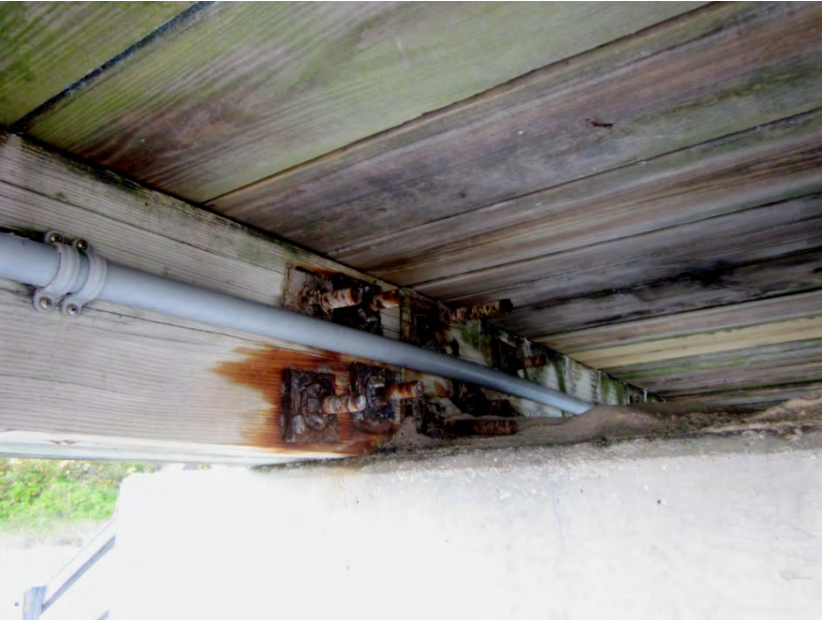
| Photo | Descriptions/Comments |
|---|---|
| | <p><b><u>Issue:</u></b> View of the same assembly on the inside face, which reveals severe corrosion of almost all the thru-bolts.</p> <p><b><u>Resolution:</u></b> Inspect and replace corroded metal hardware. Replace all broken plastic pipe straps and hangers to properly support the pipe/conduit.</p> |

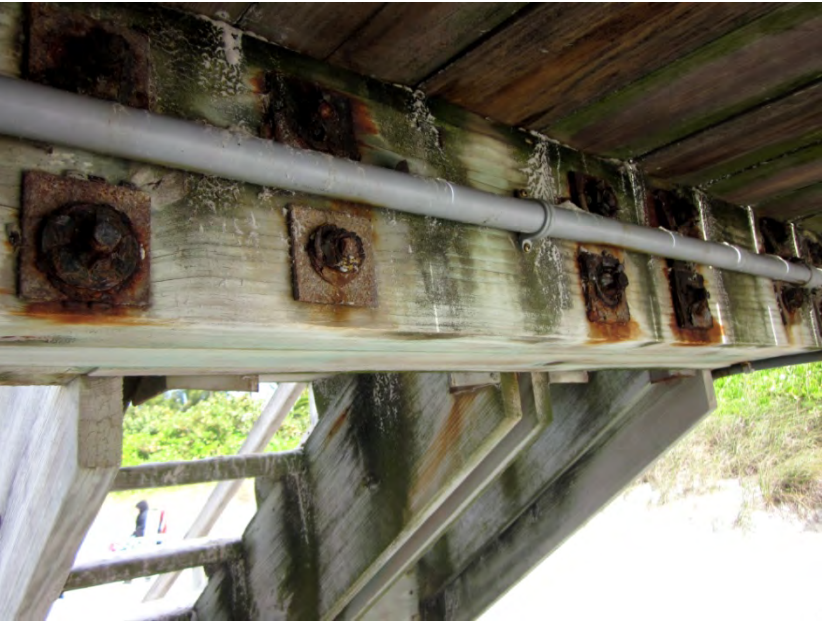
| Photo | Descriptions/Comments |
|---|---|
| | <p><b>Issue:</b> View of the rail posts/stair stringer/deck stringer thru-bolt connections on the inside face of the deck stringer.</p> <p><b>Resolution:</b> Inspect and replace corroded metal hardware.</p> |

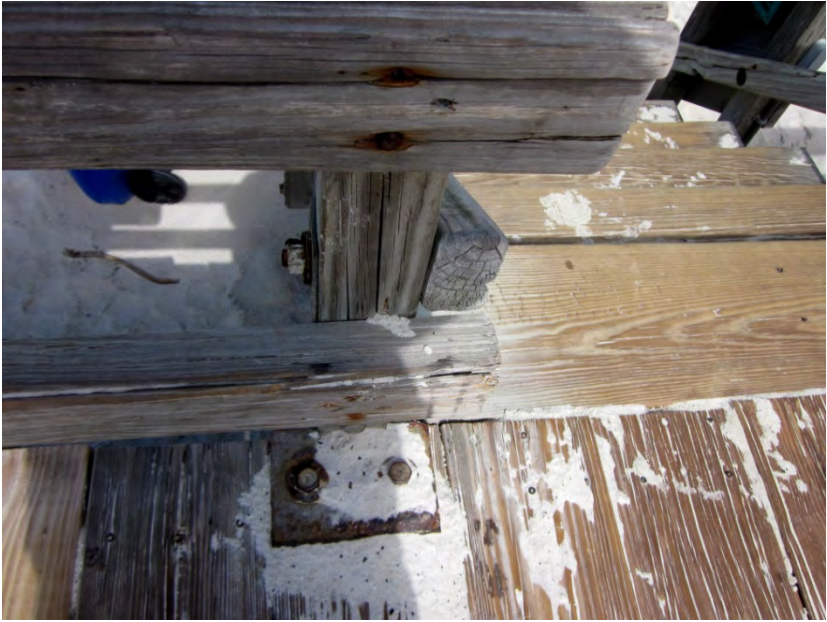
| Photo | Descriptions/Comments |
|---|---|
| | <p><b><u>Issue:</u></b> See preceding issue.</p> <p><b><u>Resolution:</u></b> See preceding resolution.</p> |

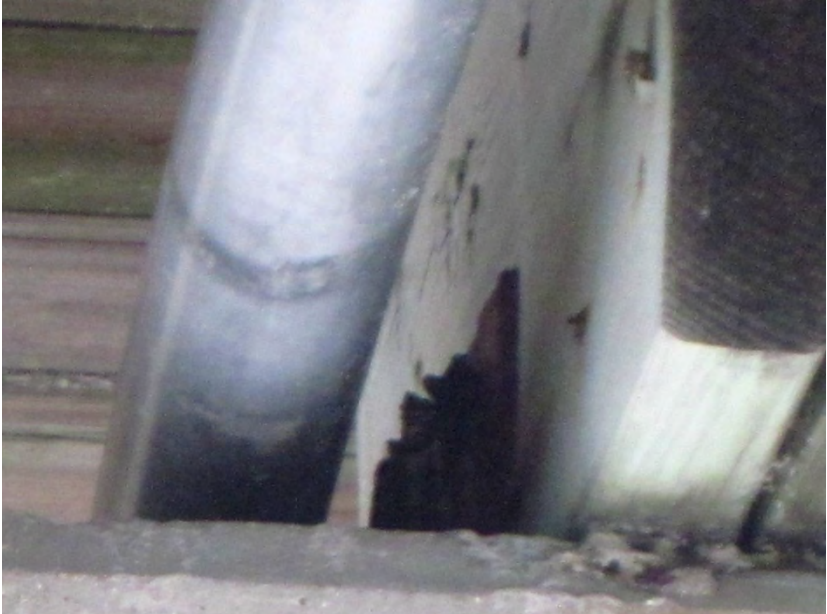
| Photo | Descriptions/Comments |
|---|---|
| | <p><b><u>Issue:</u></b> See preceding issue for metal hardware from Pier # 7 and beyond.</p> <p><b><u>Resolution:</u></b> See preceding resolution.</p> |

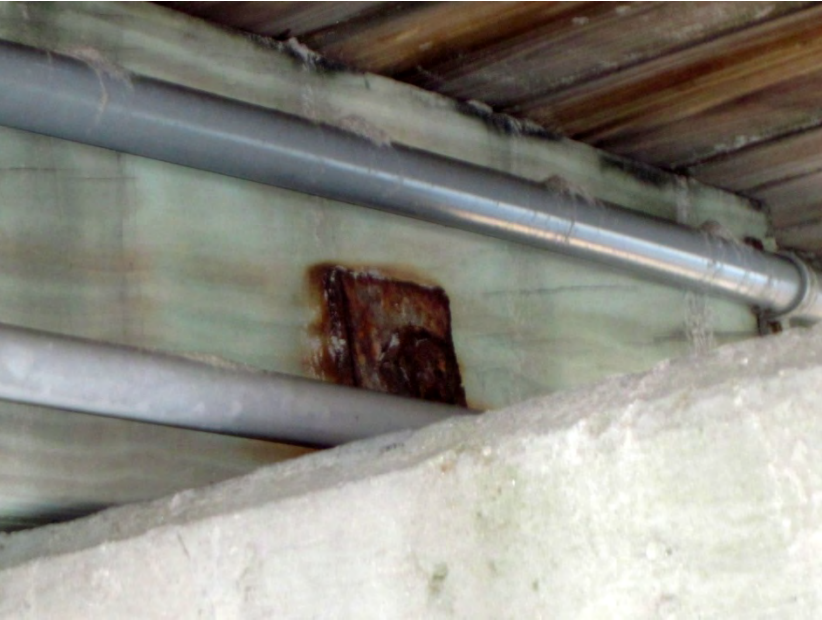
| Photo | Descriptions/Comments |
|---|---|
| | <p><b><u>Issue:</u></b> Pier #8. See preceding issue.</p> <p><b><u>Resolution:</u></b> See preceding resolution.</p> |

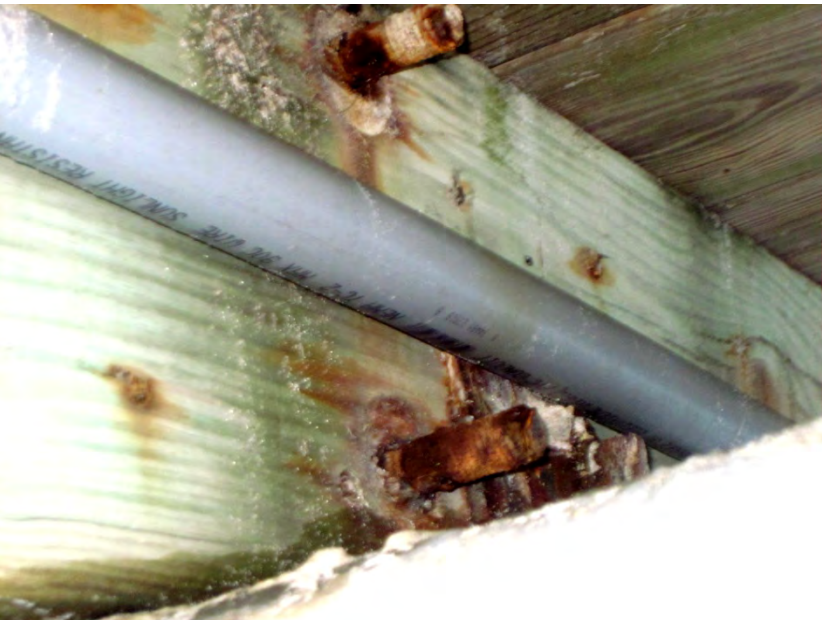
| Photo | Descriptions/Comments |
|---|---|
| | <p><b><u>Issue:</u></b> See preceding issue. Note hex-nuts and washers have corroded away and cleared from the end of the rail post thru-bolts causing potential faulty structural connections.</p> <p><b><u>Resolution:</u></b> Require immediate close inspection and repair/replacement.</p> |

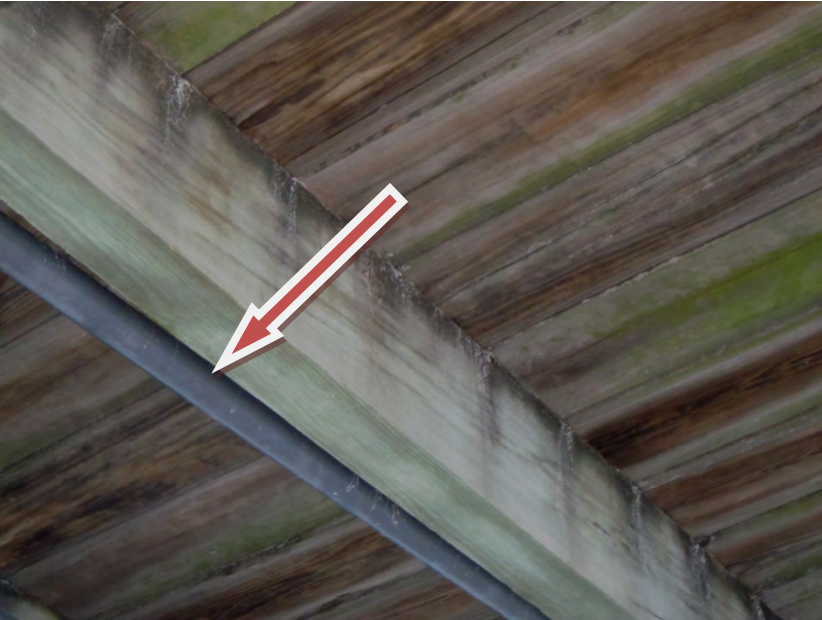
| Photo | Descriptions/Comments |
|---|---|
| | <p><b><i>Issue:</i></b> Pier # 12. The stress caused by the movement of the main power supply conduit is beyond the working strength of these thin plastic pipe straps. Note the conduit has dropped away from its strapping alongside the stringer.</p> <p><b><i>Resolution:</i></b> Provide new plastic pipe straps with better working strength and durability (i.e. more material thickness/cross-section, mass, etc).</p> |

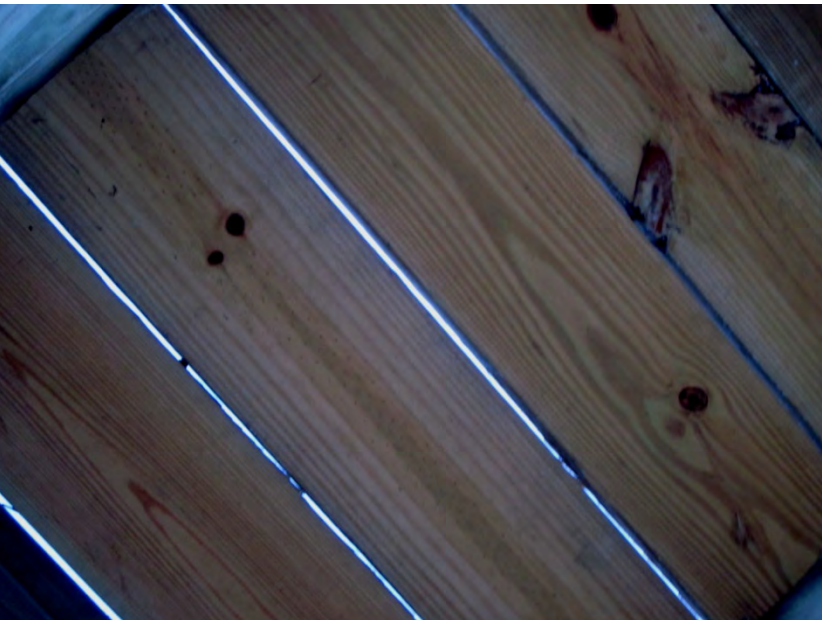
| Photo | Descriptions/Comments |
|---|---|
| | <p><b><i>Description:</i></b> Typical view of the substructure framing and the condition of the decking in the vicinity of Pier #12. Note the multiple replacement boards besides the old boards.</p> |

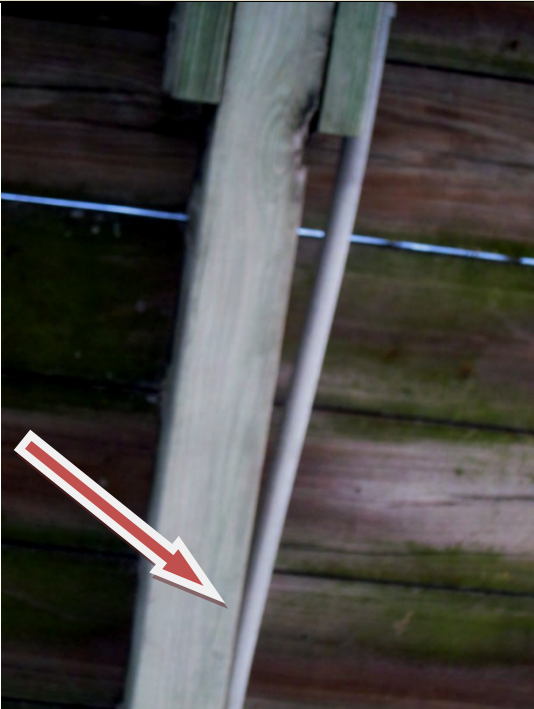
| Photo | Descriptions/Comments |
|---|---|
| | <p><b><i>Issue:</i></b> Pier #12 – Pier #13. The stress caused by the movement of the main power supply conduit is beyond the working strength of these thin plastic pipe straps. Note the conduit has dropped away from its strapping alongside the stringer.</p> <p><b><i>Resolution:</i></b> Provide new plastic pipe straps with better working strength and durability (i.e. more material thickness/cross-section, mass, etc).</p> |

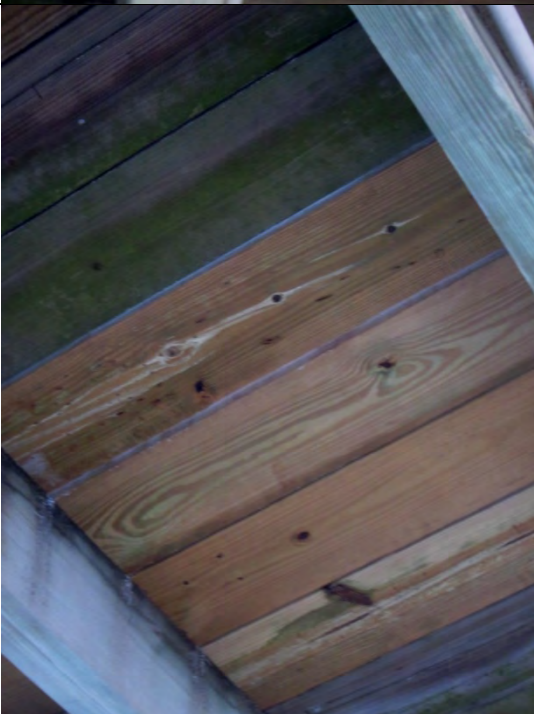
| Photo | Descriptions/Comments |
|---|---|
| | <p><b><i>Description:</i></b> Typical view of the substructure framing and the condition of the decking between Pier #12 and Pier #13. Note the multiple replacement boards besides the old boards.</p> |

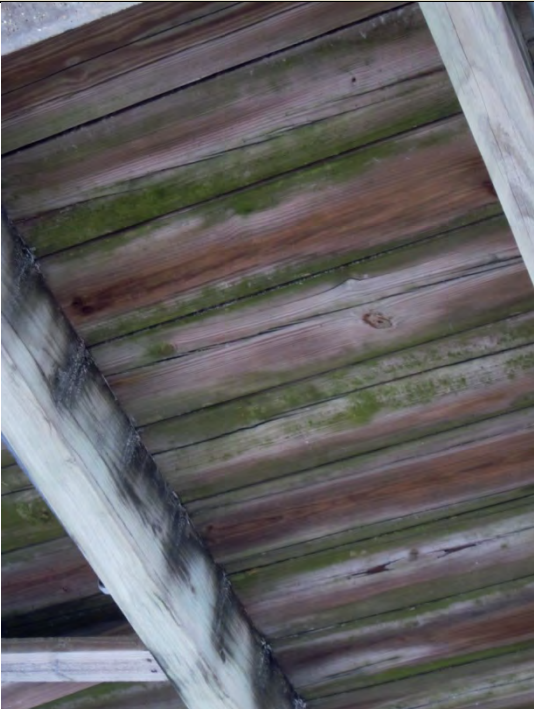
| Photo | Descriptions/Comments |
|---|---|
| | <p><b>Description:</b> Typical view of the substructure framing and the condition of the decking between Pier #12 and Pier #13. The old deck boards display fiber splitting. The lack of direct sunlight and airflow in moisture rich environment cause the proliferation of algae below deck.</p> |

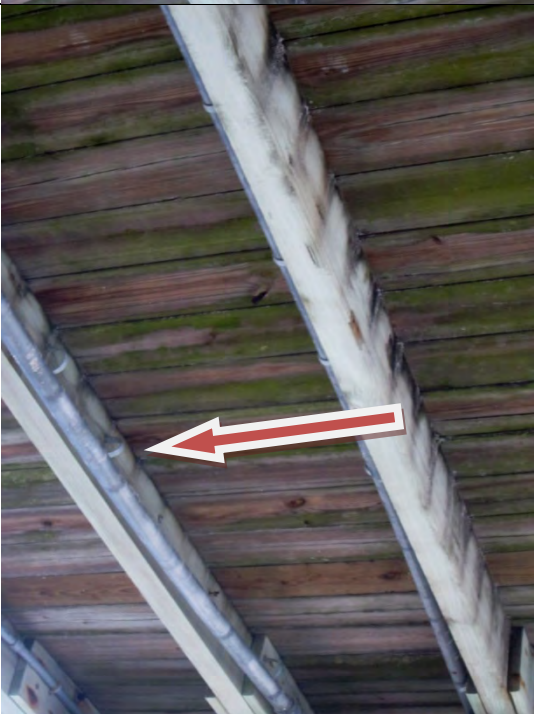
| Photo | Descriptions/Comments |
|---|---|
| | <p><b>Issue:</b> The stress caused by the movement of the main power supply conduit is beyond the working strength of these thin plastic pipe straps. Note the conduit has dropped away from its strapping alongside the stringer.</p> <p><b>Resolution:</b> Provide new plastic pipe straps with better working strength and durability (i.e. more material thickness/cross-section, mass, etc).</p> |

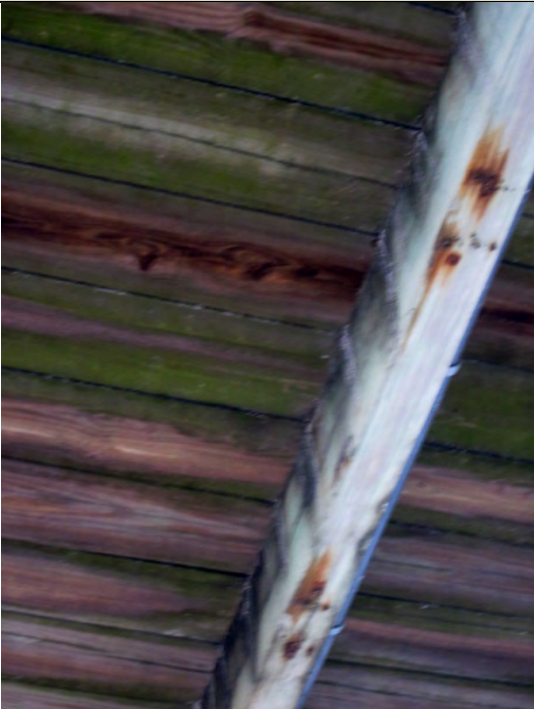
| Photo | Descriptions/Comments |
|---|---|
| | <p><b>Description:</b> Typical view of the substructure framing and the condition of the decking between Pier #12 and Pier #13. The old deck boards display fiber splitting. The lack of direct sunlight and airflow in moisture rich deck underside proliferate algae growth.</p> |

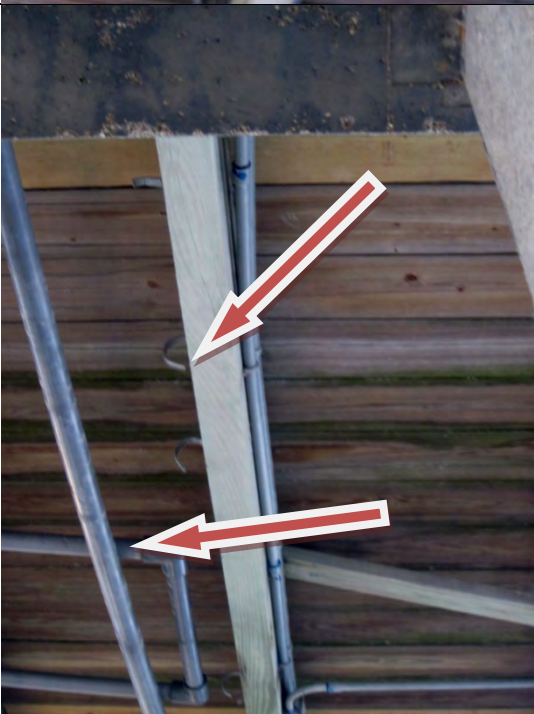
| Photo | Descriptions/Comments |
|---|---|
| | <p><b>Issue:</b> View of the condition of the decking underside between Pier #12 and Pier# 13. Note the main power conduit dropped away from its strapping along the inside stringer above.</p> <p><b>Resolution:</b> Provide new plastic pipe straps with better working strength and durability (i.e. more material thickness/cross-section, mass, etc).</p> |

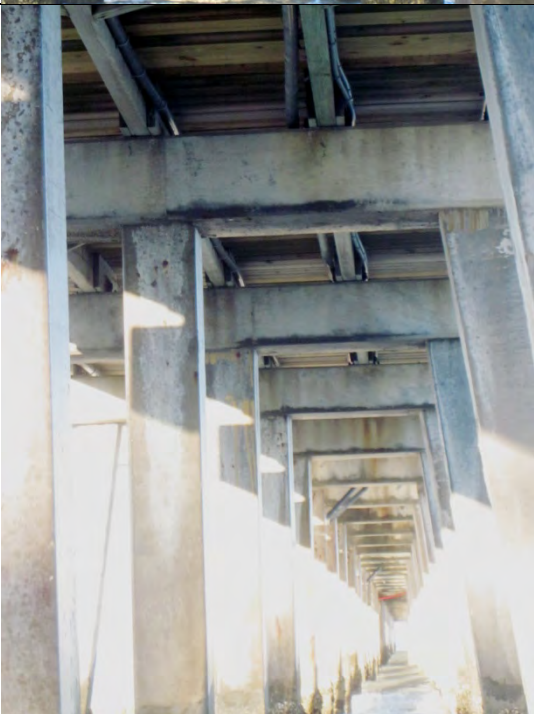
| Photo | Descriptions/Comments |
|---|---|
| | <p><b><i>Description:</i></b> Typical view of the substructure framing and the condition of the decking underside from Pier #13 right opening seaward.</p> |

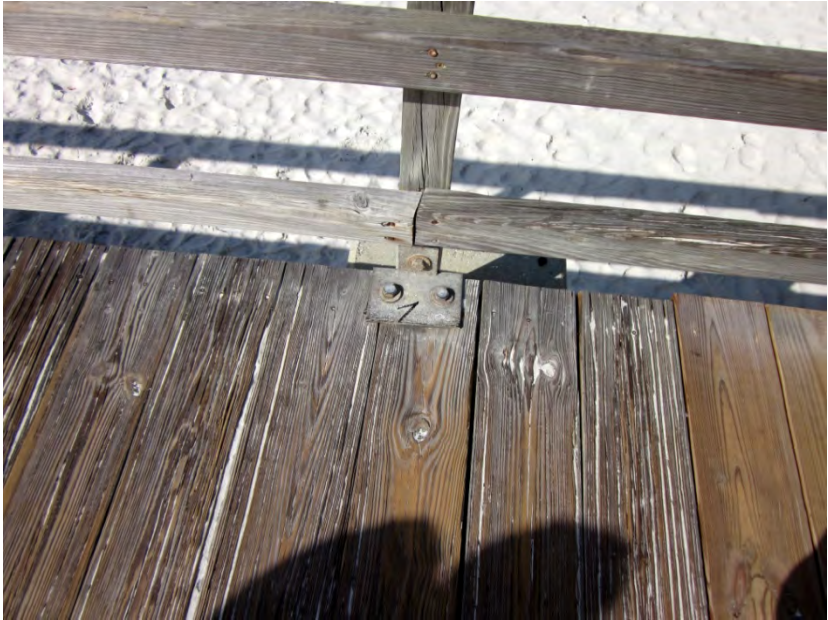
| Photo | Descriptions/Comments |
|---|---|
| | <p><i><u>Description:</u></i> View over Pier #7.</p> |

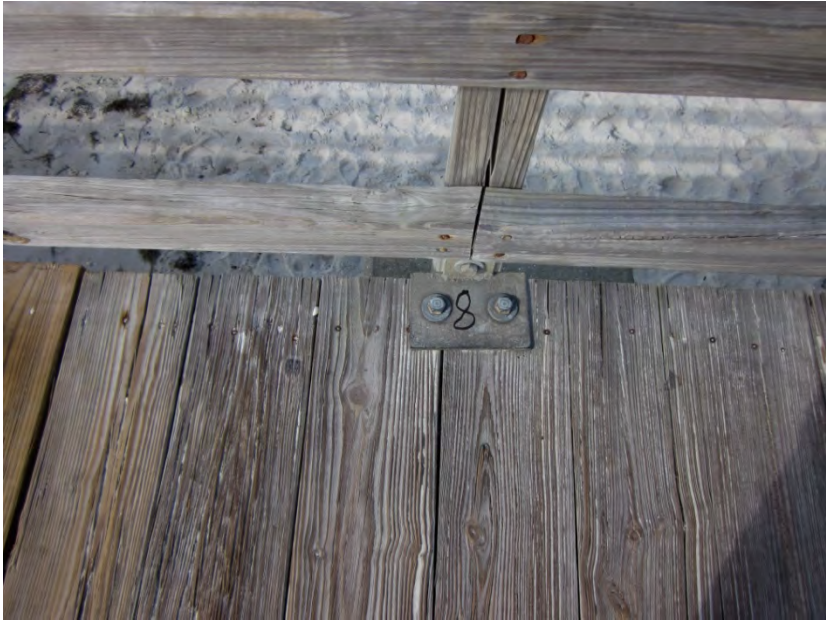
| Photo | Descriptions/Comments |
|---|---|
| | <p><i><u>Description:</u></i> View over Pier #8.</p> |

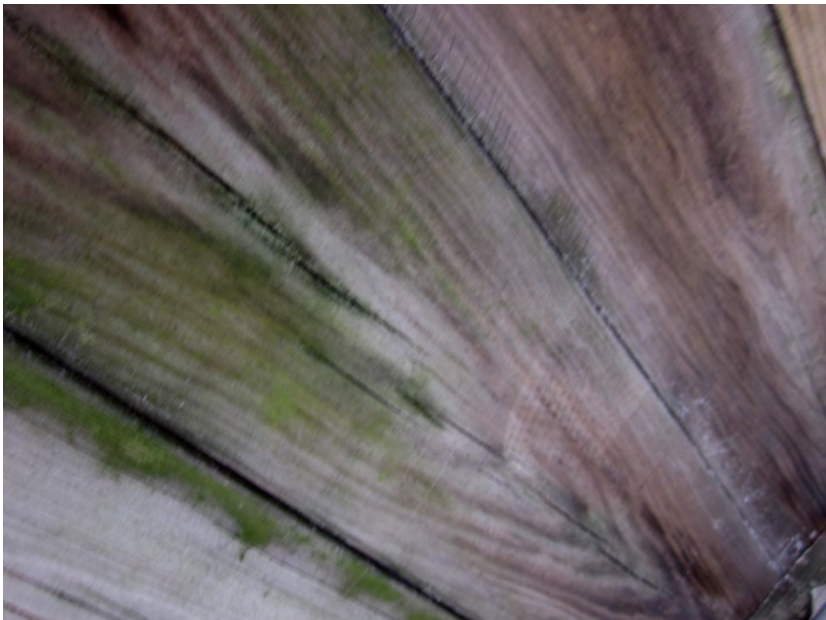
| Photo | Descriptions/Comments |
|---|---|
| | <p><i><u>Description:</u></i> Typical view of the substructure framing and the condition of the decking underside from Pier #8.</p> |

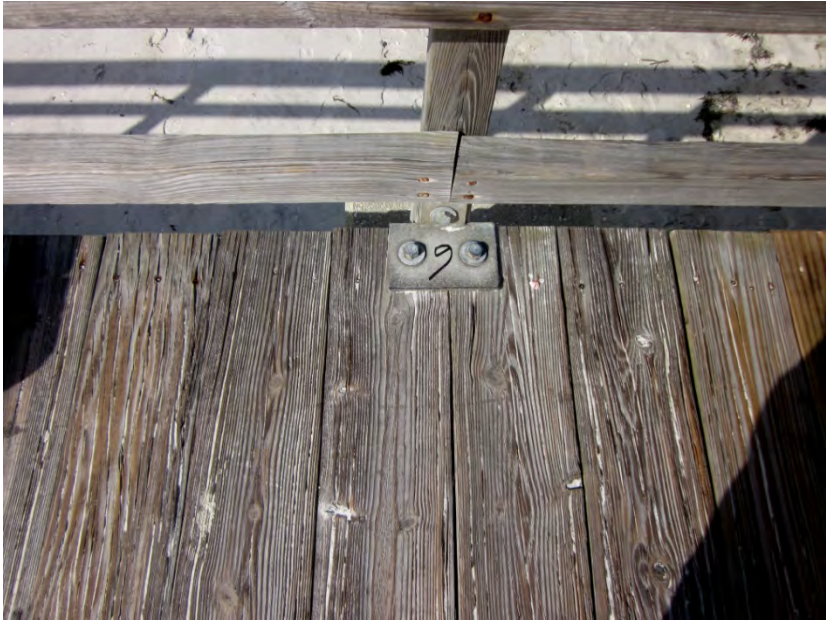
| Photo | Descriptions/Comments |
|---|---|
| | <p><i>Description:</i> View over Pier #9.</p> |

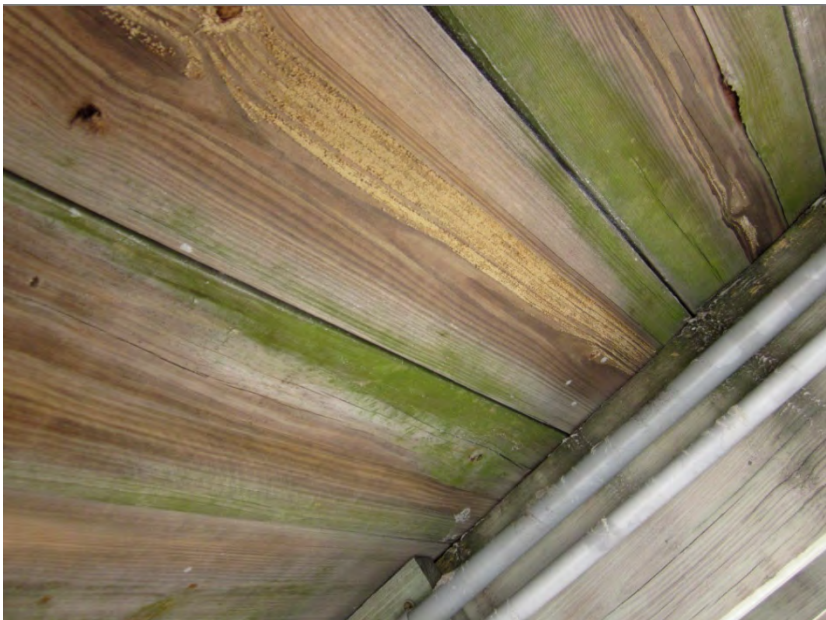
| Photo | Descriptions/Comments |
|---|---|
| | <p><i>Description:</i> Typical view of the substructure framing and the condition of the decking underside from Pier #9.</p> |

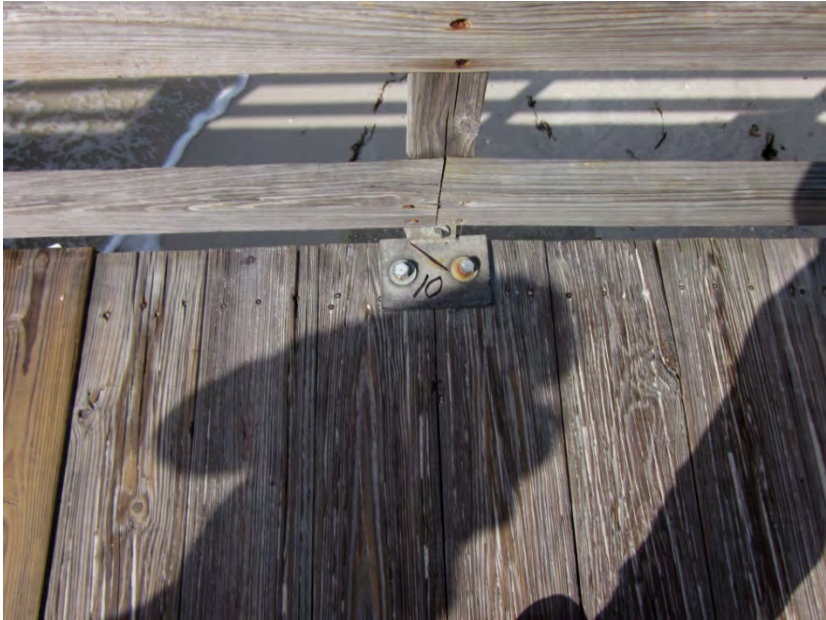
| Photo | Descriptions/Comments |
|---|---|
| | <p><i><u>Description:</u></i> View over Pier #10.</p> |

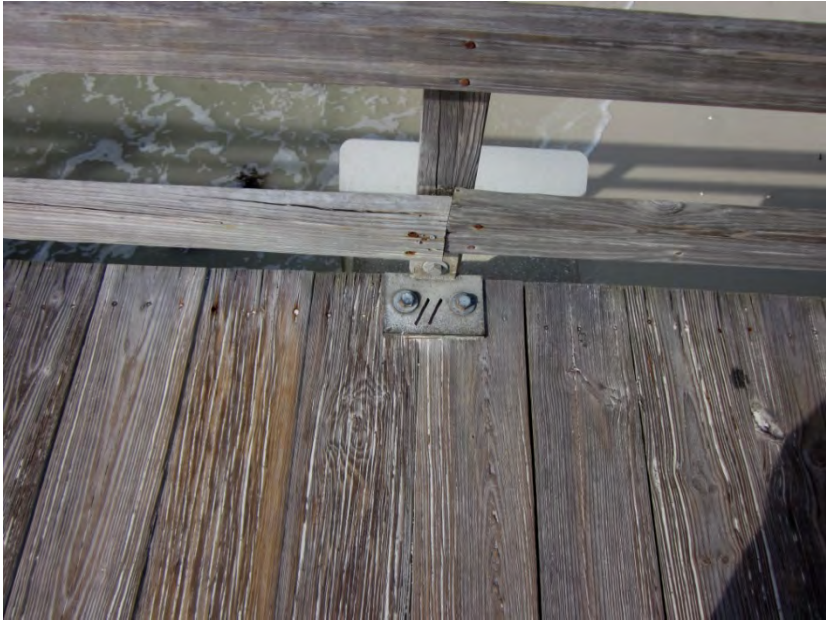
| Photo | Descriptions/Comments |
|---|---|
| | <p><i><u>Description:</u></i> View over Pier #11.</p> |

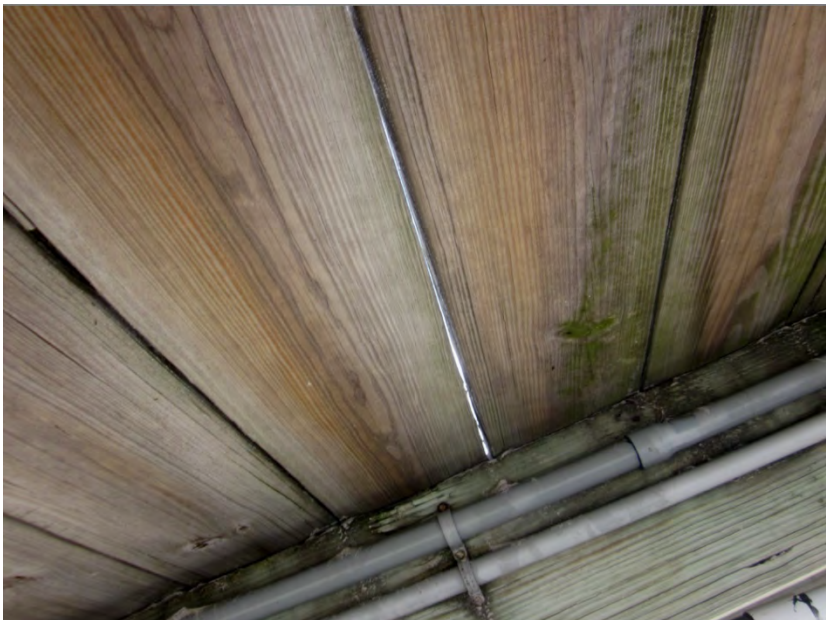
| Photo | Descriptions/Comments |
|---|---|
| | <p><i><u>Description:</u></i> Typical view of the substructure framing and the condition of the decking underside from Pier #11.</p> |

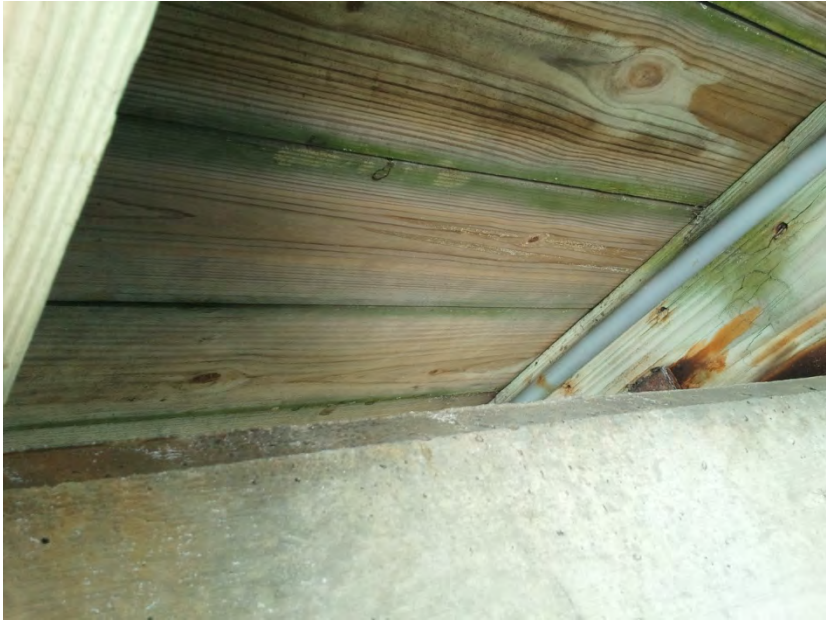
| Photo | Descriptions/Comments |
|---|---|
| | <p><b><u>Description:</u></b> Typical view of the substructure framing and the condition of the decking underside from Pier #11.</p> |

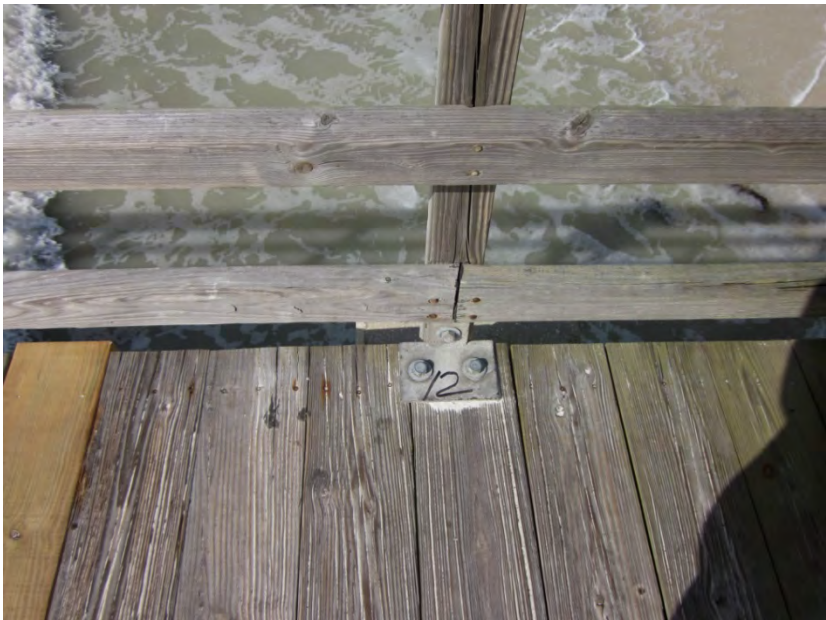
| Photo | Descriptions/Comments |
|---|---|
| | <p><b><u>Description:</u></b> View over Pier #12.</p> |

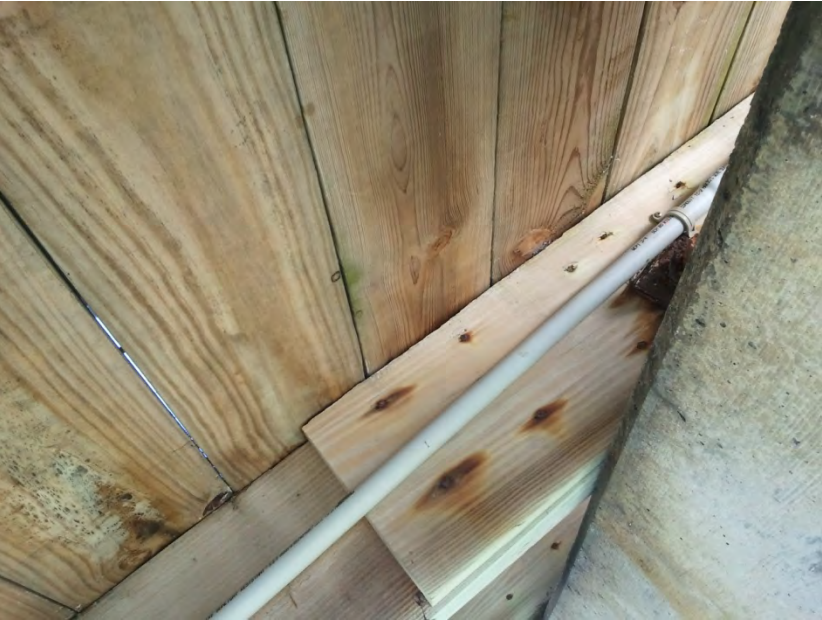
| Photo | Descriptions/Comments |
|---|---|
| | <p><b><i>Description:</i></b> Typical view of the substructure framing and the condition of the decking underside at Pier #12. Note multiple replacement boards.</p> |

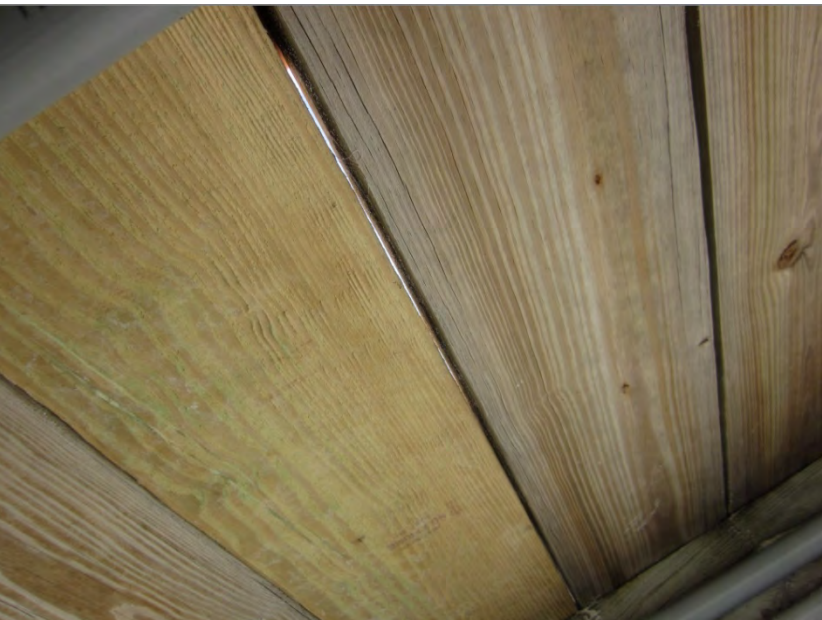
| Photo | Descriptions/Comments |
|---|---|
| | <p><b><i>Description:</i></b> Typical view of the substructure framing and the condition of the decking underside from Pier #12. Note multiple replacement boards.</p> |

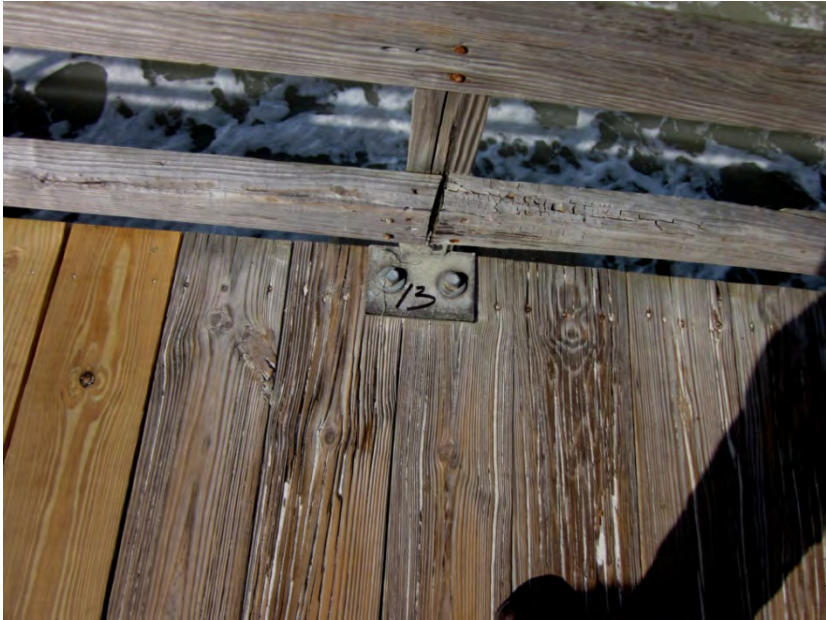
| Photo | Descriptions/Comments |
|---|---|
| | <p><i><u>Description:</u></i> View over Pier #13.</p> |

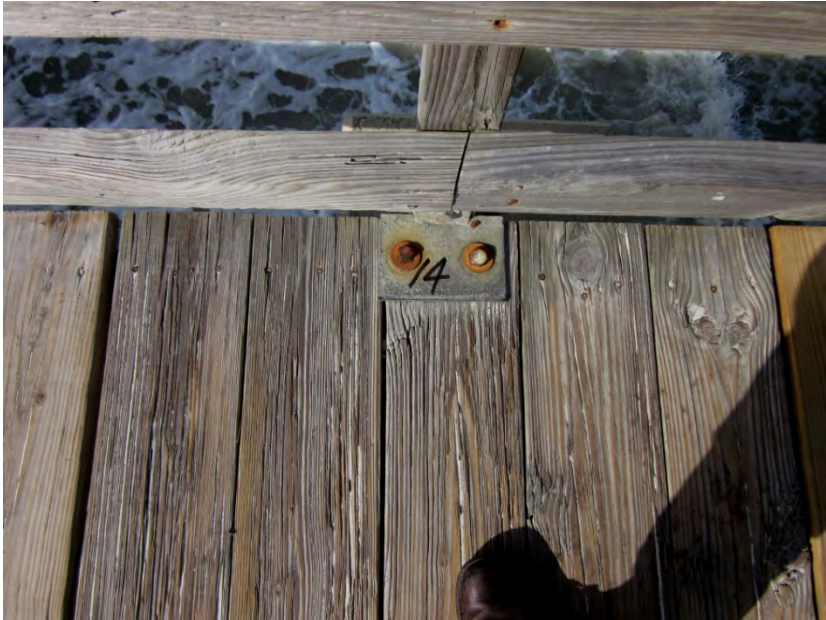
| Photo | Descriptions/Comments |
|---|---|
| | <p><i><u>Description:</u></i> View over Pier #14.</p> |

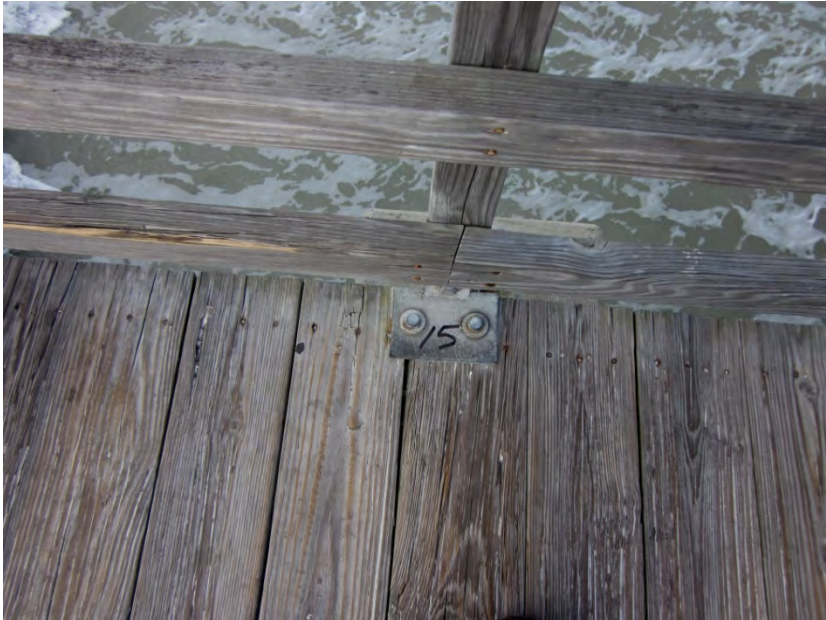
| Photo | Descriptions/Comments |
|---|---|
| | <p><i><u>Description:</u></i> View over Pier #15.</p> |

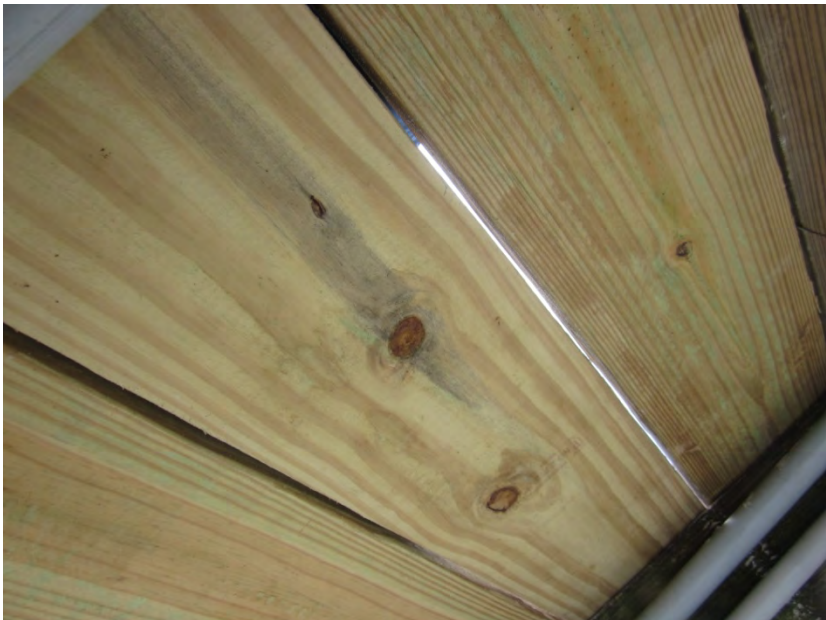
| Photo | Descriptions/Comments |
|---|---|
| | <p><i><u>Description:</u></i> Typical view of the substructure framing and the condition of the decking underside from Pier #15. Note multiple replacement boards.</p> |

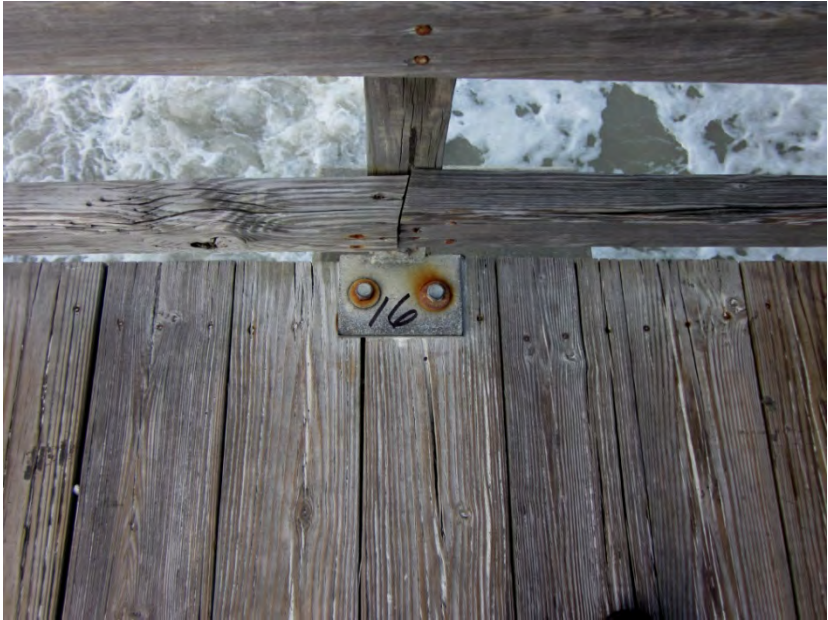
| Photo | Descriptions/Comments |
|---|---|
| | <p><i><u>Description:</u></i> View over Pier #16.</p> |

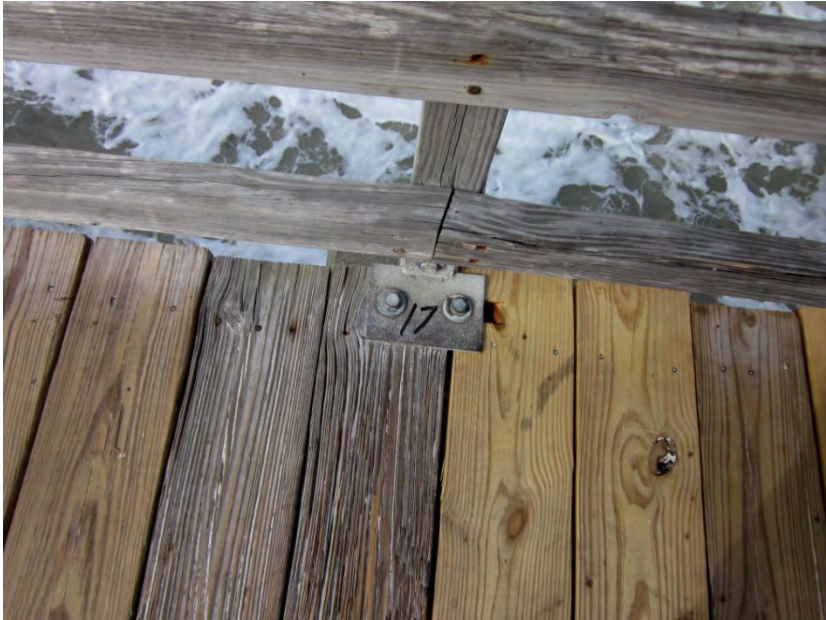
| Photo | Descriptions/Comments |
|---|---|
| | <p><i>Description:</i> View over Pier #17.</p> |

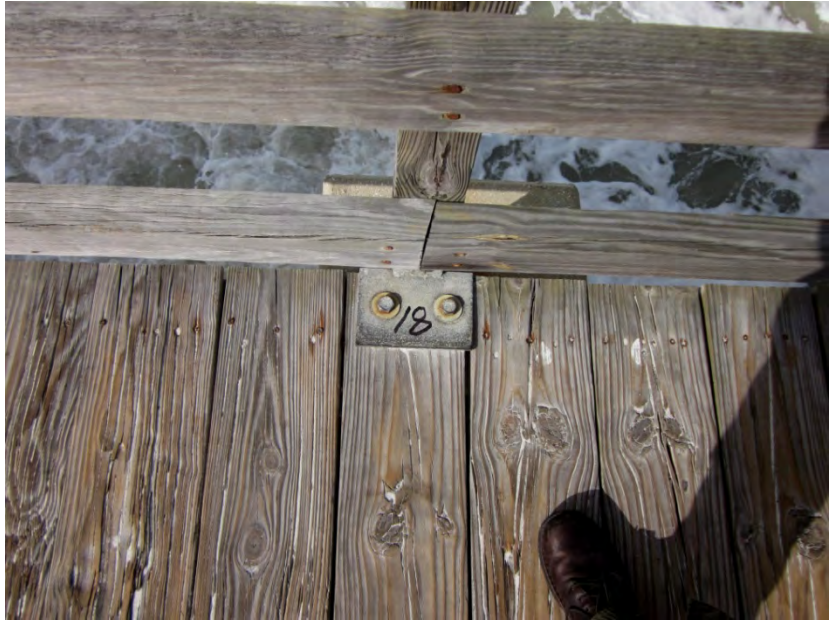
| Photo | Descriptions/Comments |
|---|---|
| | <p><i>Description:</i> View over Pier #18.</p> |

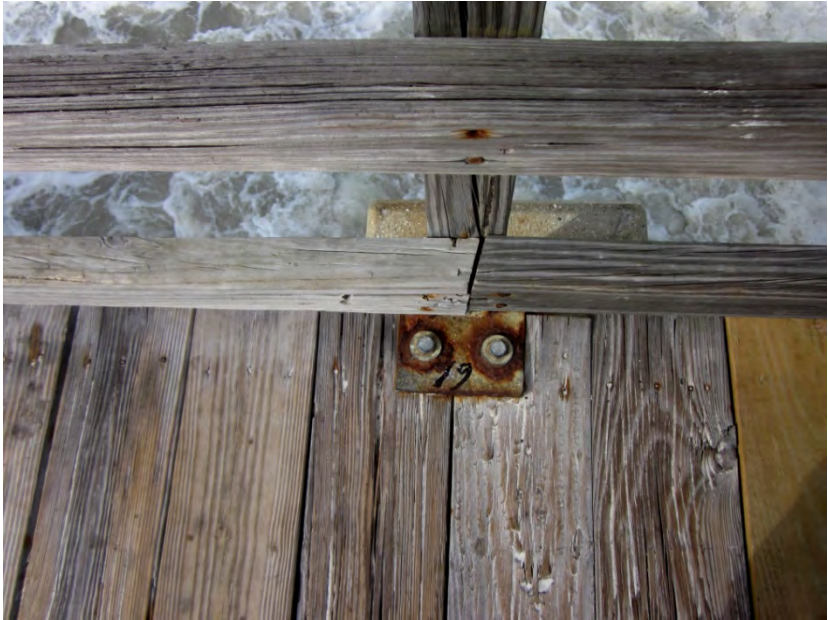
| Photo | Descriptions/Comments |
|---|---|
| | <p><i>Description:</i> View over Pier #19.</p> |

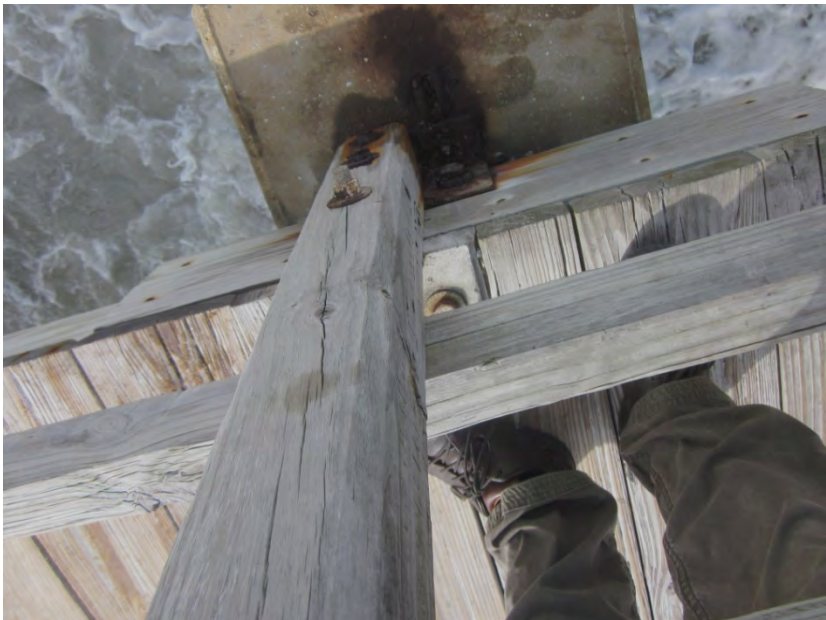
| Photo | Descriptions/Comments |
|---|---|
| | <p><b>Issue:</b> The connection assembly on the pier is the most vulnerable to sea spray that brings split and decay on wood, and promotes accelerated corrosion of metal hardware.</p> <p><b>Resolution:</b> Perform regular inspection and replace severely corroded washers and hex-nuts. In some case the galvanized clip angle may need replacement as well.</p> |
