# Pier Substructure

## City of Naples / Naples Pier

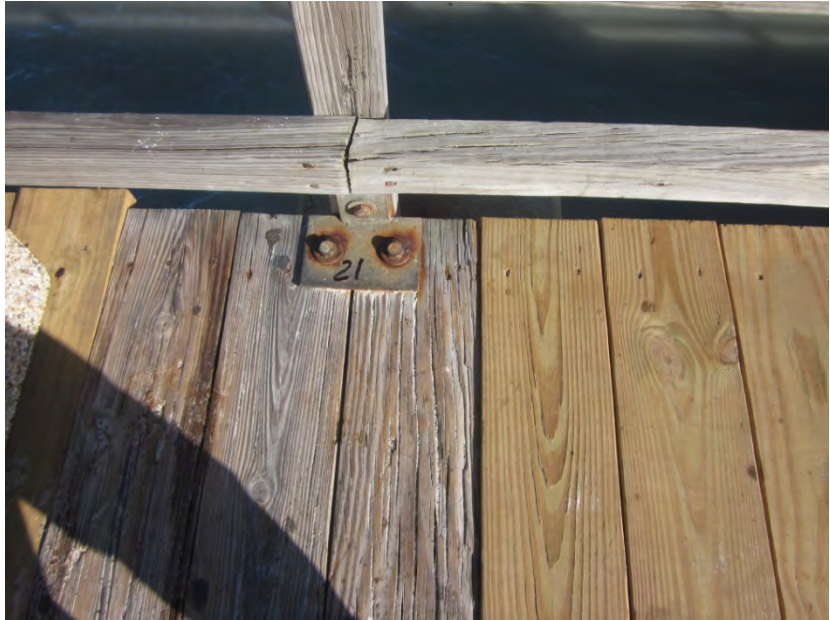
| Photo | Descriptions/Comments |
|---|---|
| | <p><b><u>Description:</u></b> View over Pier #21.</p> |

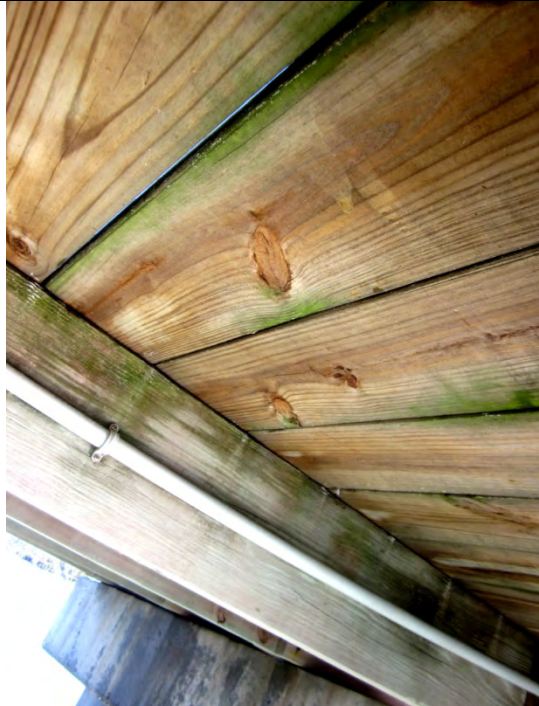
| Photo | Descriptions/Comments |
|---|---|
| | <p><b><u>Issue:</u></b> In stormy day and high waves the deck is being washed in sea spray for the duration. Note the boards are soggy from such weather event.</p> <p><b><u>Resolution:</u></b> Perform periodic inspection of the utility piping below deck. Repair/replace/remove broken piping. Provide new plastic pipe straps with better working strength and durability (i.e. more material thickness/cross-section, mass, etc).</p> |

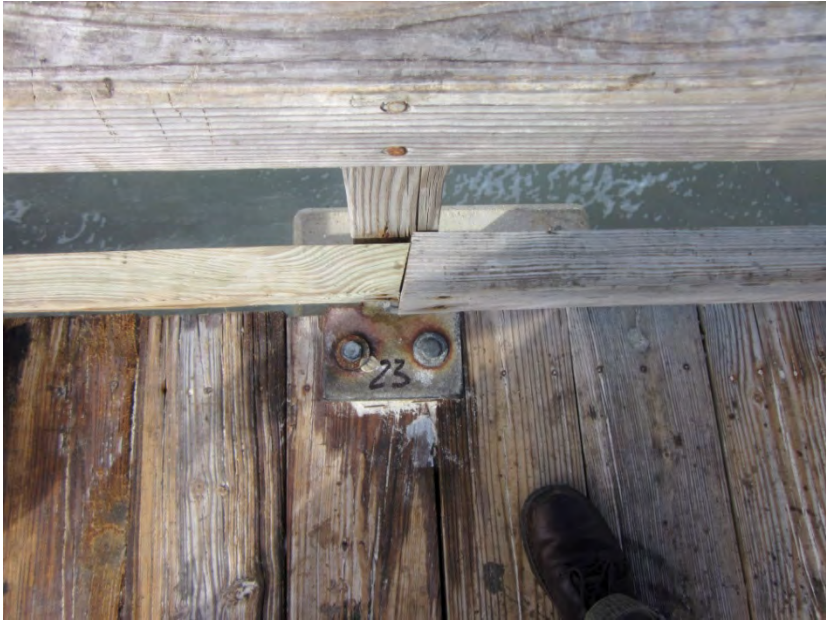
| Photo | Descriptions/Comments |
|---|---|
| | <p><b>Description:</b> View over Pier #23.</p> |

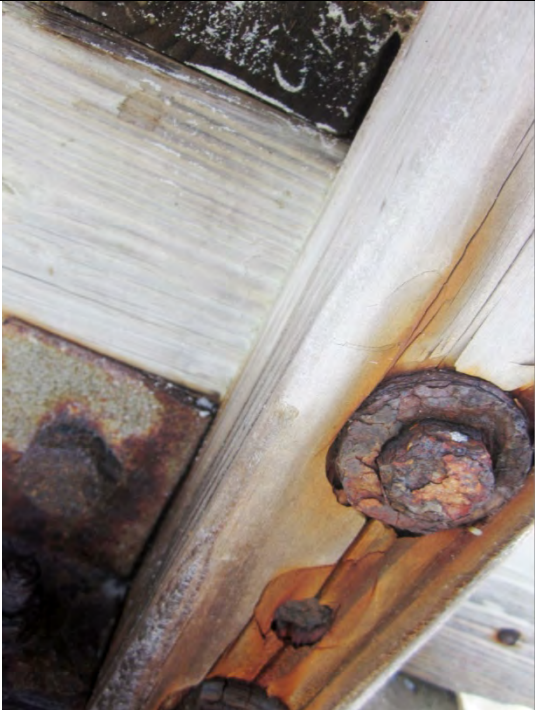
| Photo | Descriptions/Comments |
|---|---|
| | <p><b>Issue:</b> Sea spray took a heavy toll on metal hardware on the pile cap. The structural integrity and safety of the guardrail system on this part of the pier is questionable, not to mention the structural strength at the connection of the stringers to the pile cap to guard against wind uplift in future storm events.</p> <p><b>Resolution:</b> Immediately inspect/remove/replace all deteriorated metal hardware.</p> |

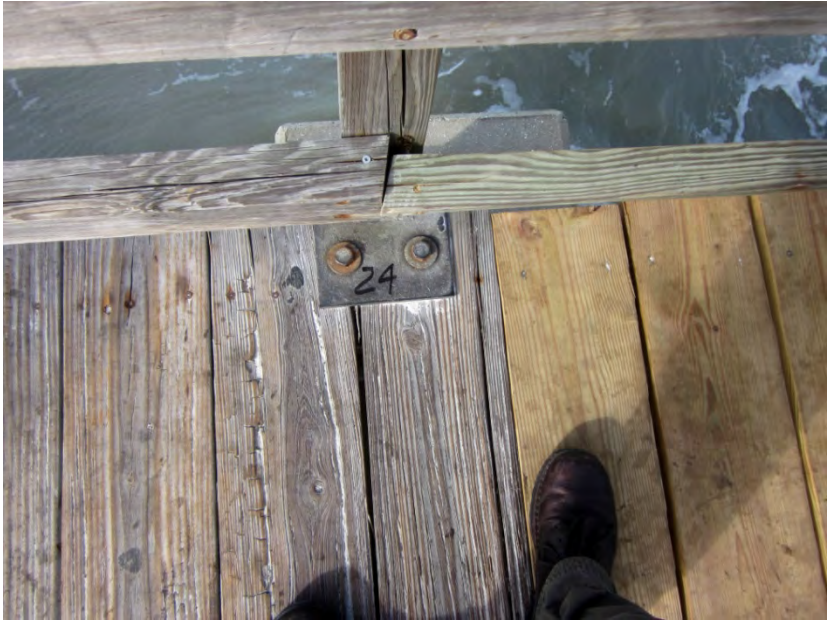
| Photo | Descriptions/Comments |
|---|---|
| | <p><b><u>Description:</u></b> View over Pier #24.</p> |

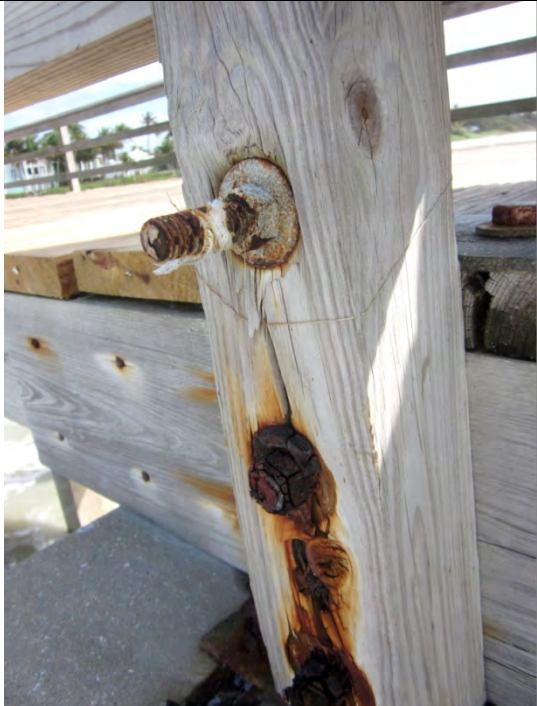
| Photo | Descriptions/Comments |
|---|---|
| | <p><b><u>Issue:</u></b> Similar pattern of rail post and thru-bolt connection issue.</p> <p><b><u>Resolution:</u></b> See preceding resolution.</p> |

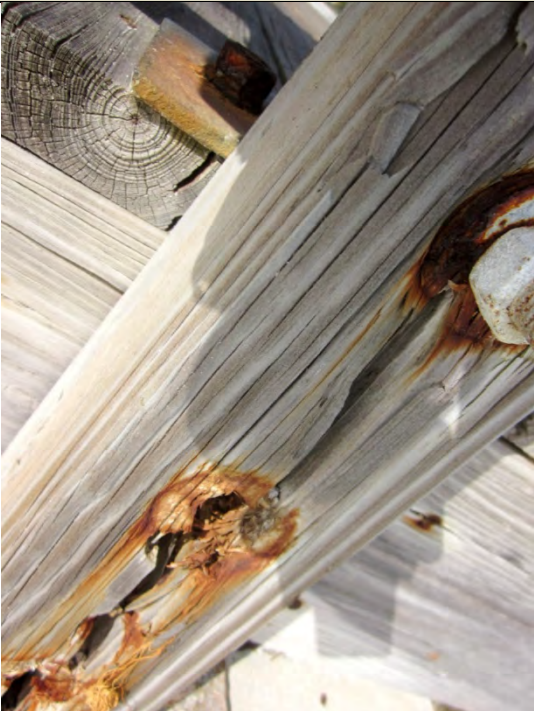
| Photo | Descriptions/Comments |
|---|---|
| | <p><b><u>Issue:</u></b> Similar pattern of rail post and thru-bolt connection issue.</p> <p>Note the middle thru-bolt connecting the rail post to the top part of the stringer is missing. The base has a wide split fiber from top bolt to bottom end.</p> <p><b><u>Resolution:</u></b> See preceding resolution.</p> |

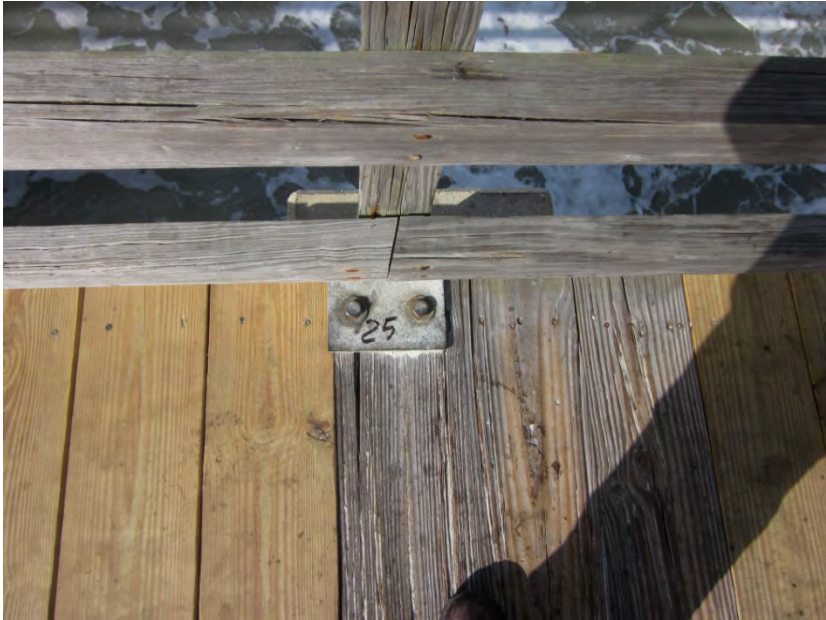
| Photo | Descriptions/Comments |
|---|---|
| | <p><i><u>Description:</u></i> View over Pier #25.</p> |

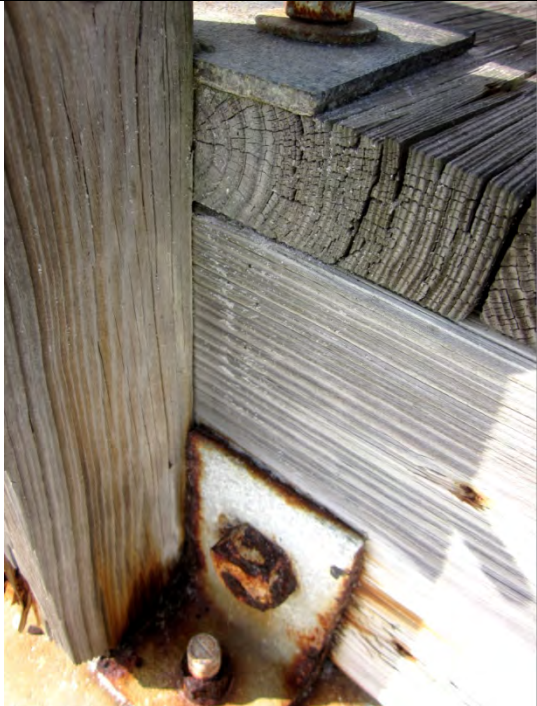
| Photo | Descriptions/Comments |
|---|---|
| | <p><i><u>Description:</u></i> Close-up view of the anchor bolt/clip angle assembly connecting the stringer to the pile cap. Note the hex-head lag screws fastening the rail post clip angle to the deck board.</p> |

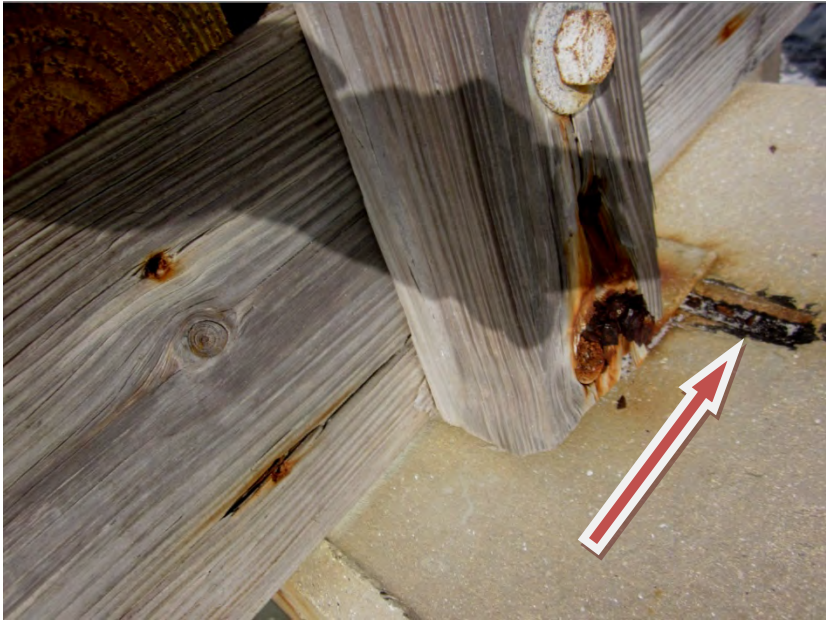
| Photo | Descriptions/Comments |
|---|---|
| | <p><b><u>Issue:</u></b> Similar pattern of rail post and thru-bolt connection issue.</p> <p>Note corrosion of the exposed adjustable-slot may preclude the provision that allows for stringer's lateral movement and adjustment.</p> <p><b><u>Resolution:</u></b> See preceding resolution.</p> |

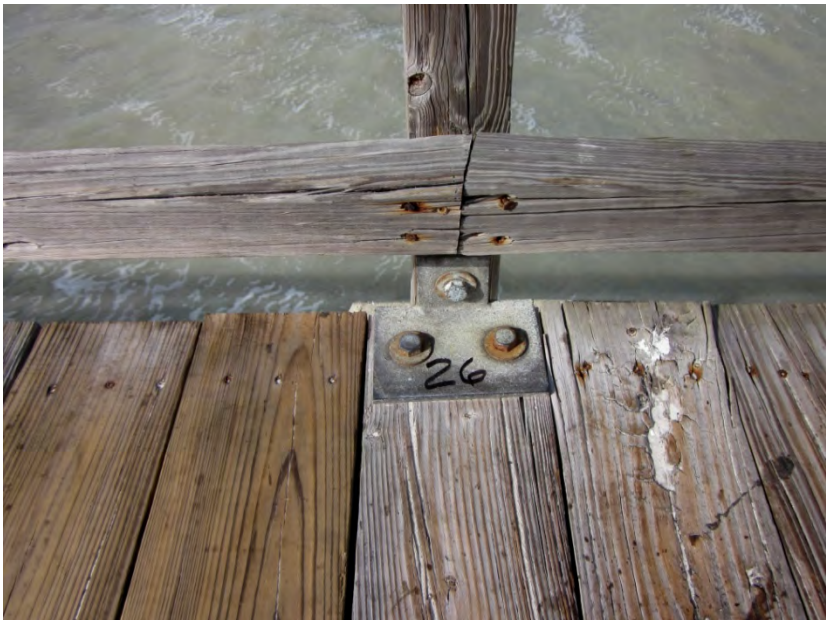
| Photo | Descriptions/Comments |
|---|---|
| | <p><b><u>Description:</u></b> View over Pier #26.</p> |

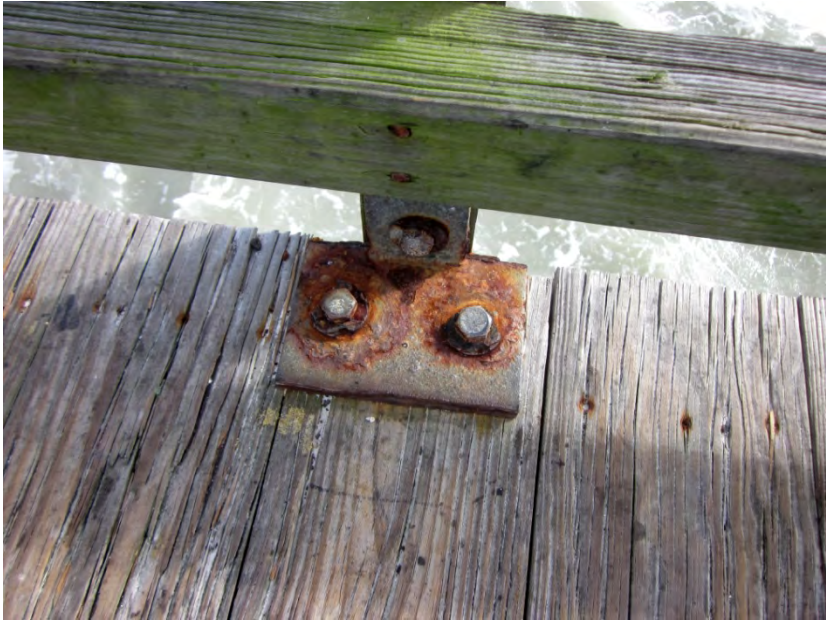
| Photo | Descriptions/Comments |
|---|---|
| | <p><b><u>Issue:</u></b> Similar pattern of rail post and thru-bolt connection issue.</p> <p>Even horizontal connection hardware is not spared by corrosion from sea spray at this post.</p> <p><b><u>Resolution:</u></b> See preceding resolution.</p> |

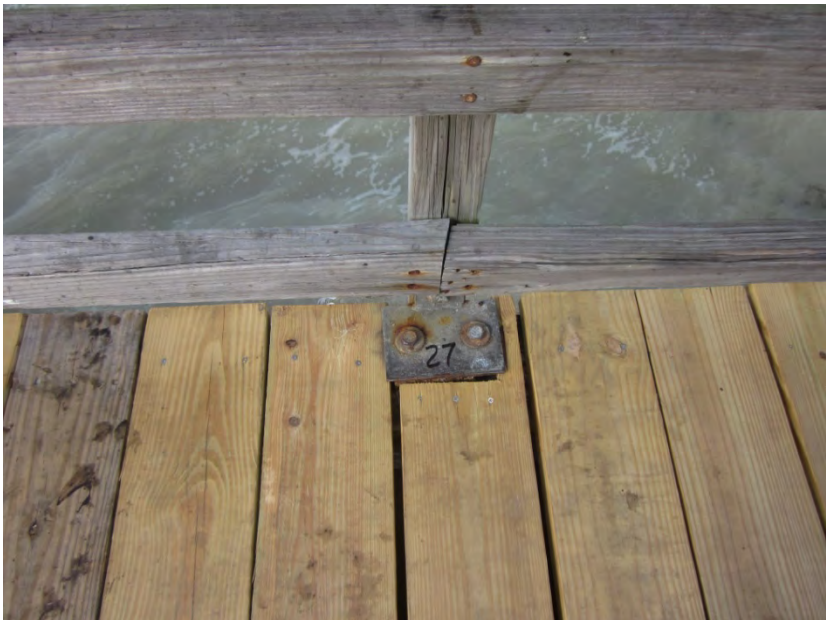
| Photo | Descriptions/Comments |
|---|---|
| | <p><b><u>Description:</u></b> View over Pier #27.</p> |

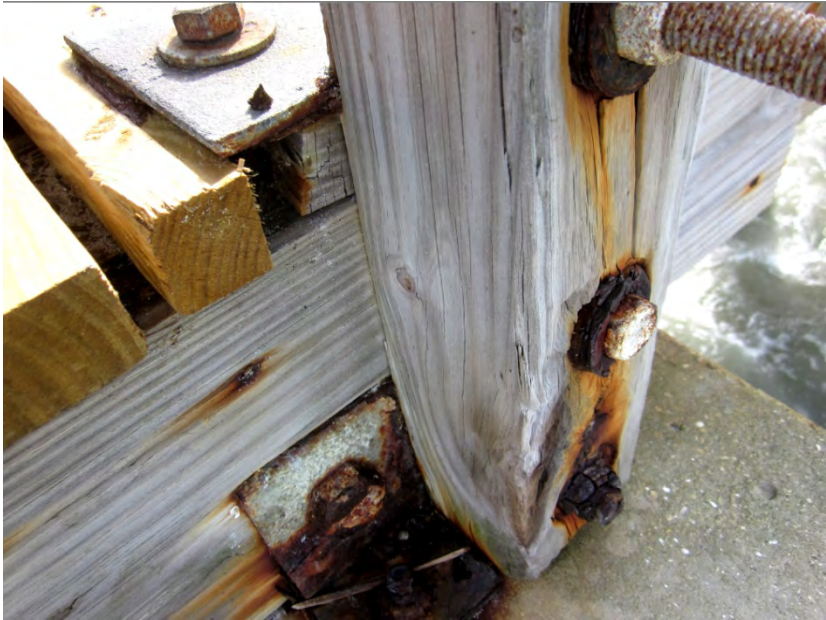
| Photo | Descriptions/Comments |
|---|---|
| | <p><b><u>Issue:</u></b> Similar pattern of rail post and thru-bolt connection issue.</p> <p><b><u>Resolution:</u></b> See preceding resolution.</p> |

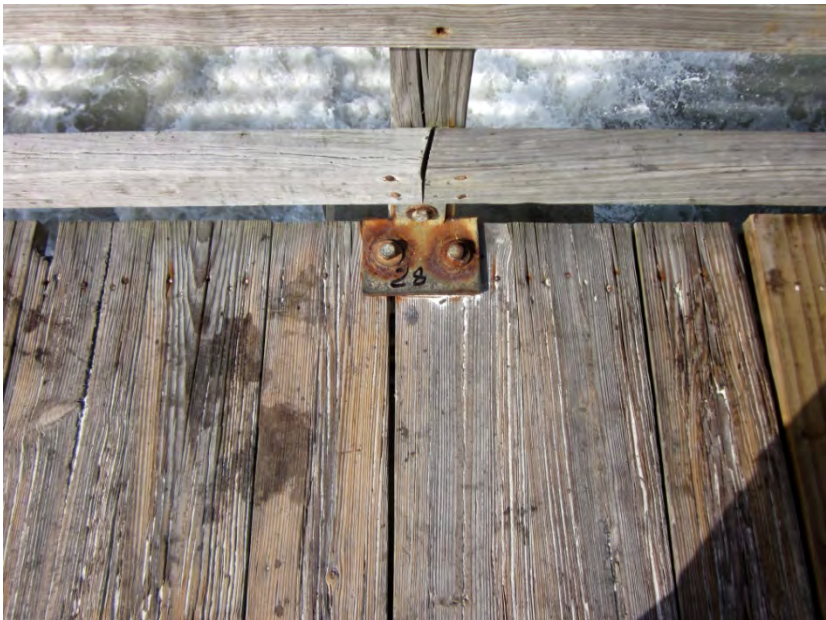
| Photo | Descriptions/Comments |
|---|---|
| | <p><b><u>Description:</u></b> View over Pier #28.</p> |

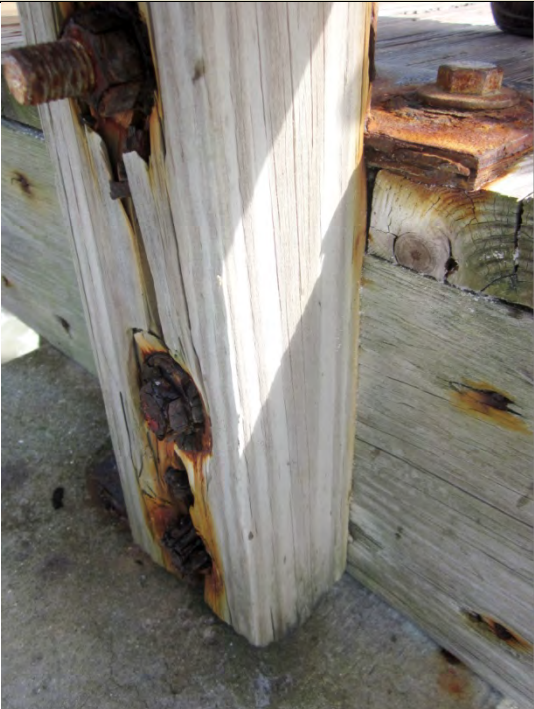
| Photo | Descriptions/Comments |
|---|---|
| | <p><b><u>Issue:</u></b> Similar pattern of rail post and thru-bolt connection issue.</p> <p>Even horizontal connection hardware is not spared by corrosion from sea spray at this post.</p> <p><b><u>Resolution:</u></b> See preceding resolution.</p> |

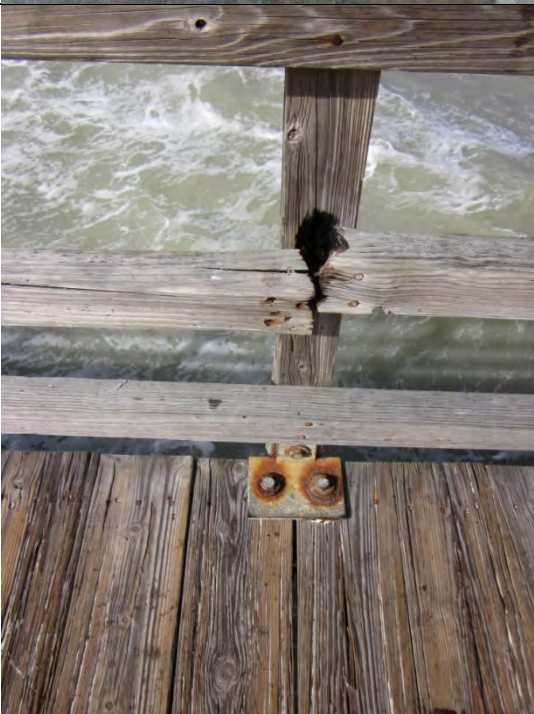
| Photo | Descriptions/Comments |
|---|---|
| | <p><b><u>Description:</u></b> Gaps between rail post and rail may look like an ideal spot to temporarily hold and/or hide a still-lit cigarette butt. Here is one of such location which accidentally caught on fire (possibly unnoticed burn) leaving a charred hollow as evidence on the post.</p> <p>Prohibiting smoking on the pier may be the ideal policy to safeguard against fire hazard by still-lit cigarette butts lodged in the wood cracks and crevices.</p> |

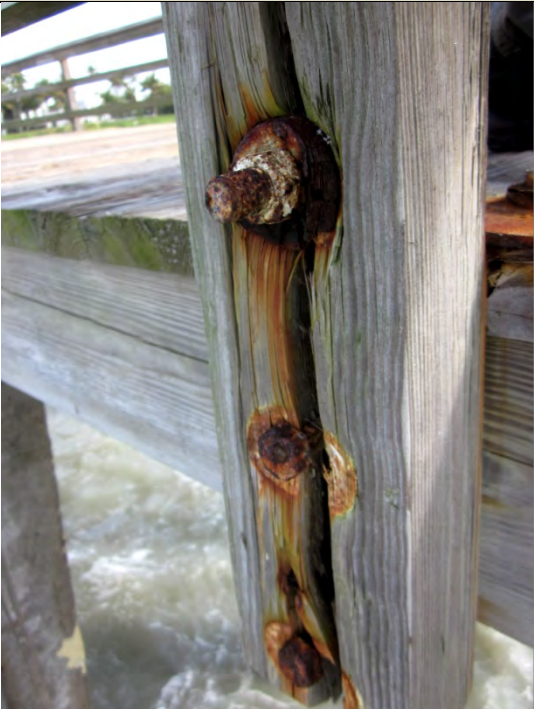
| Photo | Descriptions/Comments |
|---|---|
| | <p><b><u>Issue:</u></b> Similar pattern of rail post and thru-bolt connection issue.</p> <p><b><u>Resolution:</u></b> See preceding resolution.</p> |

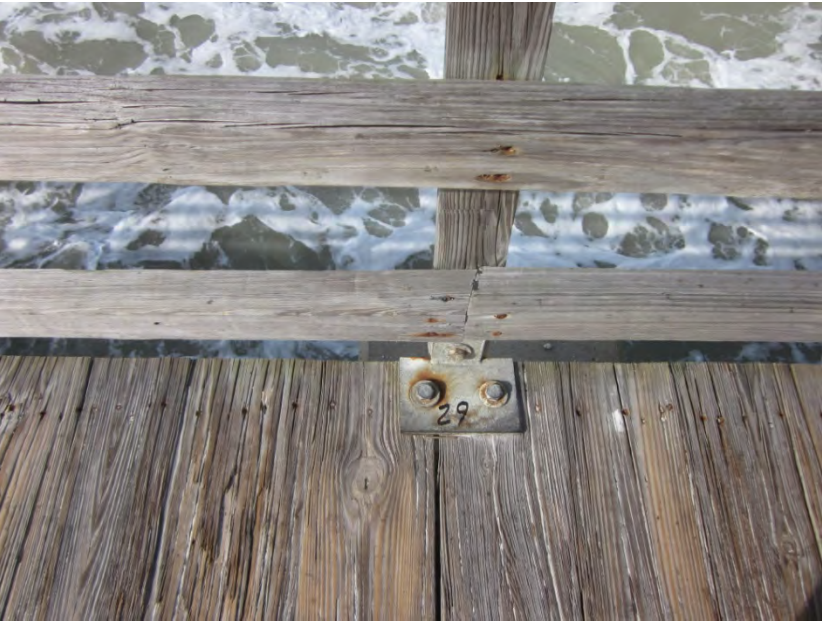
| Photo | Descriptions/Comments |
|---|---|
| | <p><b><u>Description:</u></b> View over Pier #29.</p> |

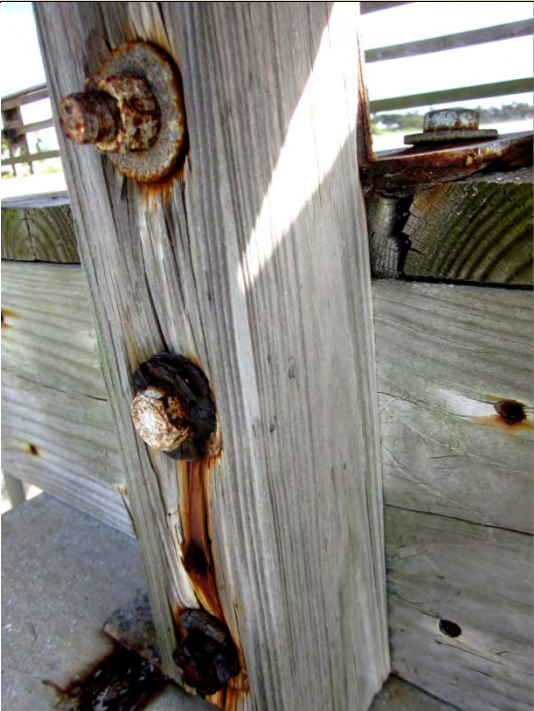
| Photo | Descriptions/Comments |
|---|---|
| | <p><b><u>Issue:</u></b> Similar pattern of rail post and thru-bolt connection issue.</p> <p><b><u>Resolution:</u></b> See preceding resolution.</p> |

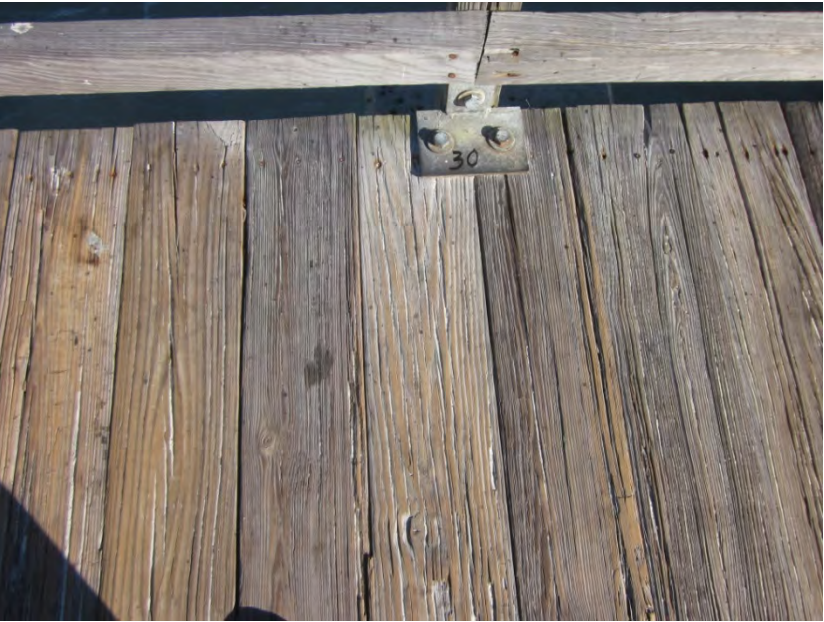
| Photo | Descriptions/Comments |
|---|---|
| | <p><b><u>Description:</u></b> View over Pier #30.</p> |

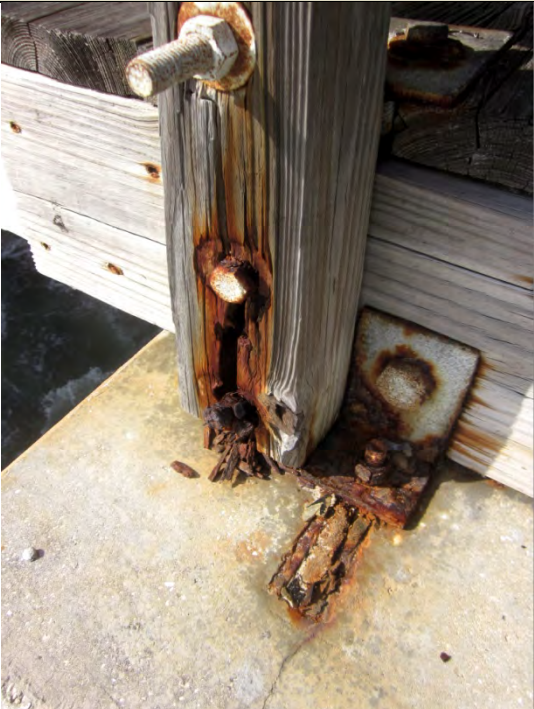
| Photo | Descriptions/Comments |
|---|---|
| | <p><b><u>Issue:</u></b> Similar pattern of rail post and thru-bolt connection issue.</p> <p>Note corrosion of the exposed adjustable-slot may preclude the provision that allows for stringer's lateral movement and adjustment.</p> <p><b><u>Resolution:</u></b> See preceding resolution.</p> |

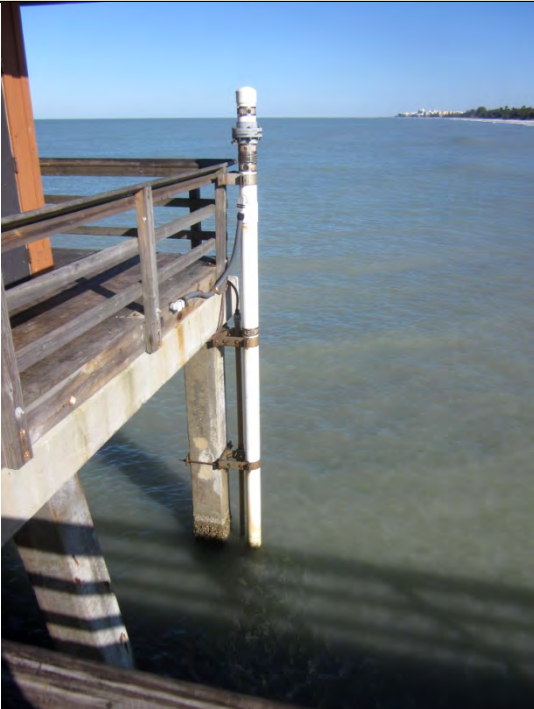
| Photo | Descriptions/Comments |
|---|---|
| | <p><b>Description:</b> View of, possibly, a tide gauge component of a weather monitoring station at the Northeast corner of the food concession pier.</p> |

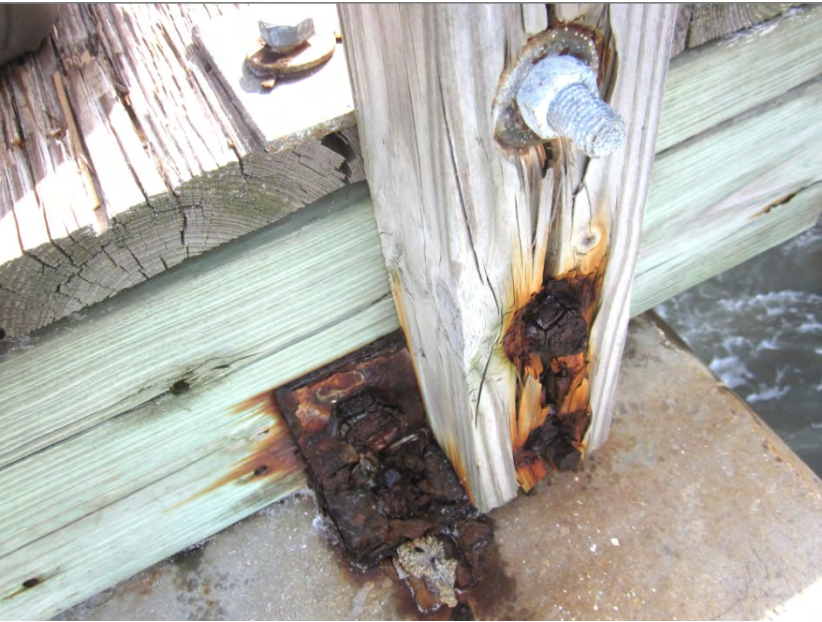
| Photo | Descriptions/Comments |
|---|---|
| | <p><b>Issue:</b> Similar pattern of rail post and thru-bolt connection issue.</p> <p><b>Resolution:</b> See preceding resolution.</p> |

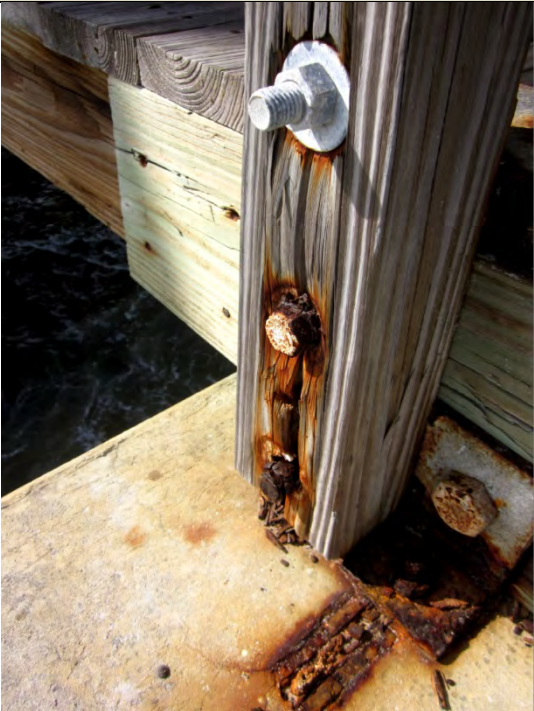
| Photo | Descriptions/Comments |
|---|---|
| | <p><b><u>Issue:</u></b> Similar pattern of rail post and thru-bolt connection issue.</p> <p>Note corrosion of the exposed adjustable-slot may preclude the provision that allows for stringer's lateral movement and adjustment.</p> <p><b><u>Resolution:</u></b> See preceding resolution.</p> |

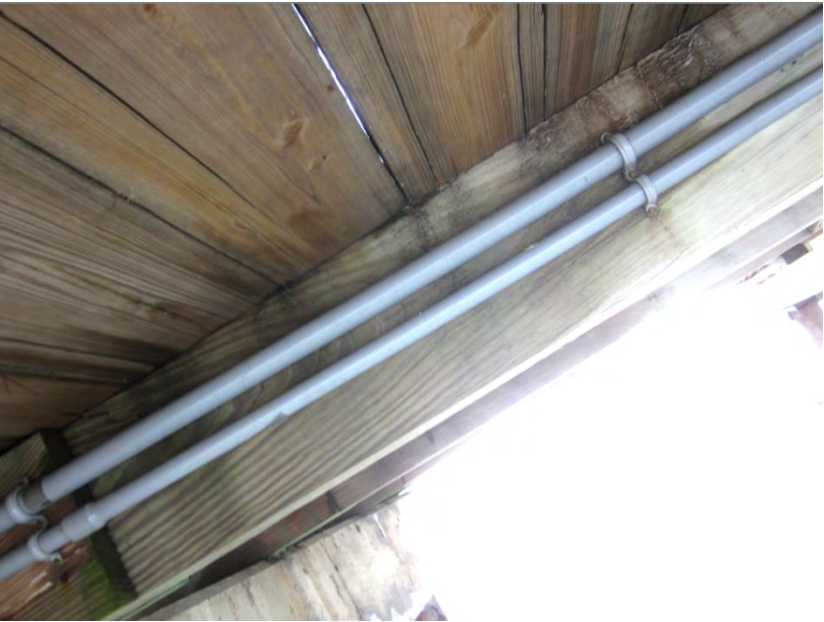
| Photo | Descriptions/Comments |
|---|---|
| | <p><b><u>Description:</u></b> Typical view of the substructure framing and the condition of the decking underside in the vicinity of Pier #32. Note the fiber split in the deck boards despite their fresh appearance. Pipe/conduit strapping is satisfactory.</p> |

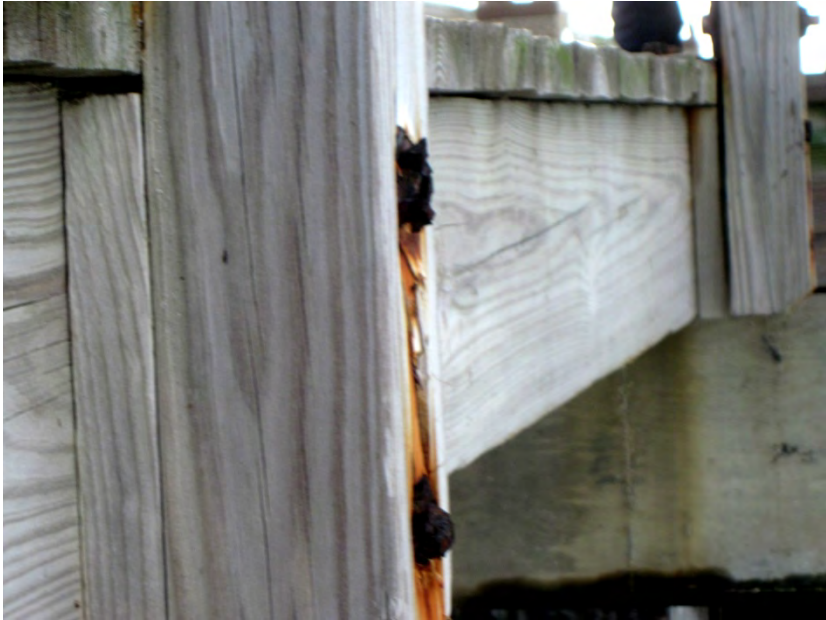
| Photo | Descriptions/Comments |
|---|---|
| | <p><b><u>Issue:</u></b> Similar pattern of rail post and thru-bolt connection issue.</p> <p><b><u>Resolution:</u></b> See preceding resolution.</p> |

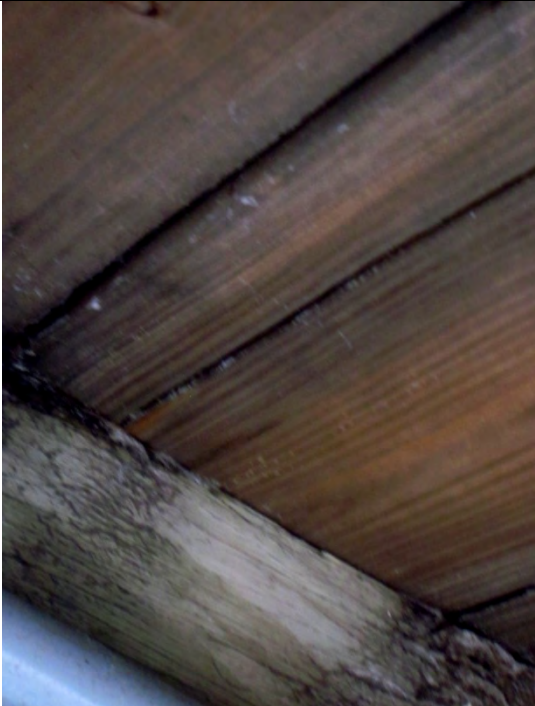
| Photo | Descriptions/Comments |
|---|---|
| | <p><b><u>Description:</u></b> Typical view of the substructure framing and the condition of the decking underside in the vicinity of Pier #32. Note the fiber split in the deck board despite its fresh appearance. Close up on the part of the stringer indicates some level of wood surface decay is taking place.</p> |

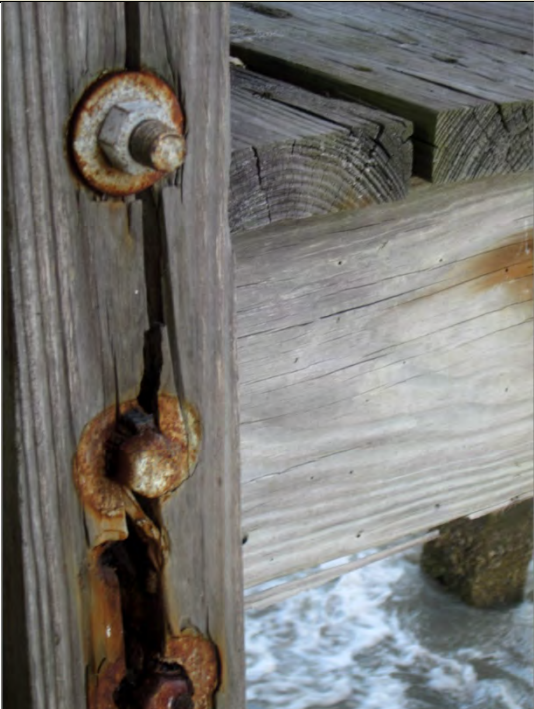
| Photo | Descriptions/Comments |
|---|---|
| | <p><b><u>Issue:</u></b> Similar pattern of rail post and thru-bolt connection issue.</p> <p><b><u>Resolution:</u></b> See preceding resolution.</p> |

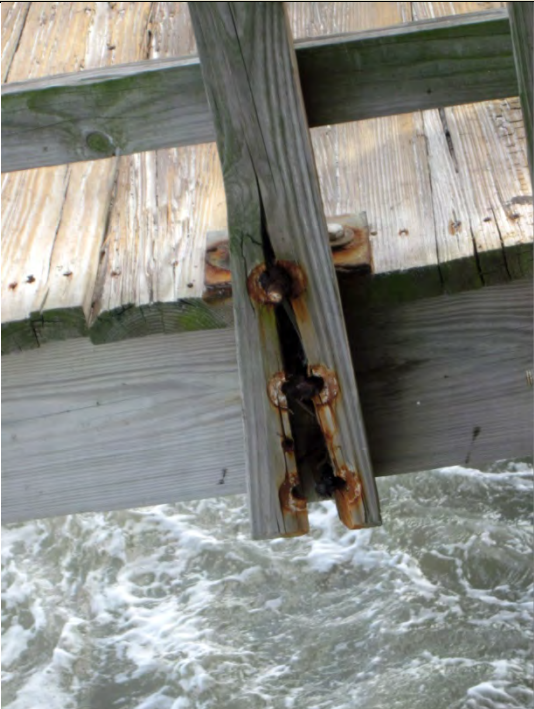
| Photo | Descriptions/Comments |
|---|---|
| | <p><b><u>Issue:</u></b> Similar pattern of rail post and thru-bolt connection issue.</p> <p><b><u>Resolution:</u></b> See preceding resolution.</p> |

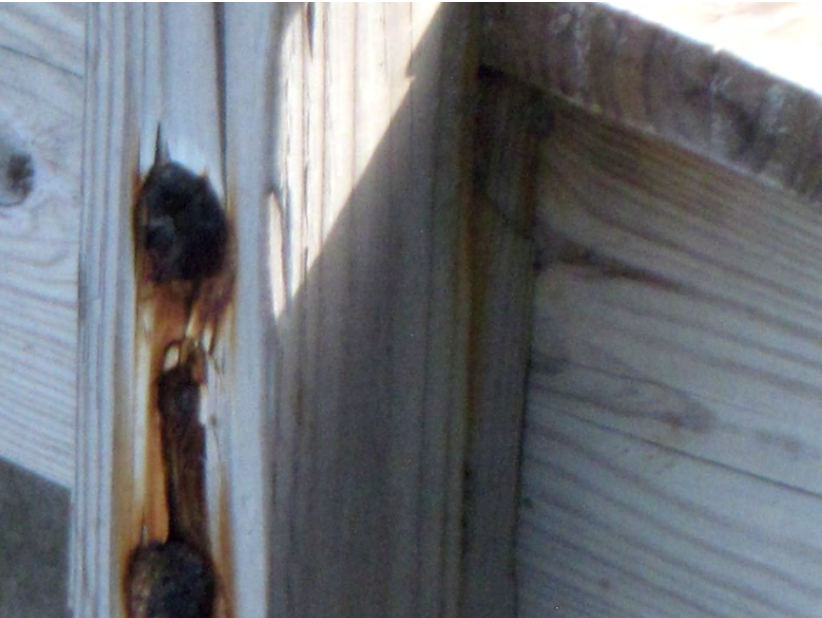
| Photo | Descriptions/Comments |
|---|---|
| | <p><b><u>Issue:</u></b> Similar pattern of rail post and thru-bolt connection issue.</p> <p><b><u>Resolution:</u></b> See preceding resolution.</p> |

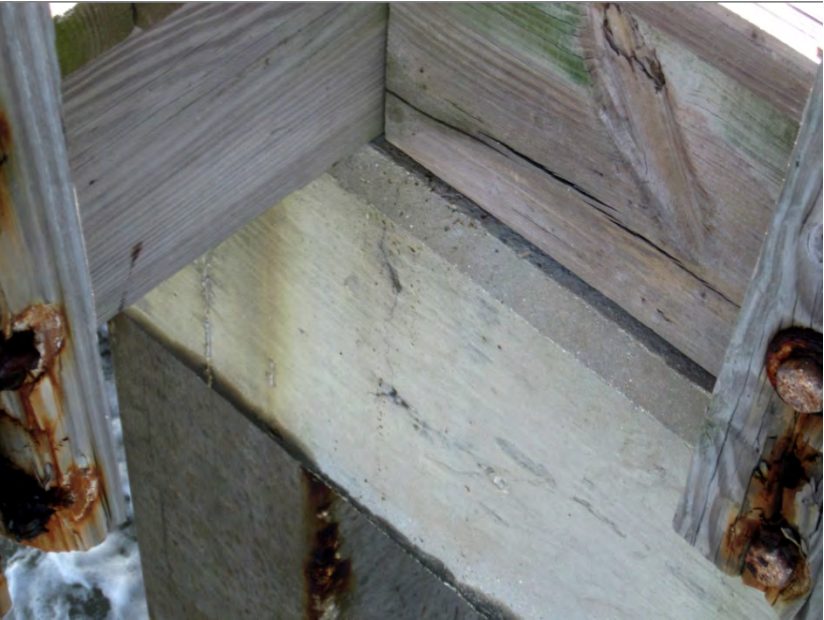
| Photo | Descriptions/Comments |
|---|---|
| | <p><b><u>Issue:</u></b> Similar pattern of rail post and thru-bolt connection issue.</p> <p><b><u>Resolution:</u></b> See preceding resolution.</p> |

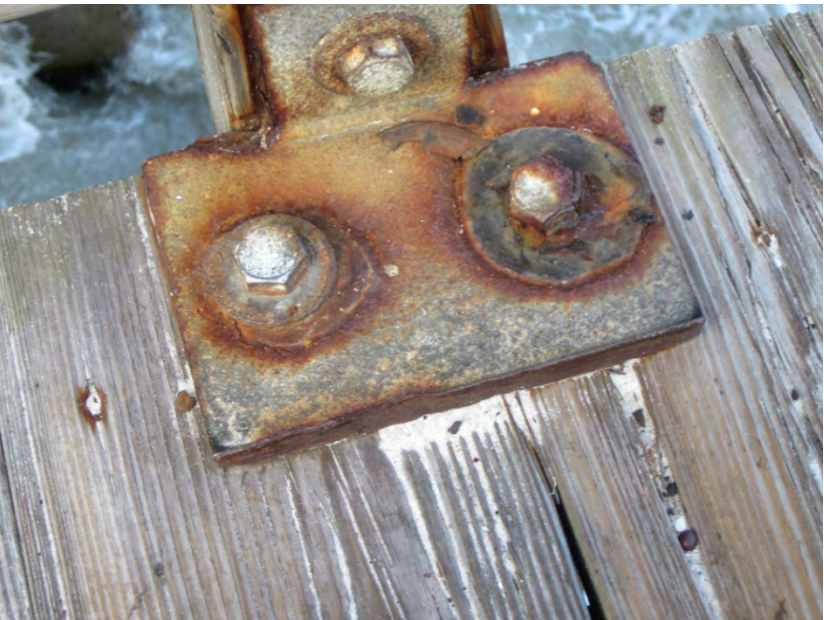
| Photo | Descriptions/Comments |
|---|---|
| | <p><b><u>Issue:</u></b> View of the post-to-deck clip angle lag screw connection undergoing early corrosion beginning with washers.</p> <p><b><u>Resolution:</u></b> See preceding resolution.</p> |

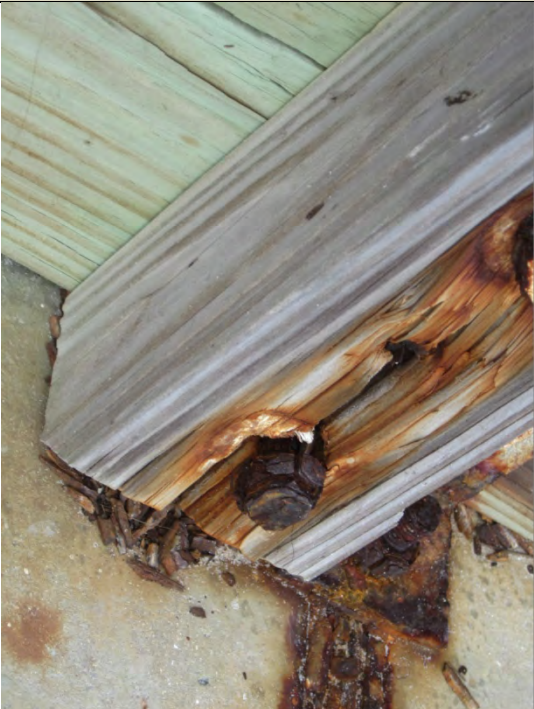
| Photo | Descriptions/Comments |
|---|---|
| | <p><b><u>Issue:</u></b> Similar pattern of rail post and thru-bolt connection issue.</p> <p>Note corrosion of the exposed adjustable-slot may preclude the provision that allows for stringer's lateral movement and adjustment.</p> <p><b><u>Resolution:</u></b> See preceding resolution.</p> |

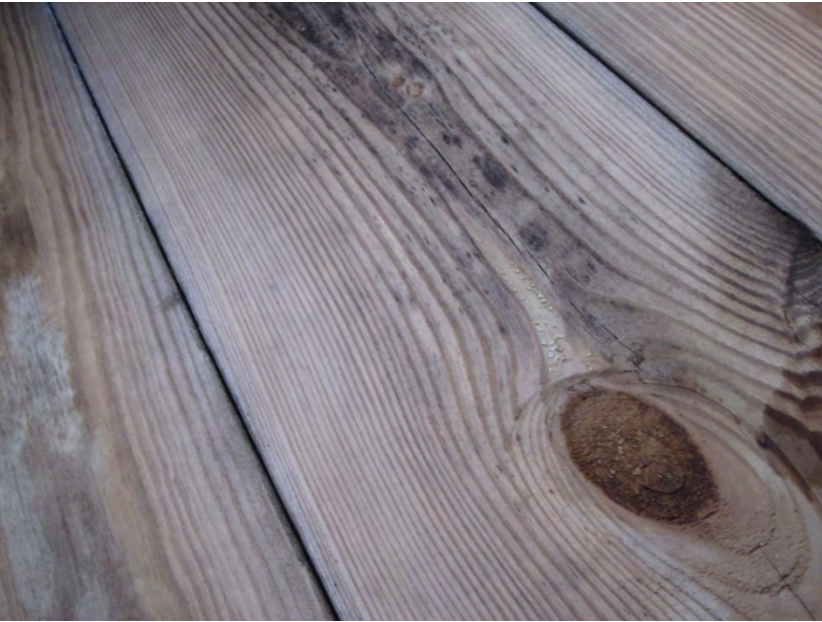
| Photo | Descriptions/Comments |
|---|---|
| | <p><b><u>Description:</u></b> Typical view of the substructure framing and the condition of the decking underside in the vicinity of Pier #31.</p> |

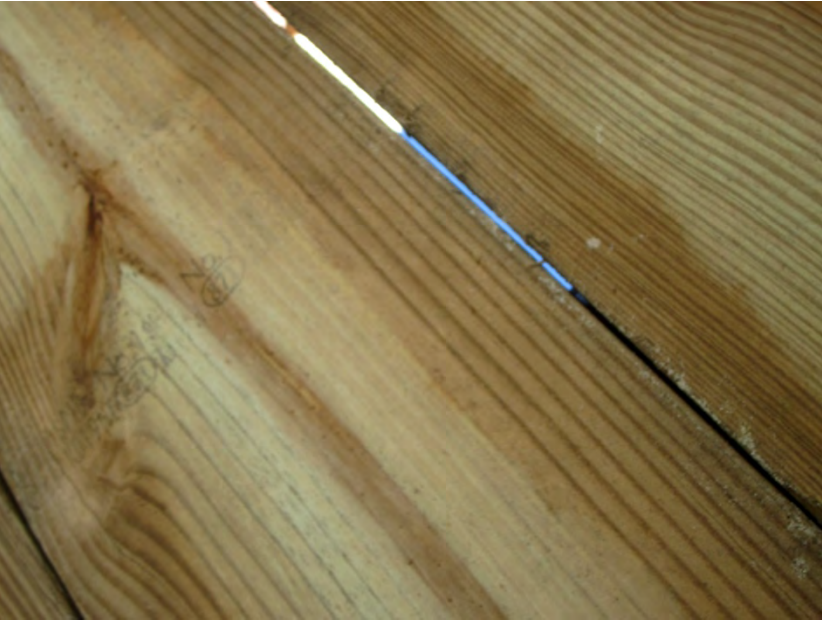
| Photo | Descriptions/Comments |
|---|---|
| | <p><b>Description:</b> Typical view of the substructure framing and the condition of the decking underside between Pier #31 and Pier #32.</p> |

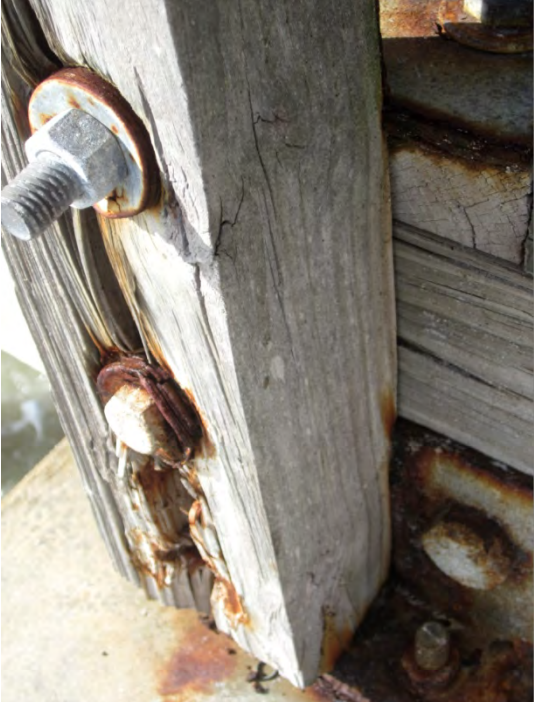
| Photo | Descriptions/Comments |
|---|---|
| | <p><b>Issue:</b> Similar pattern of rail post and thru-bolt connection issue.</p> <p><b>Resolution:</b> See preceding resolution.</p> |

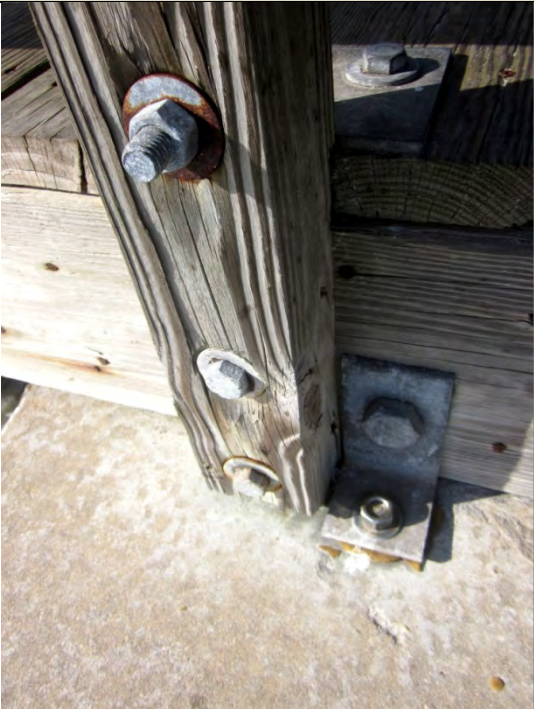
| Photo | Descriptions/Comments |
|---|---|
| | <p><b><u>Description:</u></b> Metal hardware from here onward appears to generally fare much better than the previous stations possibly due to recent repair/replacement.</p> |

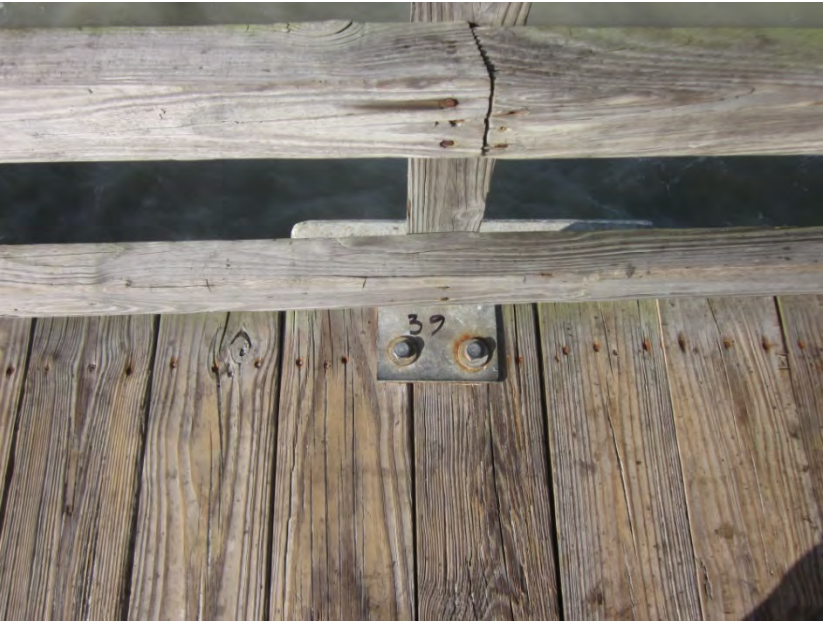
| Photo | Descriptions/Comments |
|---|---|
| | <p><b><u>Description:</u></b> View over Pier #39.</p> |

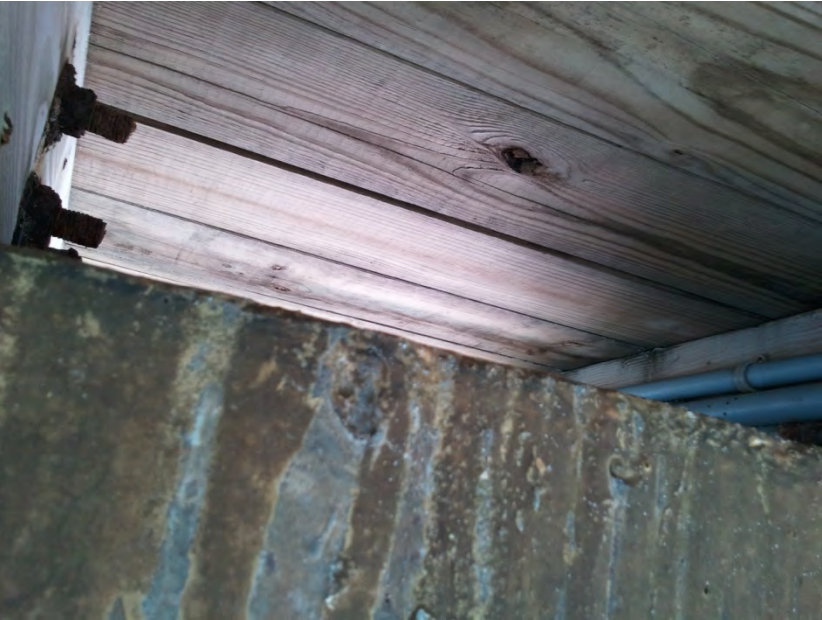
| Photo | Descriptions/Comments |
|---|---|
| | <p><b><u>Description:</u></b> View of the underside at Pier #39. Note the rail post thru-bolt connectors display only mild corrosion.</p> |

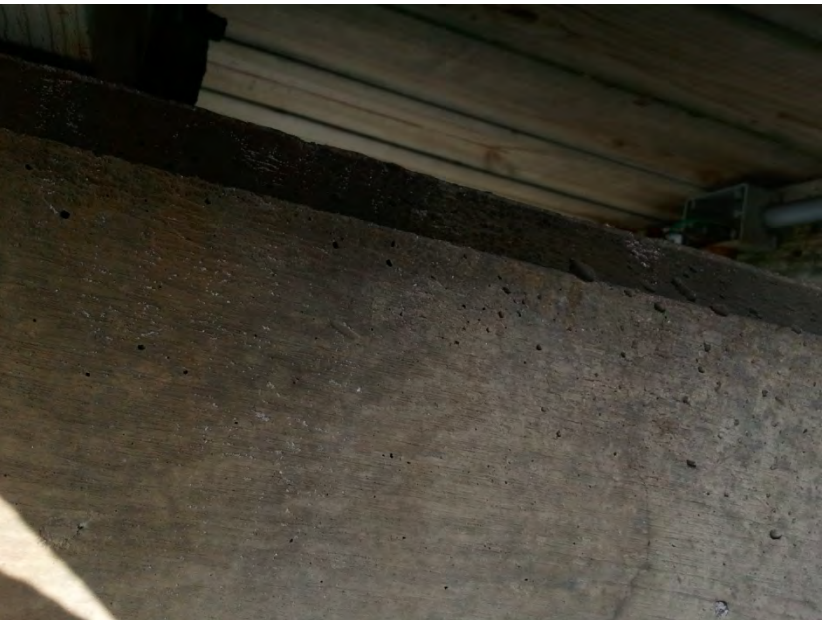
| Photo | Descriptions/Comments |
|---|---|
| | <p><b><u>Description:</u></b> View of the underside at Pier #39. Note the electrical junction box with missing cover.</p> |

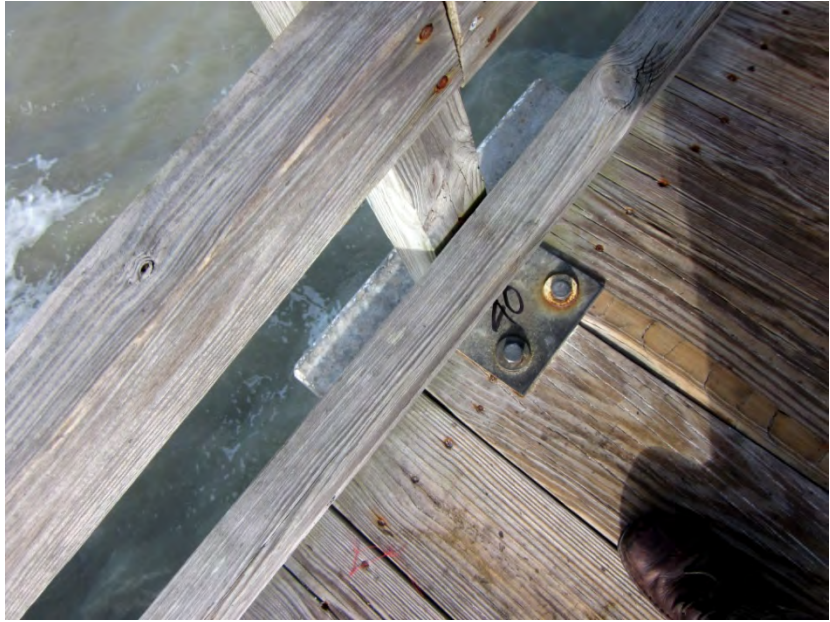
| Photo | Descriptions/Comments |
|---|---|
| | <p><i><u>Description:</u></i> View over Pier #40.</p> |

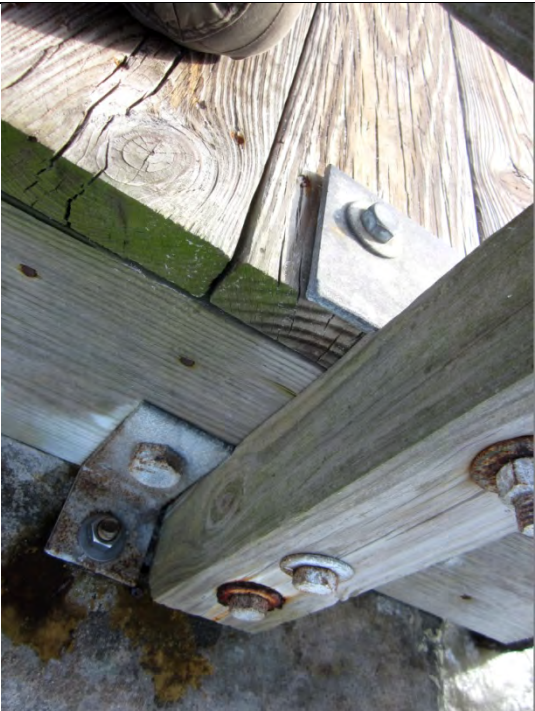
| Photo | Descriptions/Comments |
|---|---|
| | <p><i><u>Description:</u></i> Metal hardware from here onward appears to generally fare much better than the previous stations possibly due to recent repair/replacement.</p> |

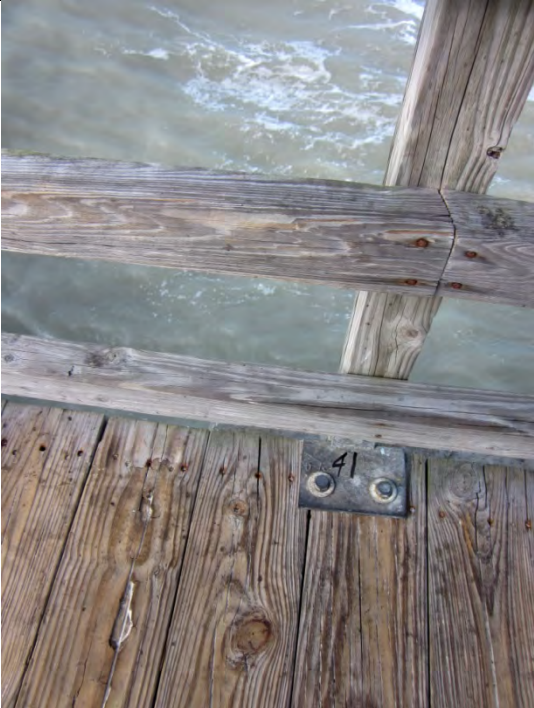
| Photo | Descriptions/Comments |
|---|---|
| | <p><b>Description:</b> View over Pier #41.</p> |
