# Pier Substructure

## City of Naples / Naples Pier

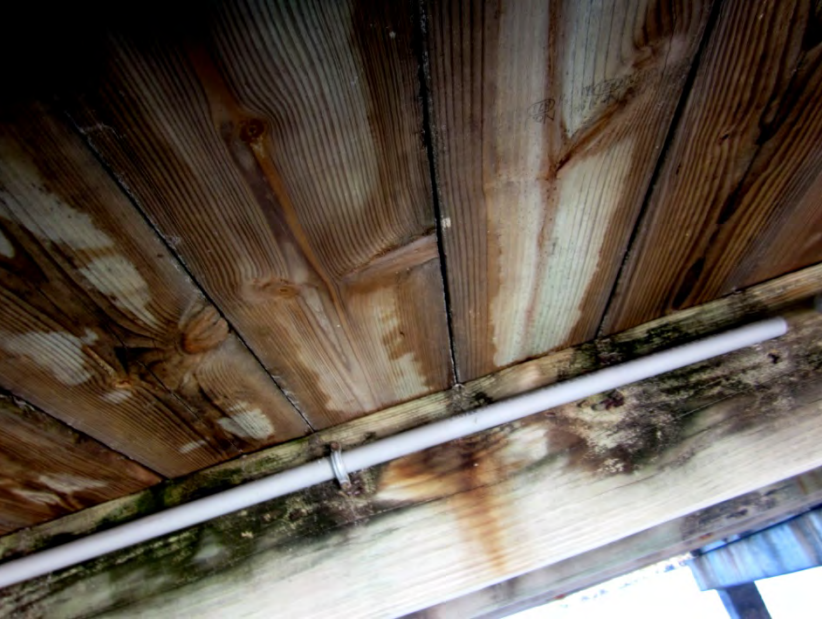
| Photo | Descriptions/Comments |
|---|---|
| | <p><b>Issue:</b> In stormy day and high waves the deck is being washed in sea spray for the duration. Note the boards are soggy from such weather event. Note the small pipe/conduit appears to have been broken off.</p> <p><b>Resolution:</b> Perform periodic inspection of the utility piping below deck. Repair/replace/remove broken piping. Provide new plastic pipe straps with better working strength and durability (i.e. more material thickness/cross-section, mass, etc).</p> |

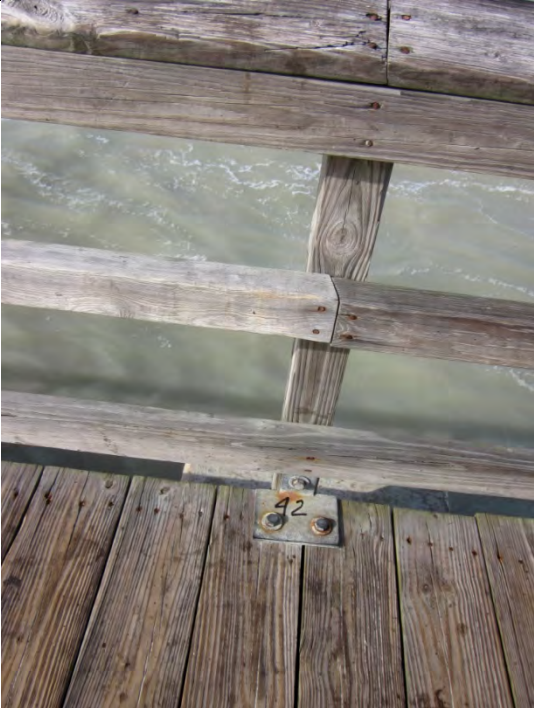
| Photo | Descriptions/Comments |
|---|---|
| | <p><i><u>Description:</u></i> View over Pier #42.</p> |

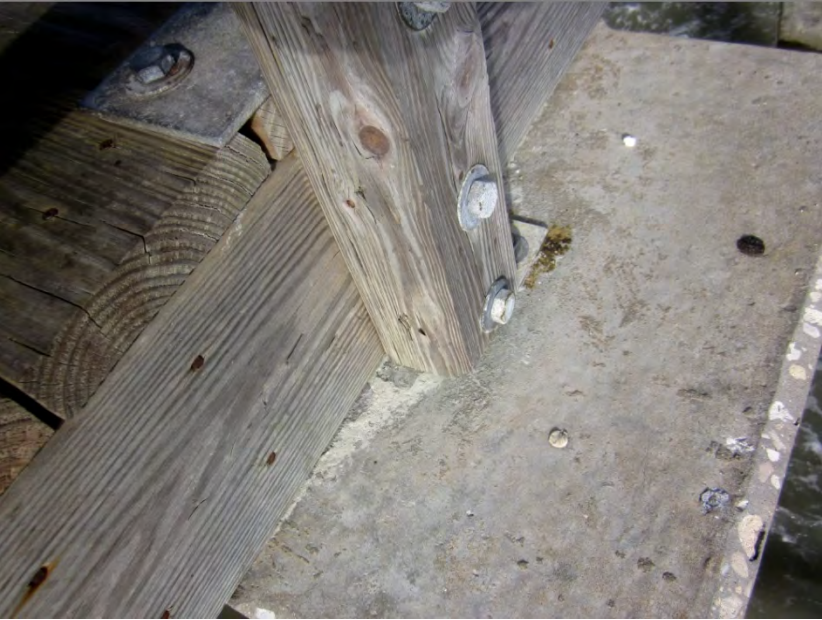
| Photo | Descriptions/Comments |
|---|---|
| | <p><i><u>Description:</u></i> Metal hardware from here onward appears to generally fare much better than the previous stations possibly due to recent repair/replacement.</p> |

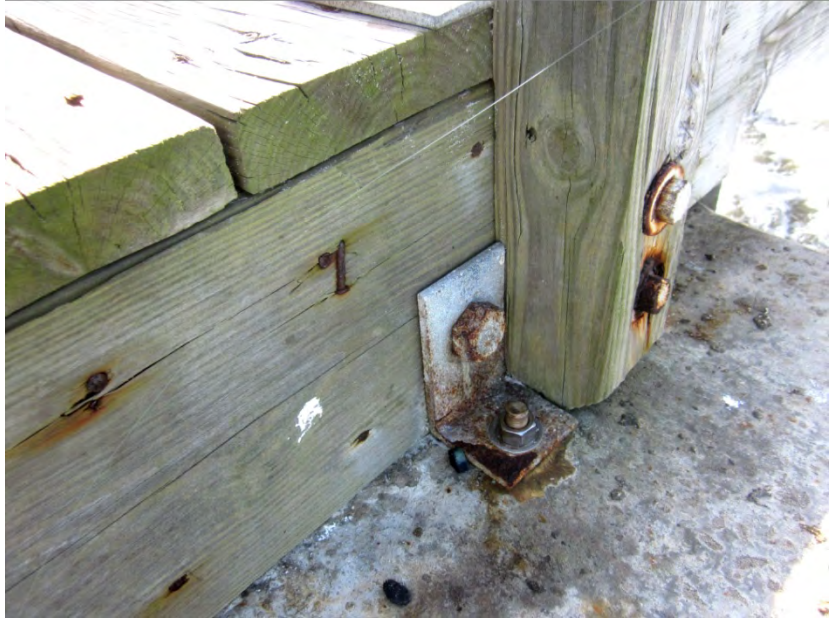
| Photo | Descriptions/Comments |
|---|---|
| | <p><b><u>Description:</u></b> Metal hardware from here onward appears to generally fare much better than the previous stations possibly due to recent repair/replacement.</p> |

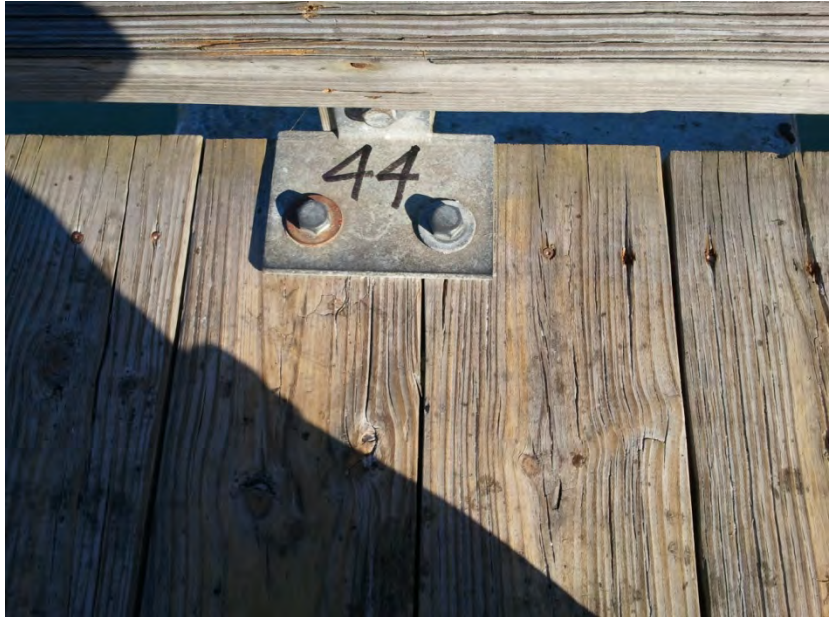
| Photo | Descriptions/Comments |
|---|---|
| | <p><b><u>Description:</u></b> View over Pier #44.</p> |

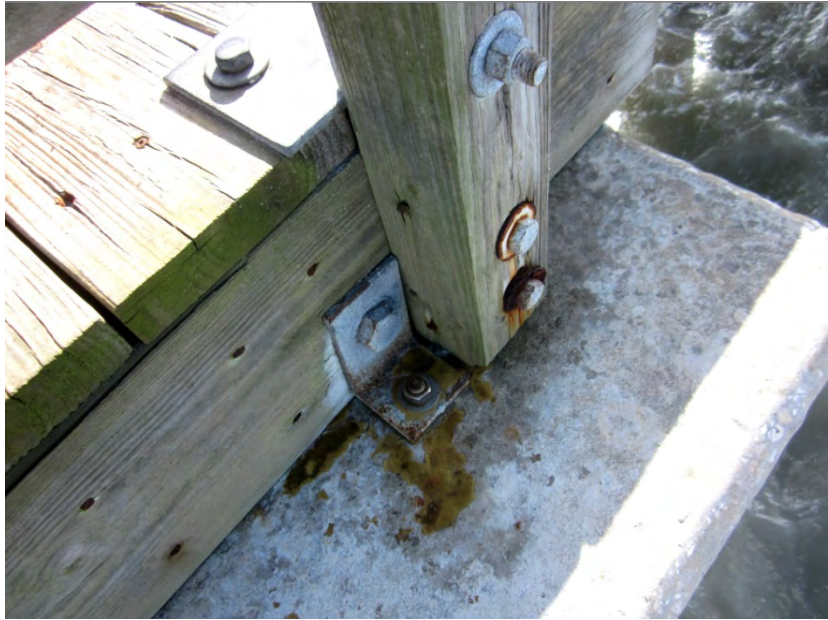
| Photo | Descriptions/Comments |
|---|---|
| | <p><b>Description:</b> Metal hardware from here onward appears to generally fare much better than the previous stations possibly due to recent repair/replacement.</p> |

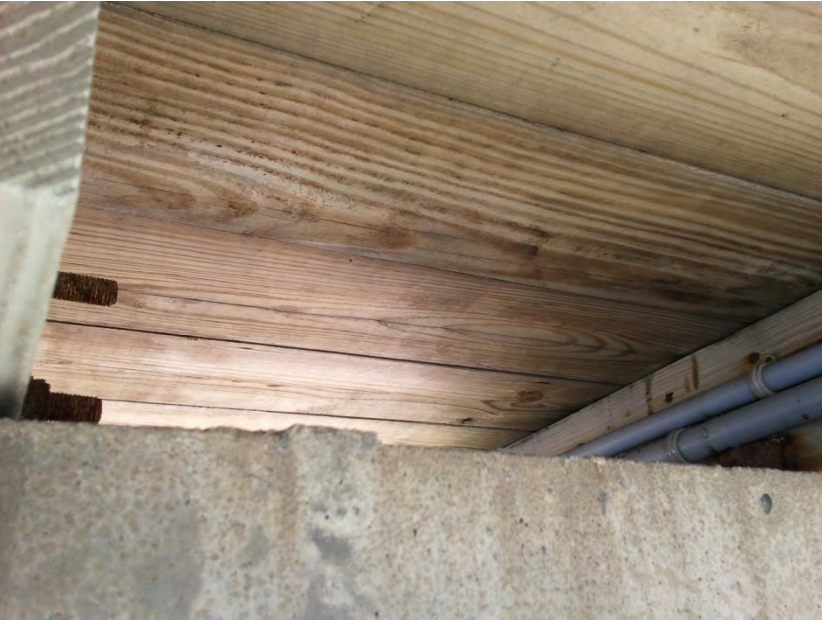
| Photo | Descriptions/Comments |
|---|---|
| | <p><b><i>Description:</i></b> View of the underside at Pier #44. Note the rail post thru-bolt connectors display only mild corrosion.</p> |

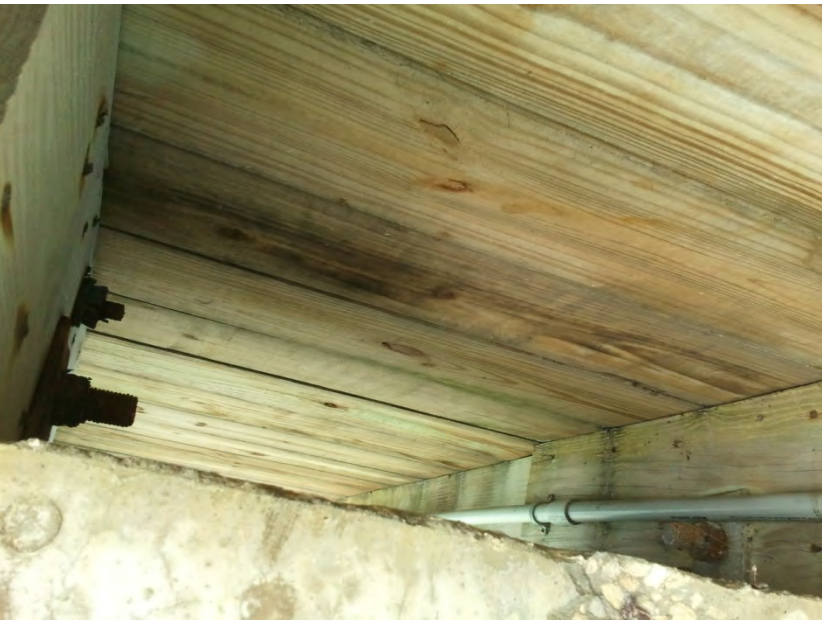
| Photo | Descriptions/Comments |
|---|---|
| | <p><b><i>Description:</i></b> View of the underside at Pier #44. Note the rail post thru-bolt connectors display only mild corrosion.</p> |

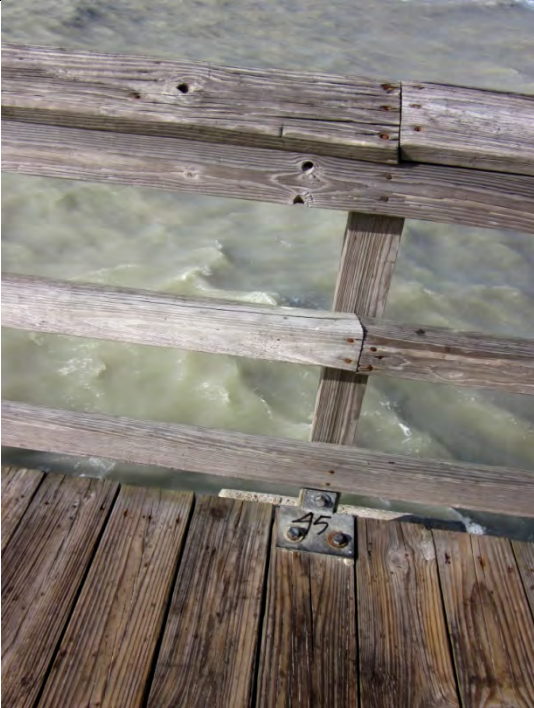
| Photo | Descriptions/Comments |
|---|---|
| | <p><i><u>Description:</u></i> View over Pier #45.</p> |

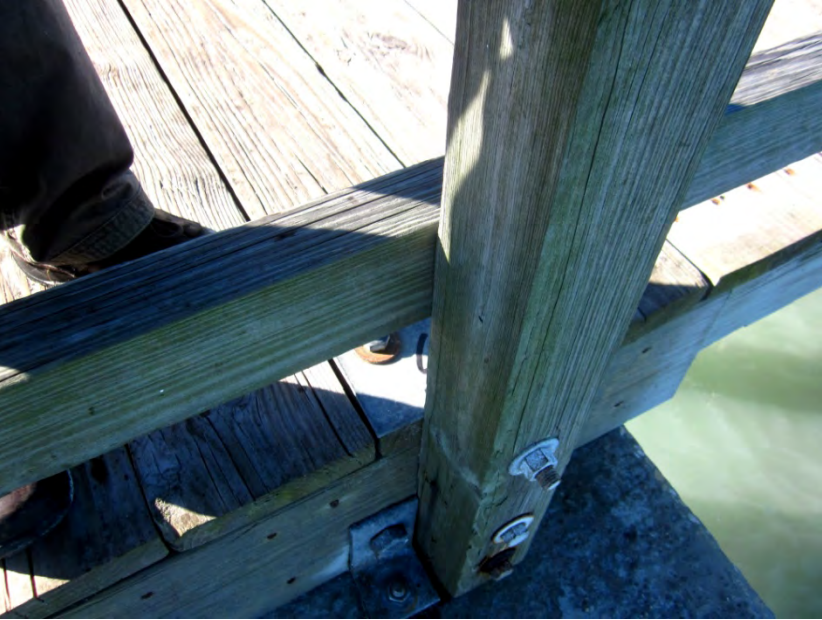
| Photo | Descriptions/Comments |
|---|---|
| | <p><i><u>Description:</u></i> Metal hardware from here onward appears to generally fare much better than the previous stations possibly due to recent repair/replacement.</p> |

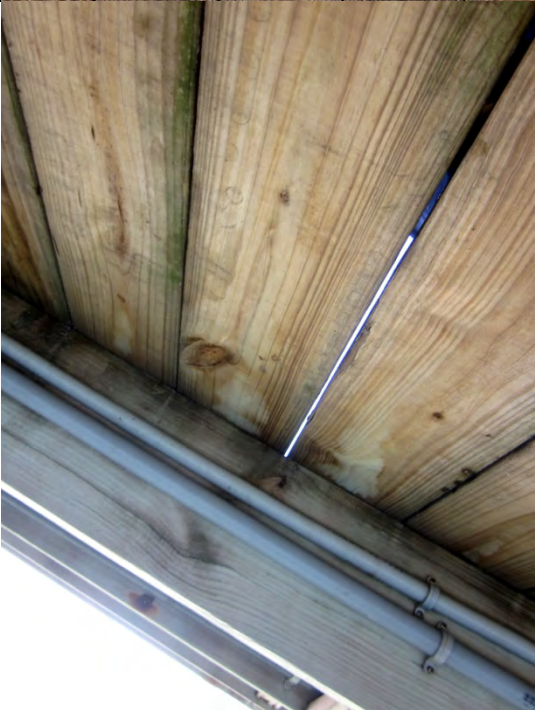
| Photo | Descriptions/Comments |
|---|---|
| | <p><b>Issue:</b> In stormy day and high waves the deck is being washed in sea spray for the duration. Note the boards are soggy from such weather event.</p> <p><b>Resolution:</b> Perform periodic inspection of the utility piping below deck. Repair/replace/remove broken piping. Provide new plastic pipe straps with better working strength and durability (i.e. more material thickness/cross-section, mass, etc).</p> |

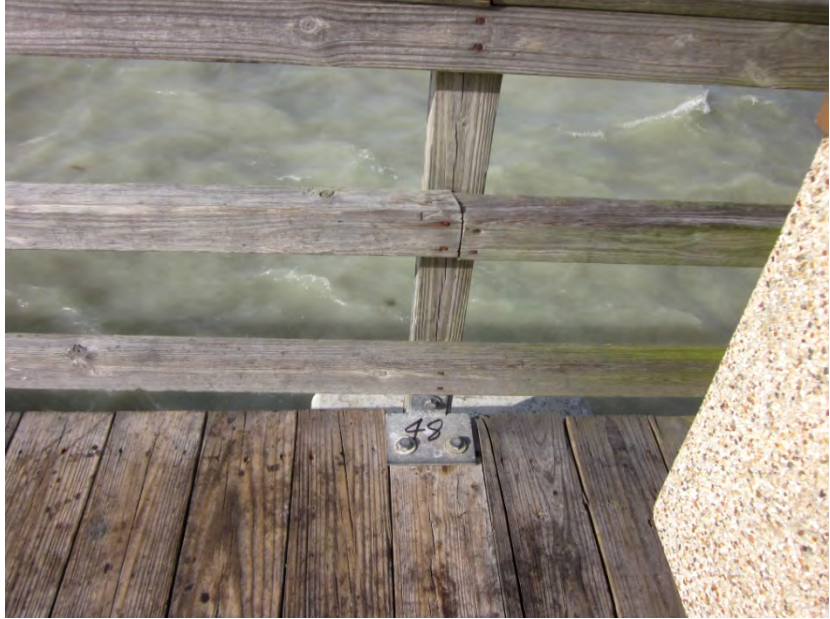
| Photo | Descriptions/Comments |
|---|---|
| | <p><b>Description:</b> View over Pier #48.</p> |

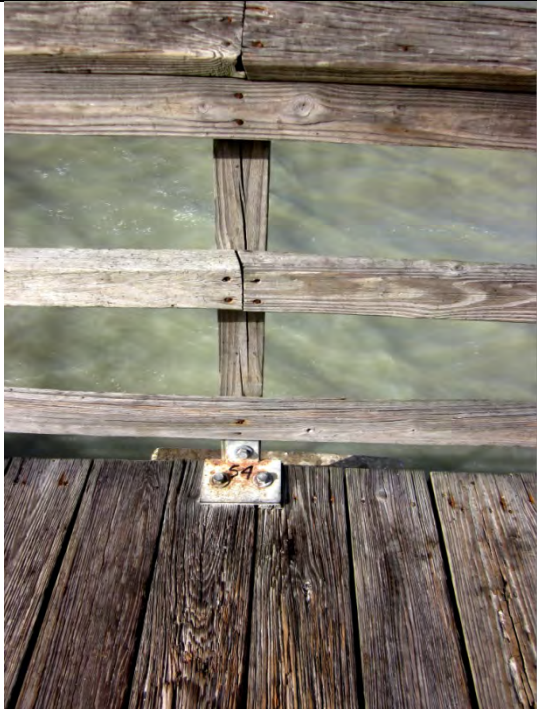
| Photo | Descriptions/Comments |
|---|---|
| | <p><i><u>Description:</u></i> View over Pier #54.</p> |

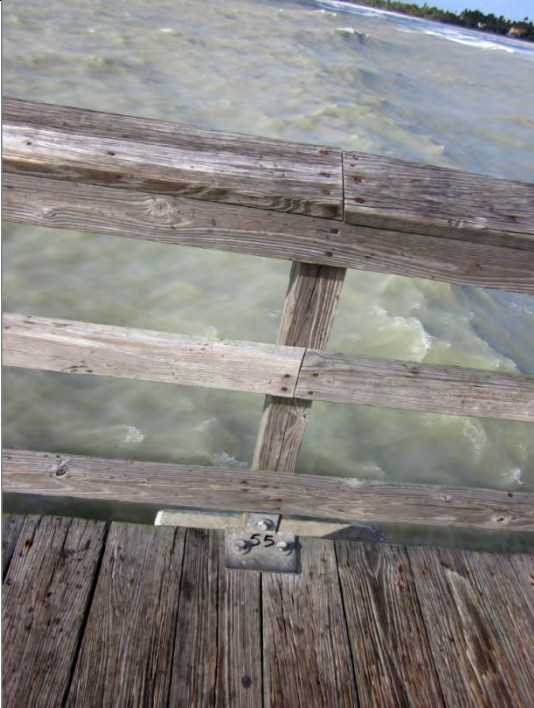
| Photo | Descriptions/Comments |
|---|---|
| | <p><i><u>Description:</u></i> View over Pier #55.</p> |

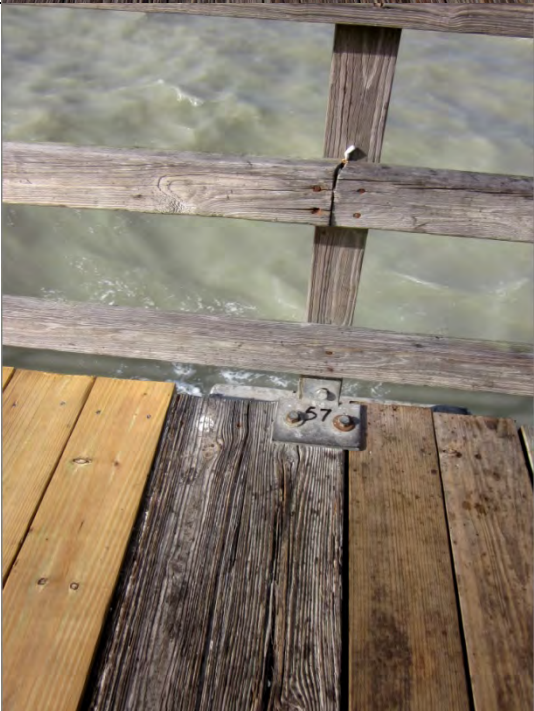
| Photo | Descriptions/Comments |
|---|---|
| | <p><i><u>Description:</u></i> View over Pier #57. Note the decaying board beside new replacement boards.</p> |

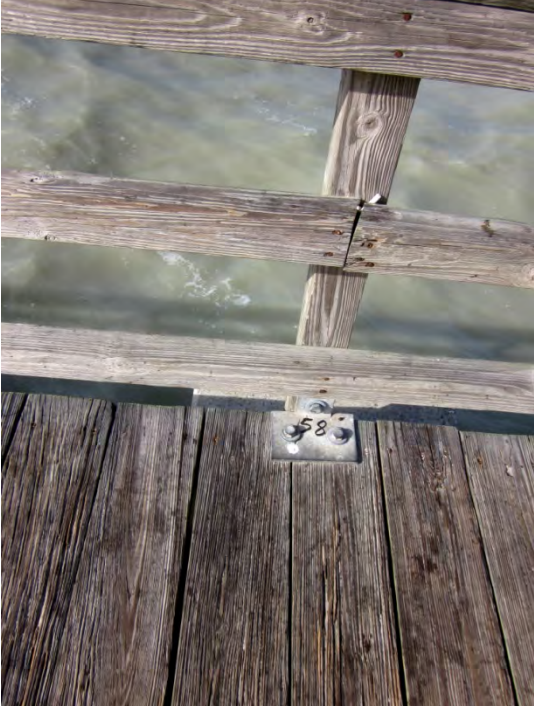
| Photo | Descriptions/Comments |
|---|---|
| | <p><i><u>Description:</u></i> View over Pier #58.</p> |

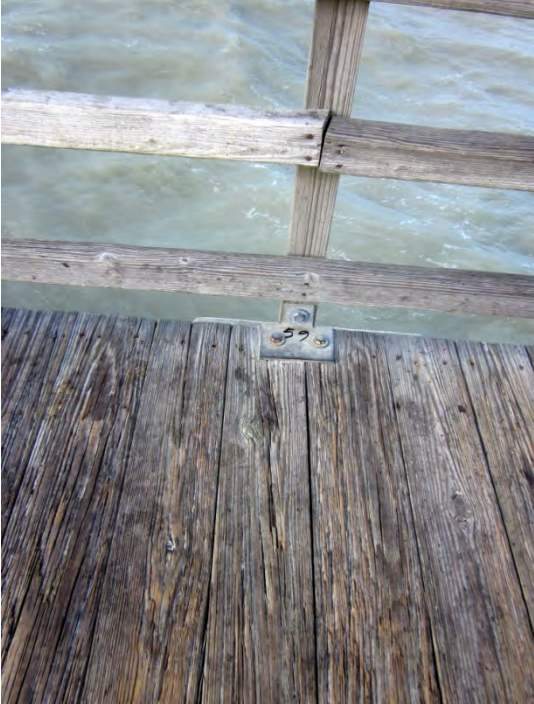
| Photo | Descriptions/Comments |
|---|---|
| | <p><i><u>Description:</u></i> View over Pier #59.</p> |

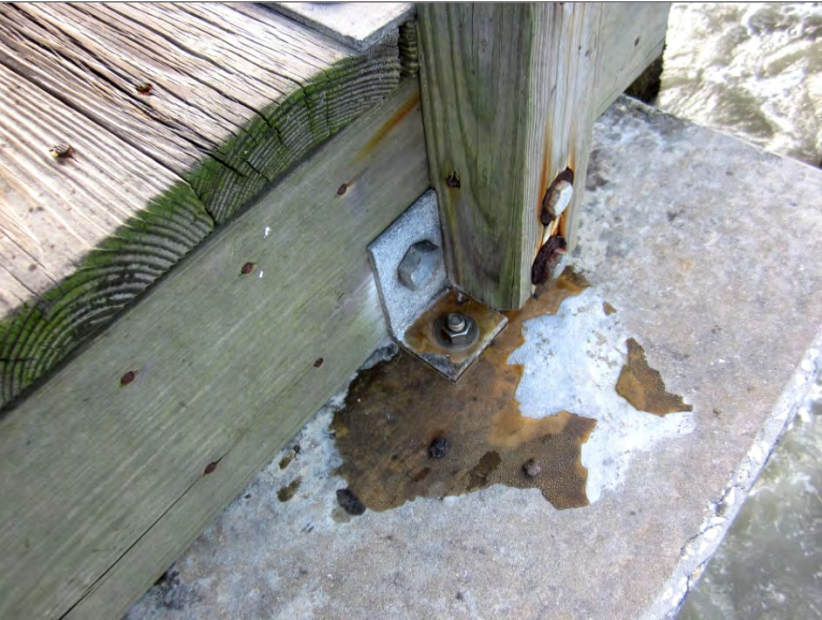
| Photo | Descriptions/Comments |
|---|---|
| | <p><b><i>Description:</i></b> Metal hardware from here onward appears to generally fare much better than the previous stations possibly due to recent repair/replacement.</p> |

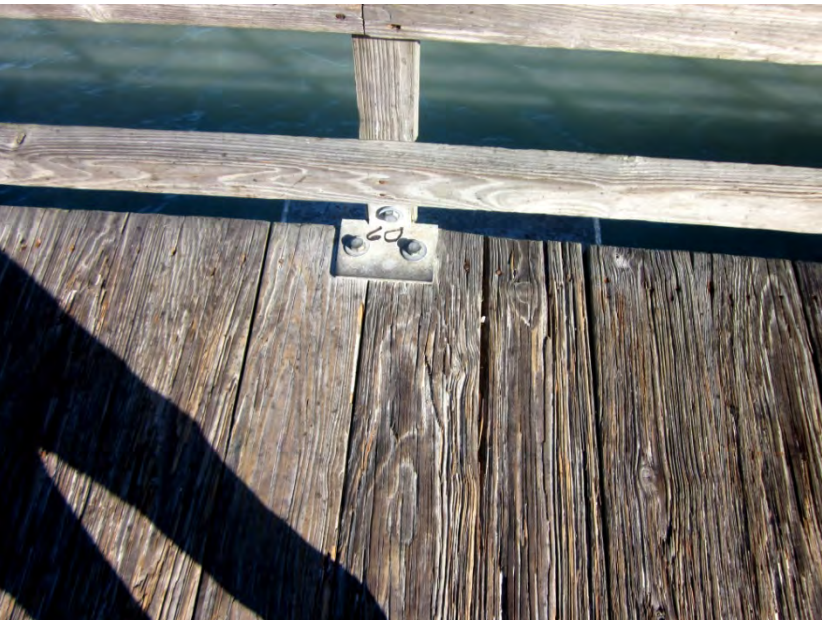
| Photo | Descriptions/Comments |
|---|---|
| | <p><b><i>Description:</i></b> View over Pier #60. Note the decking displays severe wear and tear.</p> |
