Owner
City of Naples

Police Station / Fire Department

Executive Summary Report

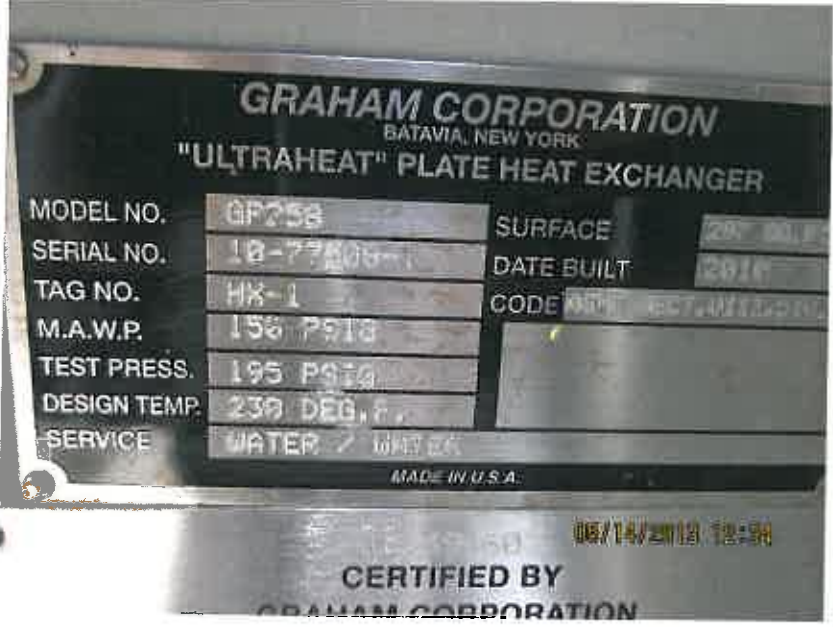
<p>Description: View of the machine plate on the plate heat-exchanger.</p>

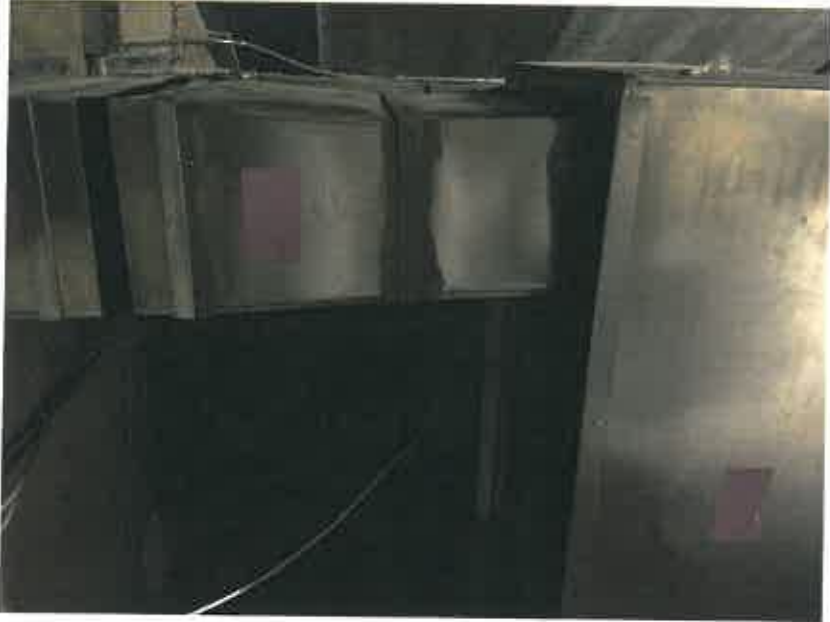
<p><u>Description:</u> View of the fresh-air duct from the dehumidifier in the rear storage room below entering the FAHU.</p>

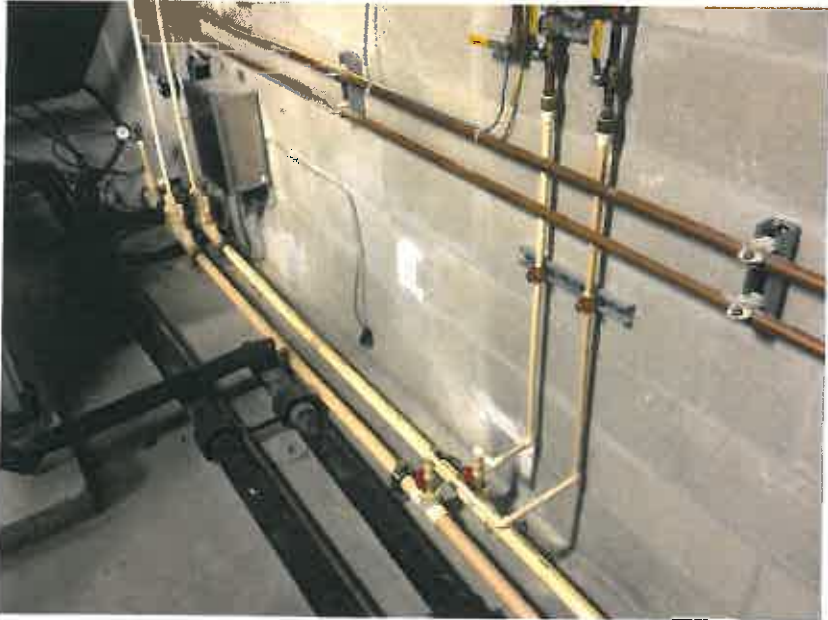
<p><u>Description:</u> View of the mechanical piping for the geothermal and the DX FAHU within the mezzanine.</p>

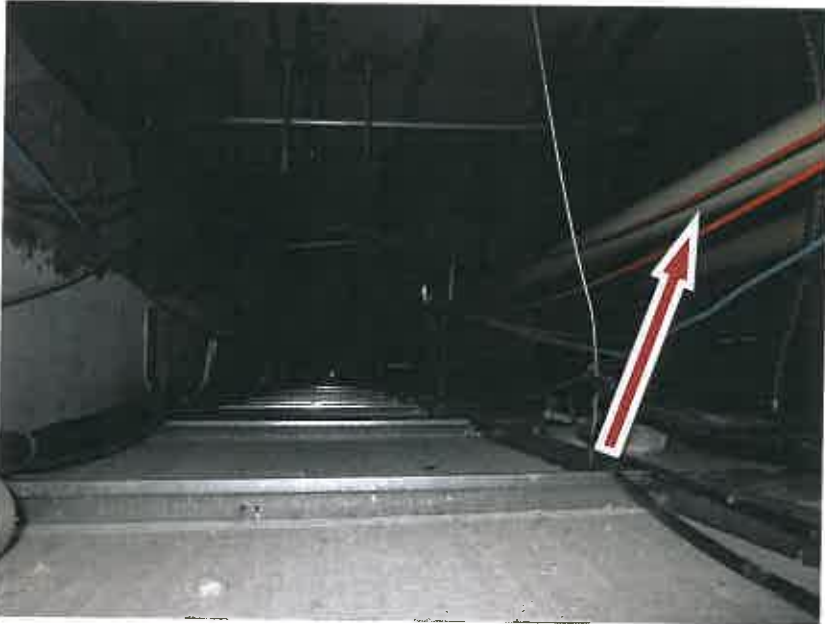
A photograph showing a long, narrow ceiling plenum. The floor is made of metal grates. On the right side, there are several large pipes, some with red and blue markings. A red and white arrow points to these pipes. The lighting is dim, and the background is dark.	<p>Description: General view of the ceiling plenum. Note the geothermal water supply and return piping on the right.</p>

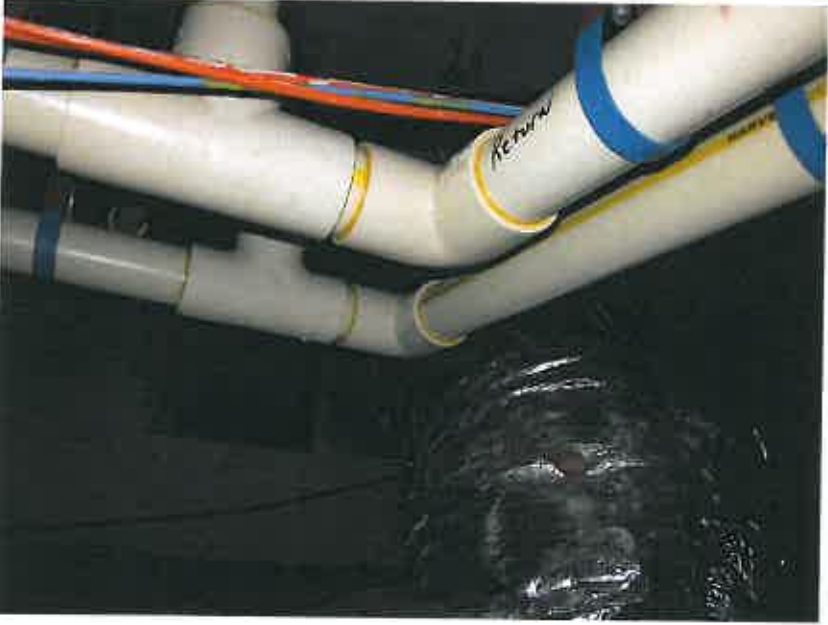
A close-up photograph of the piping and ductwork. There are several large white pipes, some with yellow and blue markings. One pipe has the name "Kevin" written on it. There are also flexible ducts and other components visible. The background is dark.	<p>Description: View of the geothermal water supply/return piping, and flexible ductwork within the ceiling plenum.</p>

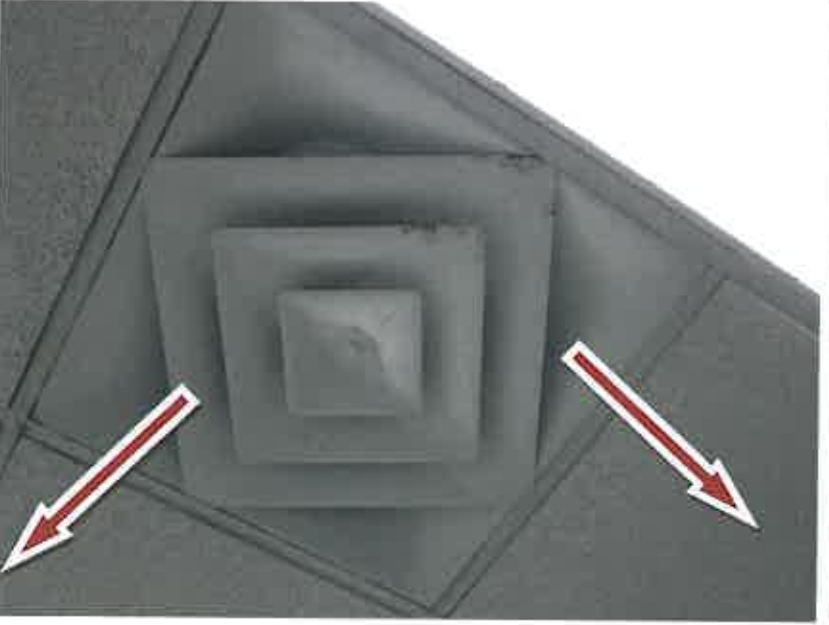
<p><u>Description:</u> A real air diffuser has a slight feature variation.</p>

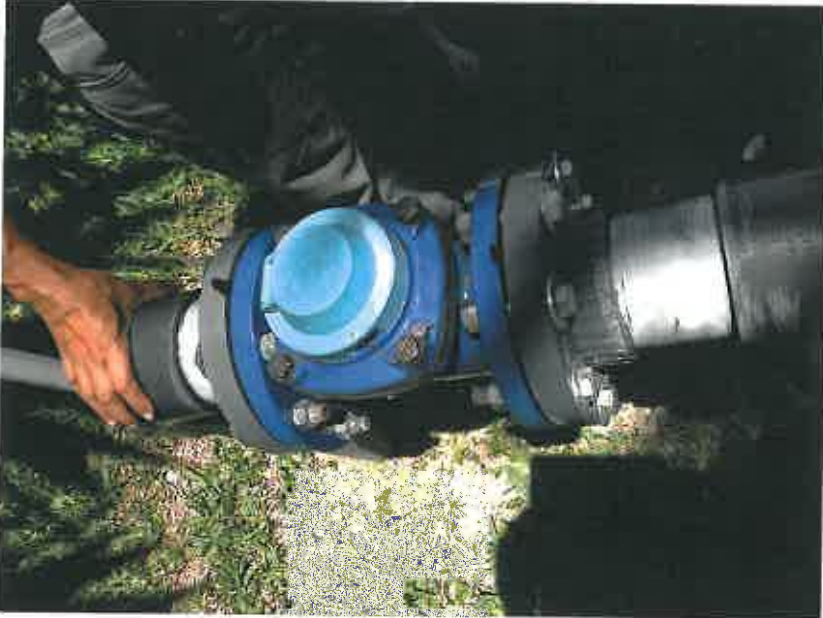
<p><u>Description:</u> View one of the geothermal (supply or recharge well?) Northwest of the West building.</p>

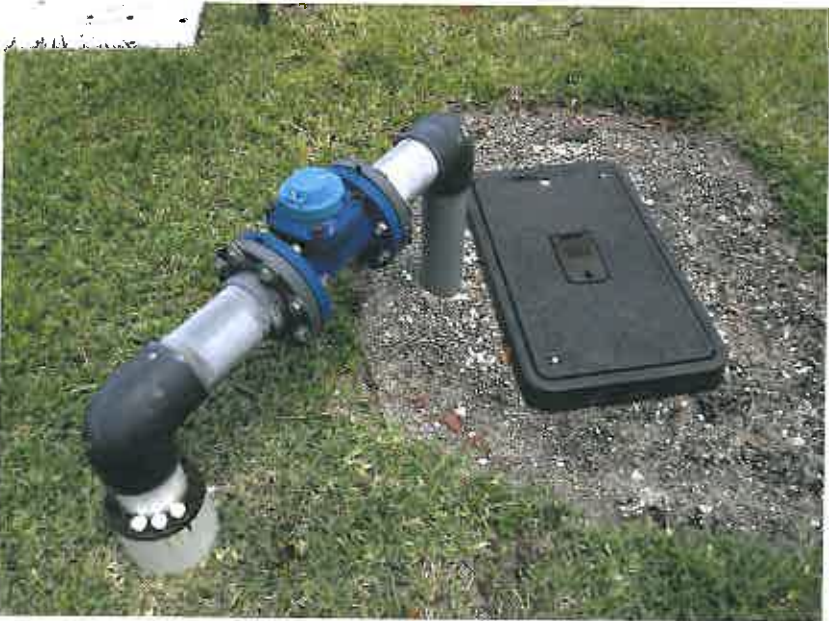
<p><u>Description:</u> View one of the geothermal (supply or recharge well?) Northeast of the East building.</p>

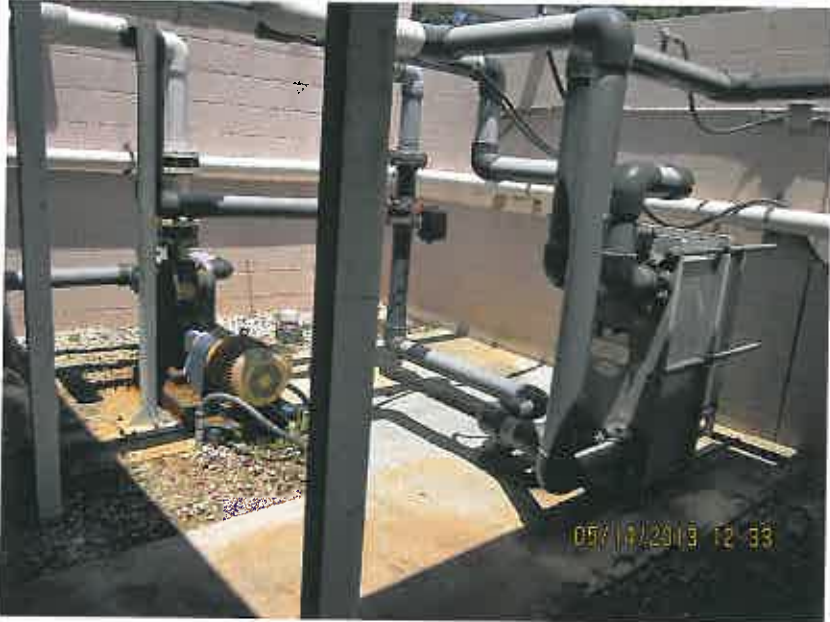
<p>Description: View of the geothermal well pumps (left) and the plate heat-exchanger (right), within the geothermal compound.</p>

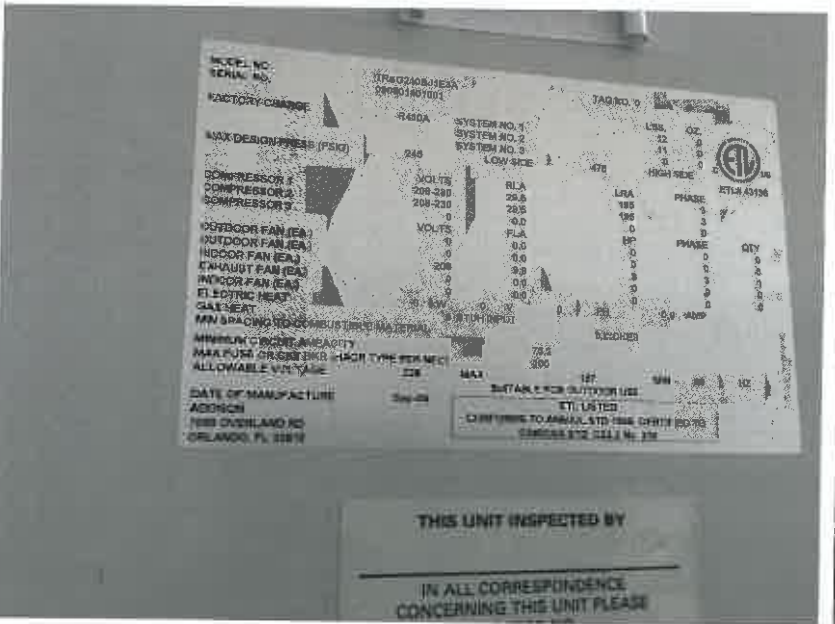
<p>Description: View of the equipment plate.</p>

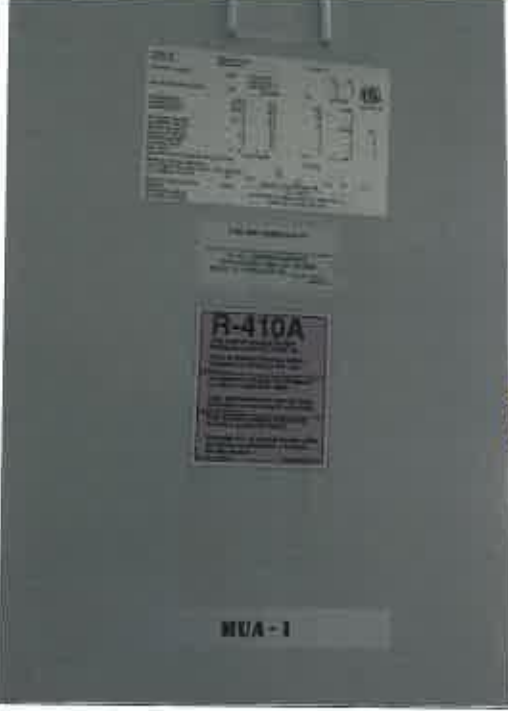
<p><u>Description:</u> The FAHU air-conditioning is a DX package system using R-410A refrigerant.</p>

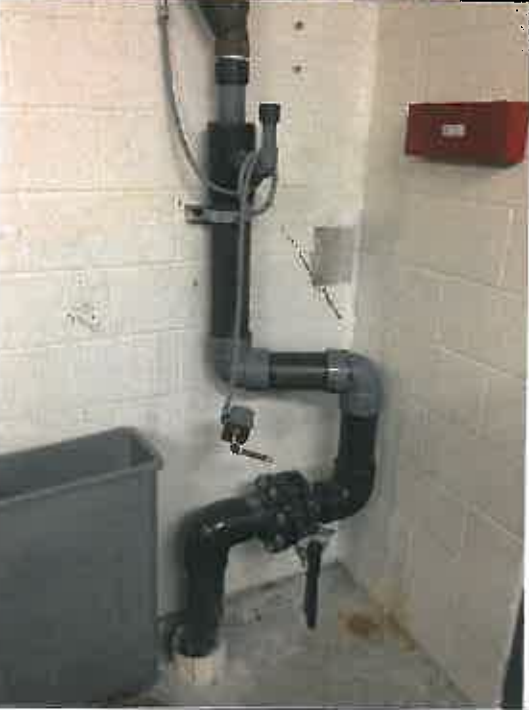
<p><u>Description:</u> View of the geothermal water entrance riser at the West/East building joint North emergency exit corridor.</p>

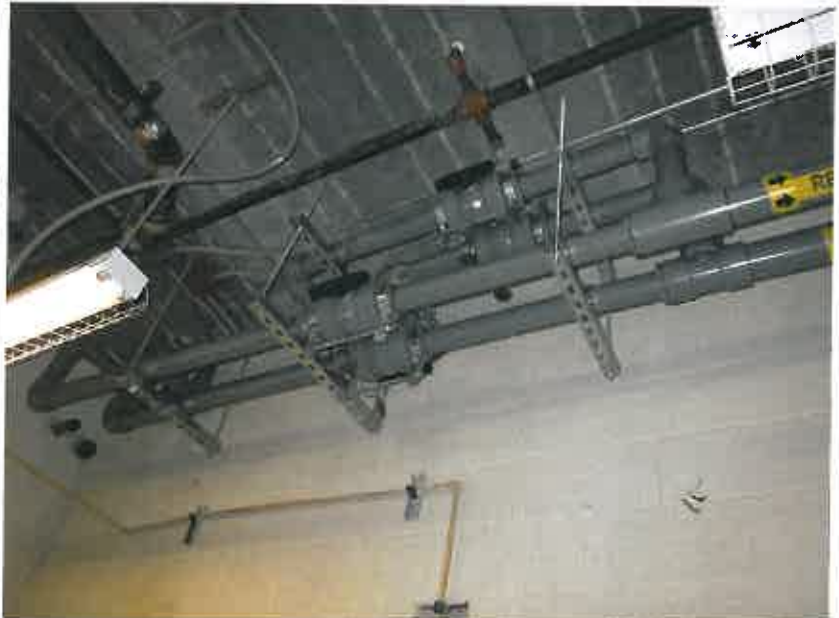
<p><u>Description:</u></p> <p>View of the geothermal supply/return piping turning West through the west building wall.</p>

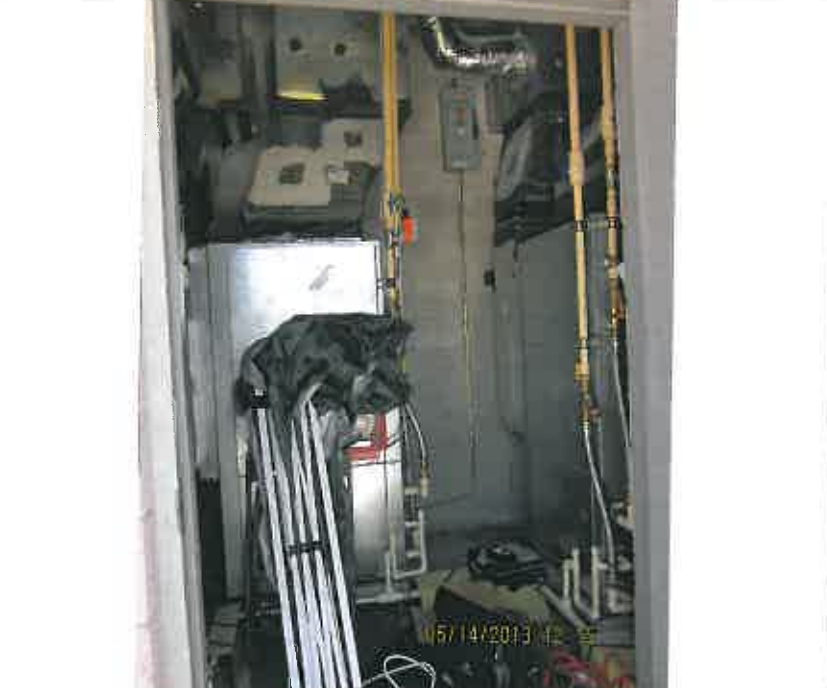
<p>A photograph showing the interior of a mechanical room. The room is filled with various pieces of equipment, including a large white unit on the left, and a dense arrangement of pipes and conduits. A timestamp '05/14/2013 12:31' is visible in the bottom right corner of the photo.</p>	<p><u>Description:</u> View inside the South mechanical room.</p>

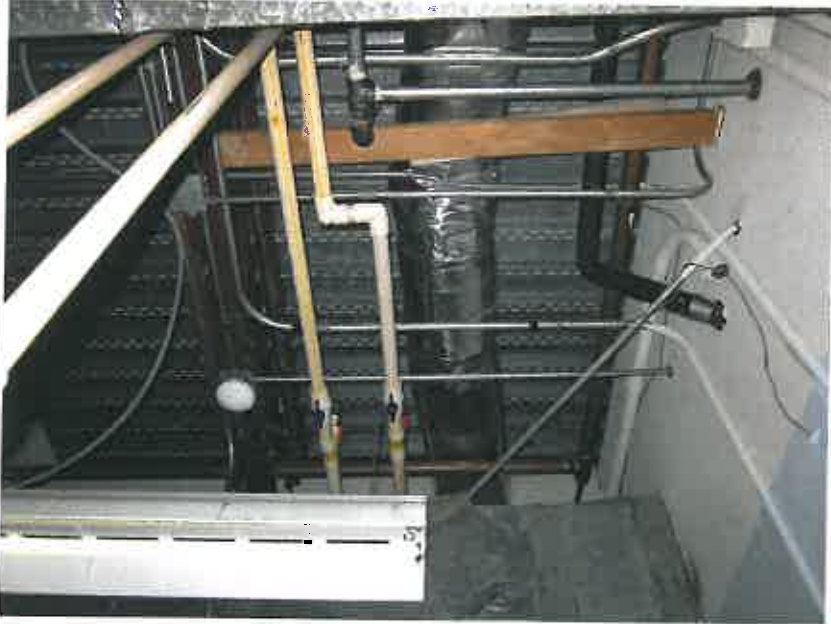
A photograph showing a complex network of pipes and conduits in a mechanical room. The pipes are wrapped in insulation and are connected to a system. A white electrical panel is visible in the foreground.	<p><u>Description:</u> View of the geothermal water supply/return connection inside the middle mechanical room.</p>

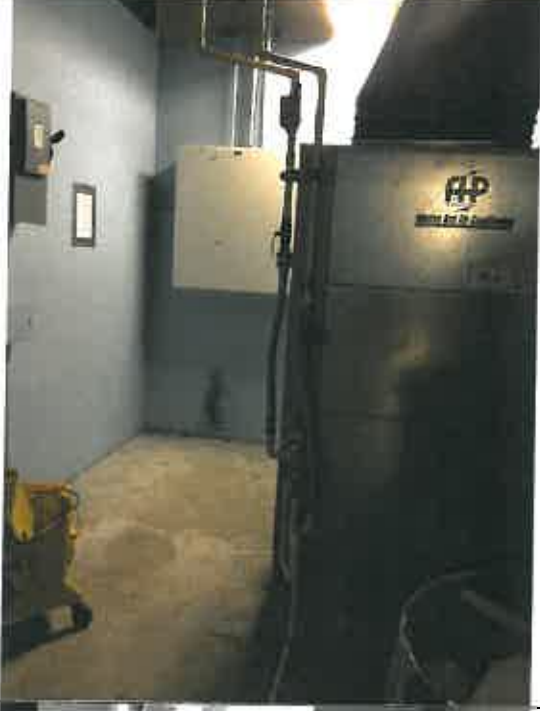
A photograph showing a tall, dark-colored HVAC unit in a utility room. The unit has a logo on top that reads "HP". To the left of the unit is a white electrical control panel. The room has a concrete floor and a white wall.	<p><u>Description:</u> View of HP-6.</p>

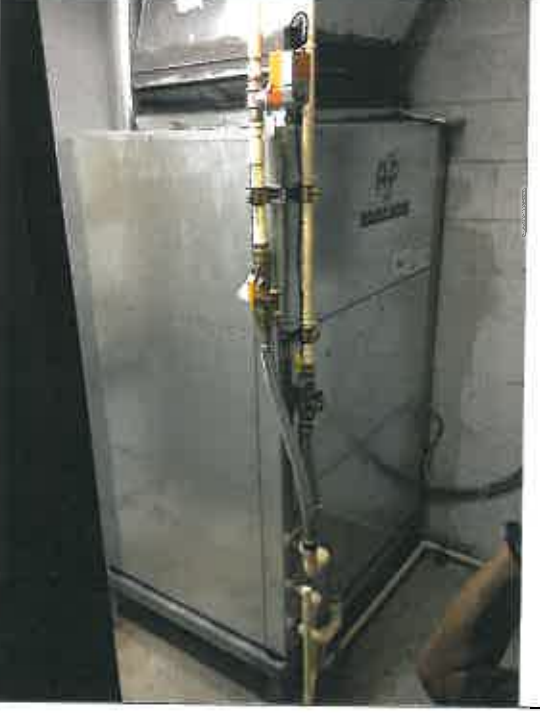
A close-up photograph of the HVAC unit HP-2. It shows the refrigerant lines and service valves on the side of the unit. The unit is silver or light-colored metal. The background is a white wall.	<p><u>Description:</u> View of HP-2.</p>

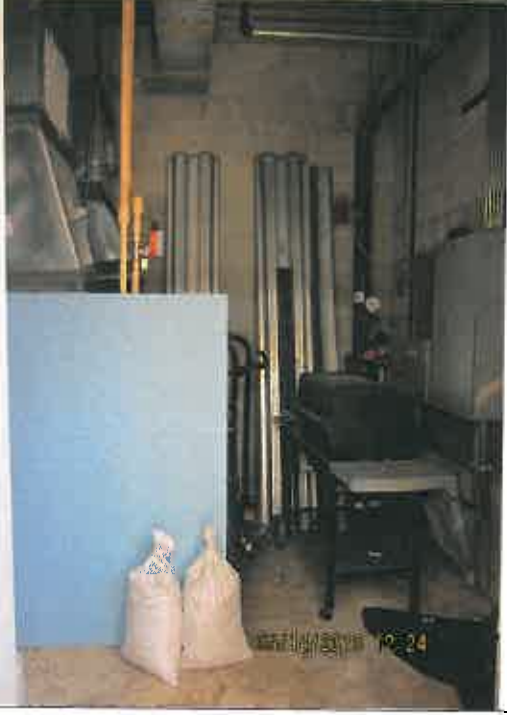
<p><u>Description:</u> View of the North end mechanical room where HP-1 is located.</p>

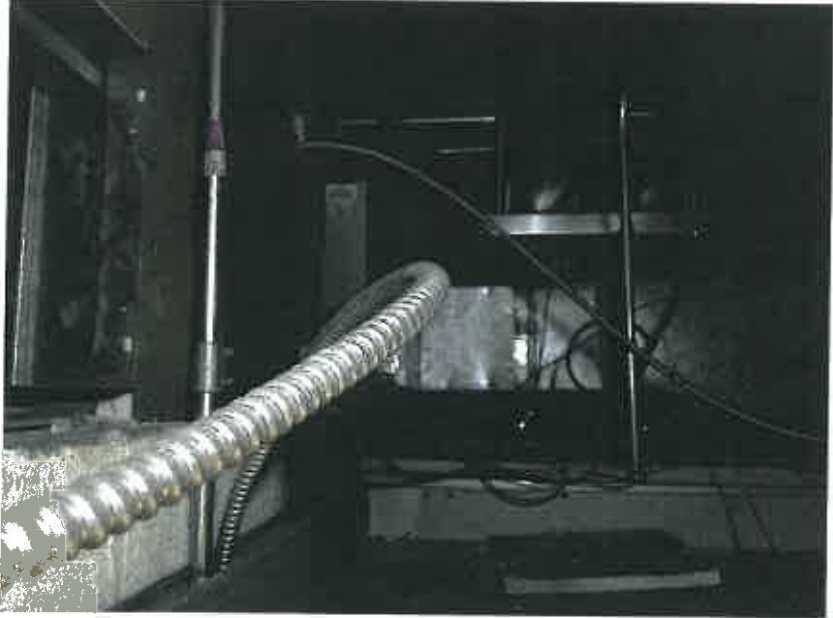
<p><u>Description:</u> Typical view inside the ceiling plenum.</p>
