City of Marco Island

# Seawall Owner's Manual

Waterways Advisory Committee

April 2014

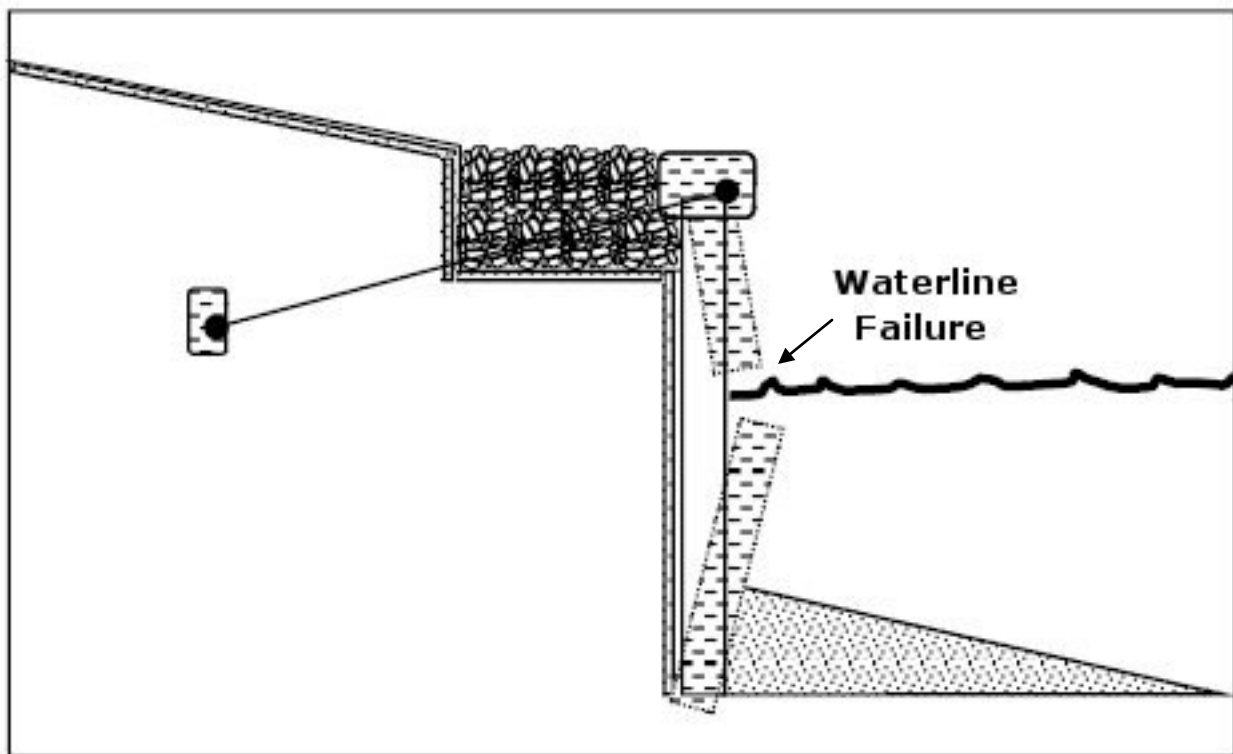
WATERLINE FAILURE

**Cause:** Aging, corrosion of concrete and reinforcing rod and uneven hydrostatic pressure. Slabs or panels develop horizontal cracks usually along the water line, and the panels eventually break along these lines.

**Symptoms:** The principal symptom is the cracks along with rust marks on the panels facing the water.

**Remedies:** The remedy for an advanced failure will usually mean new panels, cap, tie-back rods and deadman; in other words a complete new seawall. Seawalls with minor cracks could probably be repaired in the manner of cap and tie-back rod failure, i.e. stabilization of the berm and cap repairs. Attention will need to be given to reducing or eliminating uneven hydrostatic pressure from water behind the wall. Also helical anchors may be used to secure the wall.
