EXHIBIT A

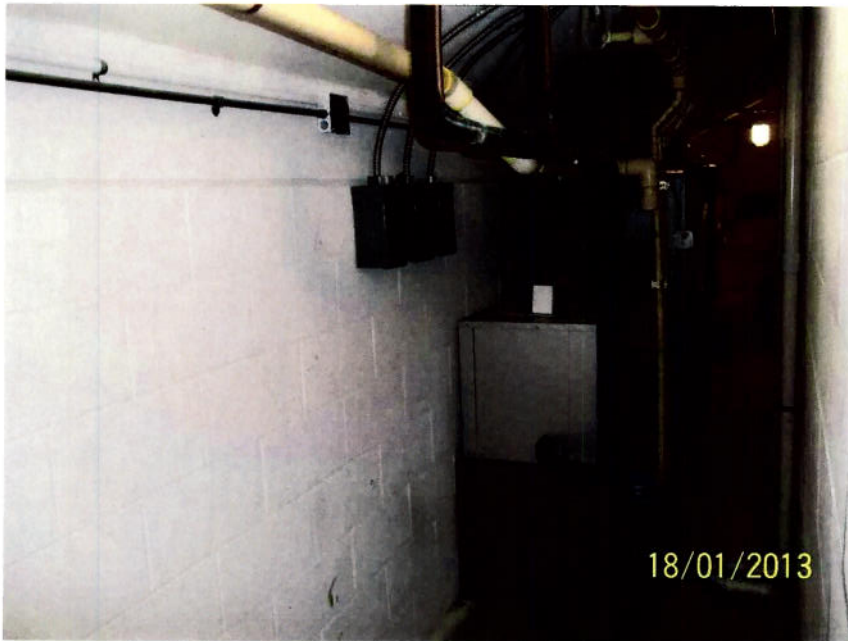
CU-4: Existing unit to be disconnected, sealed off, and left in place to prevent having to disconnect CU-1 for removal of CU-4

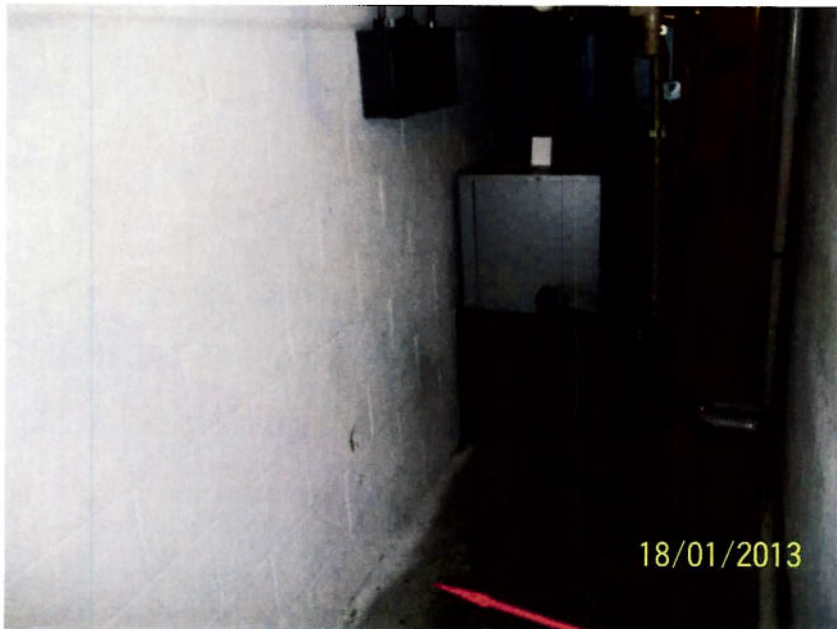
Location for new CU-3 & CU-4: The bottom CU shall be set on rubber isolator pads. The upper CU shall be mounted on a shelf or rack that will support the upper CU but not restrict full maintenance access to bottom CU. Plumbing and refrigerant lines are to be relocated in a neat and professional manner that will not interfere with maintenance access of the units. Power and control equipment shall be relocated in a neat and professional manner that will not interfere with maintenance access of the units.

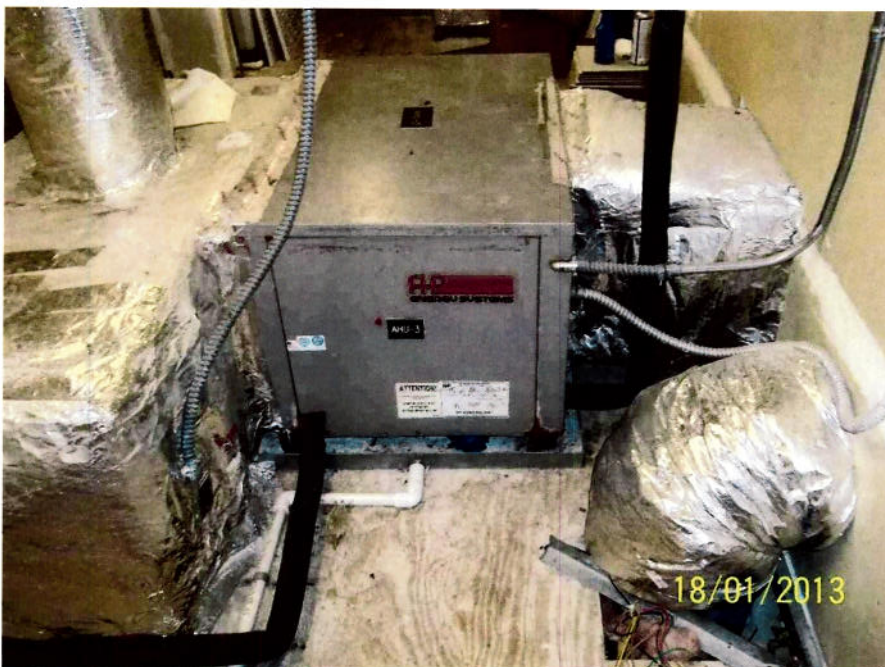
AHU-3: Located above 2nd floor bathrooms. Remove and dispose of properly. Replace and full reconnect with new unit.

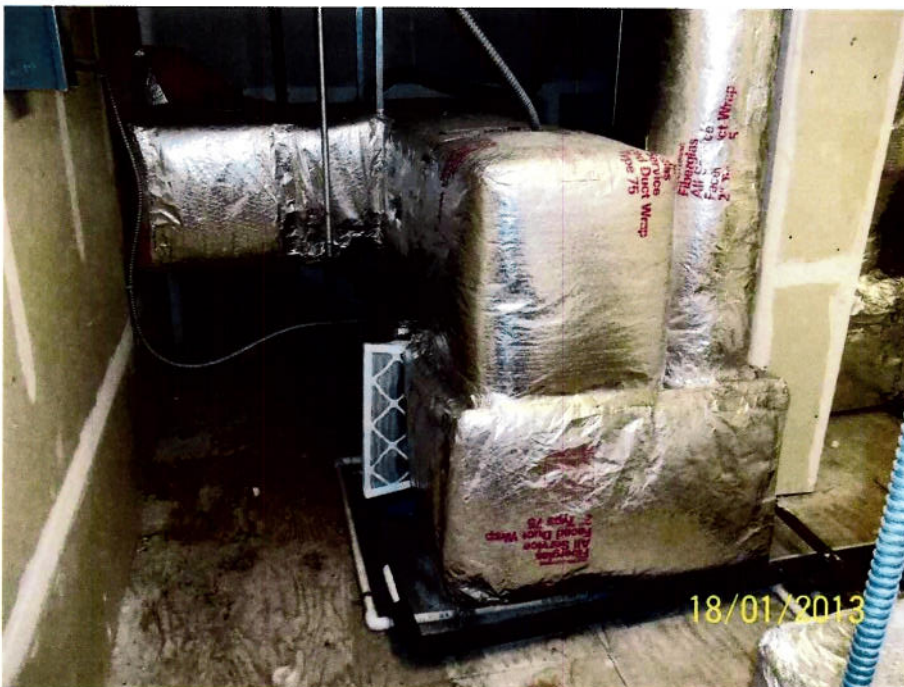
AHU-4: Located above 2nd floor bathrooms. Remove & properly dispose of unit. Replace and full reconnect with new unit.

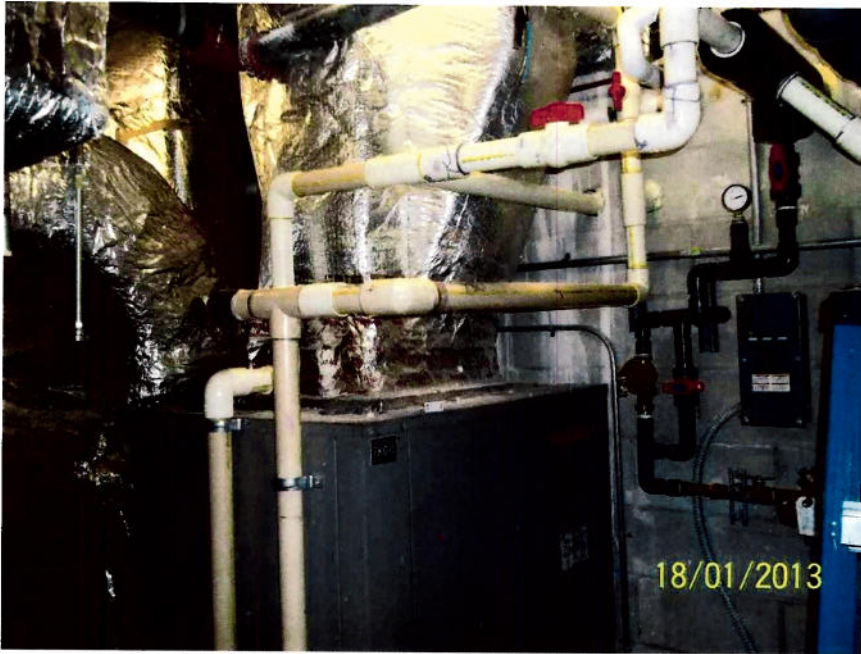
Package Unit#1: Re-circulated water coolant piping and discharge duct.

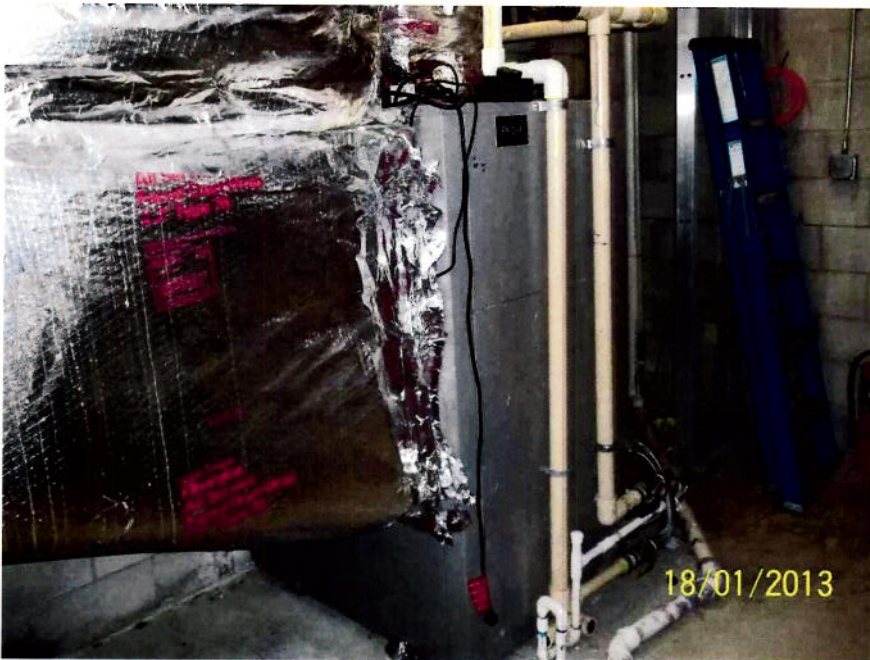
Package Unit#1: Air intake duct needs reworked/replaced and supported properly to allow proper filter installation and replacement for new unit.

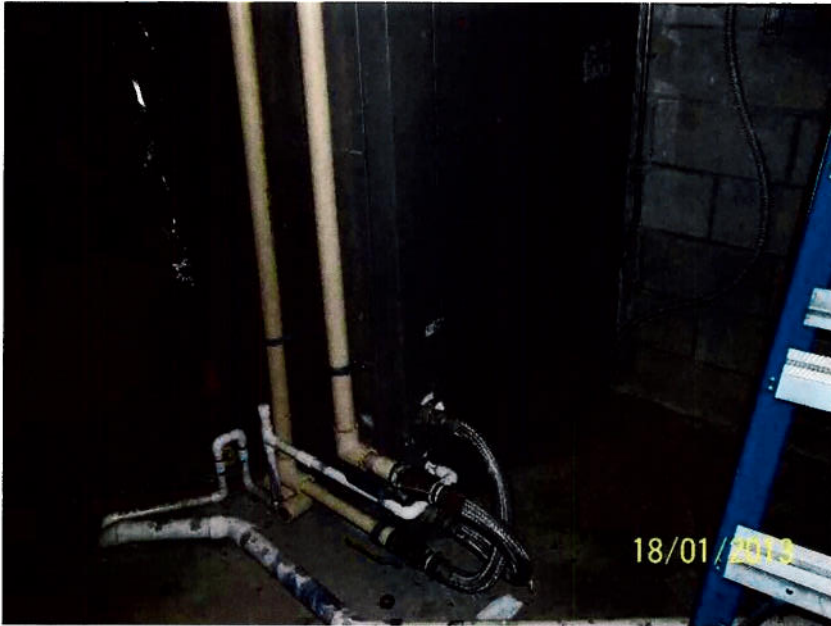
Package Unit#1: Re-circulated coolant water piping connections.

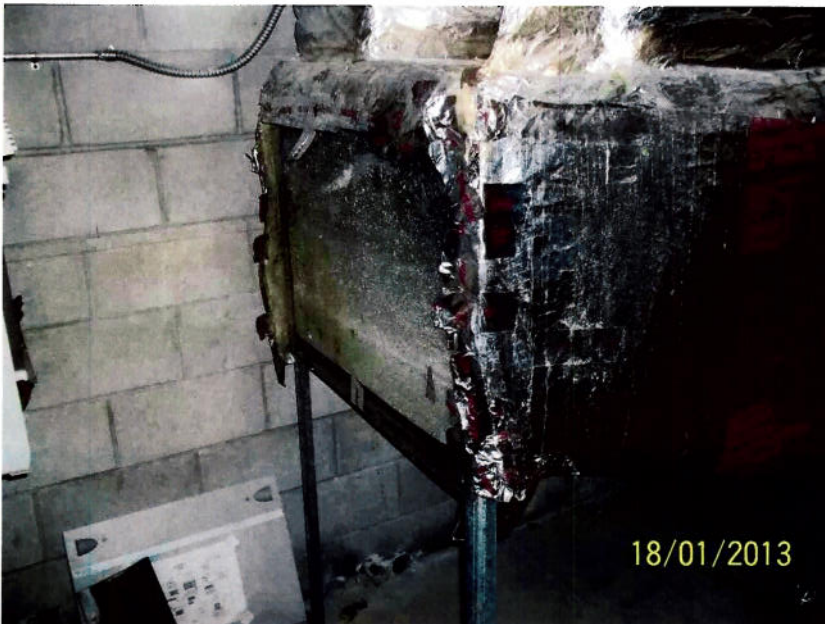
Package Unit#1: Air intake duct needs repair/replacement. Make-shift filter and plexiglass needs removed and duct repaired/replaced.

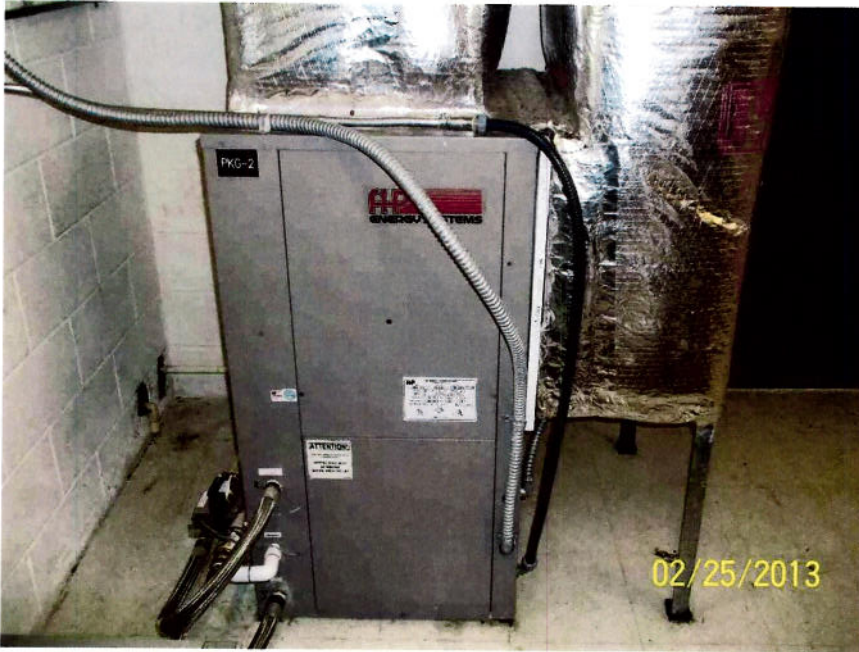
Package Unit #2: Located in storage room off Training Room. Full replacement. Dispose of old unit properly.
